HORNSBY SHIRE COUNCIL  
REPORT ON PROPOSED FILLING

OLD MAN'S VALLEY  
HORNSBY

REPORT S8463/2-AC      JULY, 1989

RE: Report on Proposed Filling, Old Man's Valley, Hornsby

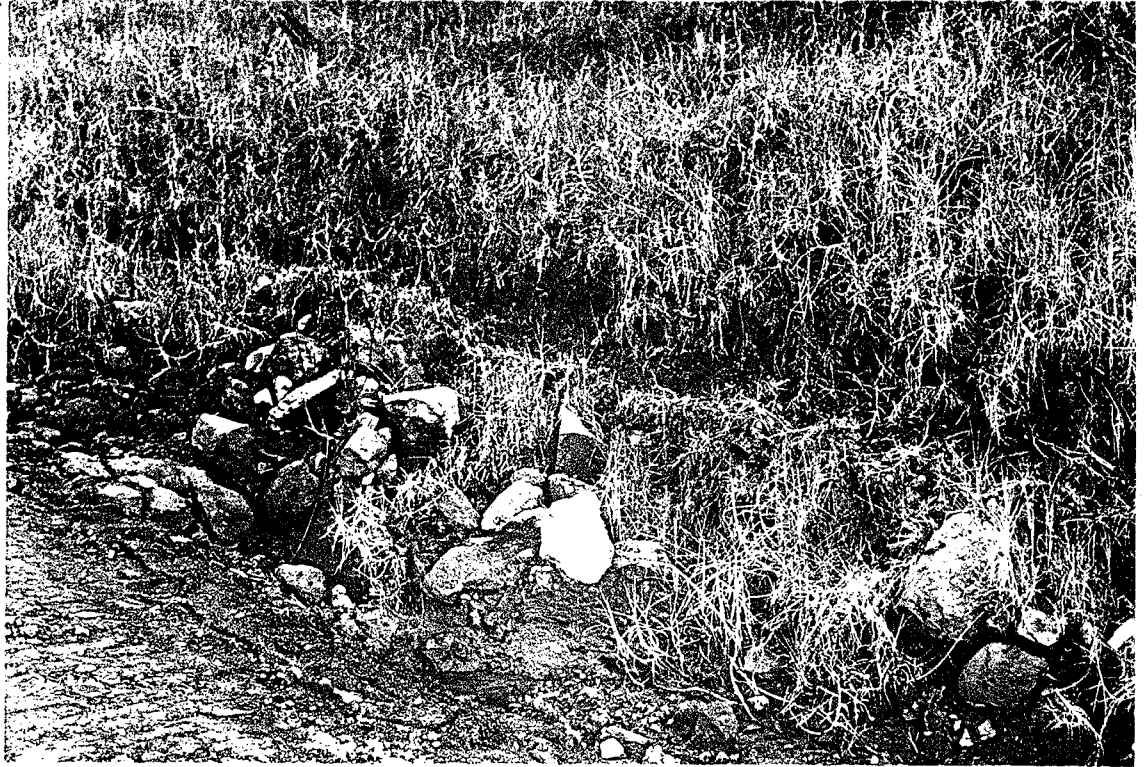
Seepage was noted from halfway along the access road which runs down to the quarry. This road forms a berm in the northern batter of the existing playing field and is cut into natural soil on the uphill side over part of its length (Figure 3 and Photographs 1a, 1b and 1c). A substantial localised seepage flow emerges from this batter in the centre of a feature which could be a shallow slip in the batter. Elsewhere, general seepage was evident along the toe. This seepage is presently collected in an unlined drain and led to the creek which runs from south to north along the west boundary.

Photograph 1a - Natural drainage gully developed at (Approx. Ch.260m) boundary between northern toe of playing fields and access road. Note residual red-brown clay exposed in gully. Water in gully is almost entirely derived from seepage from toe of fill embankment.

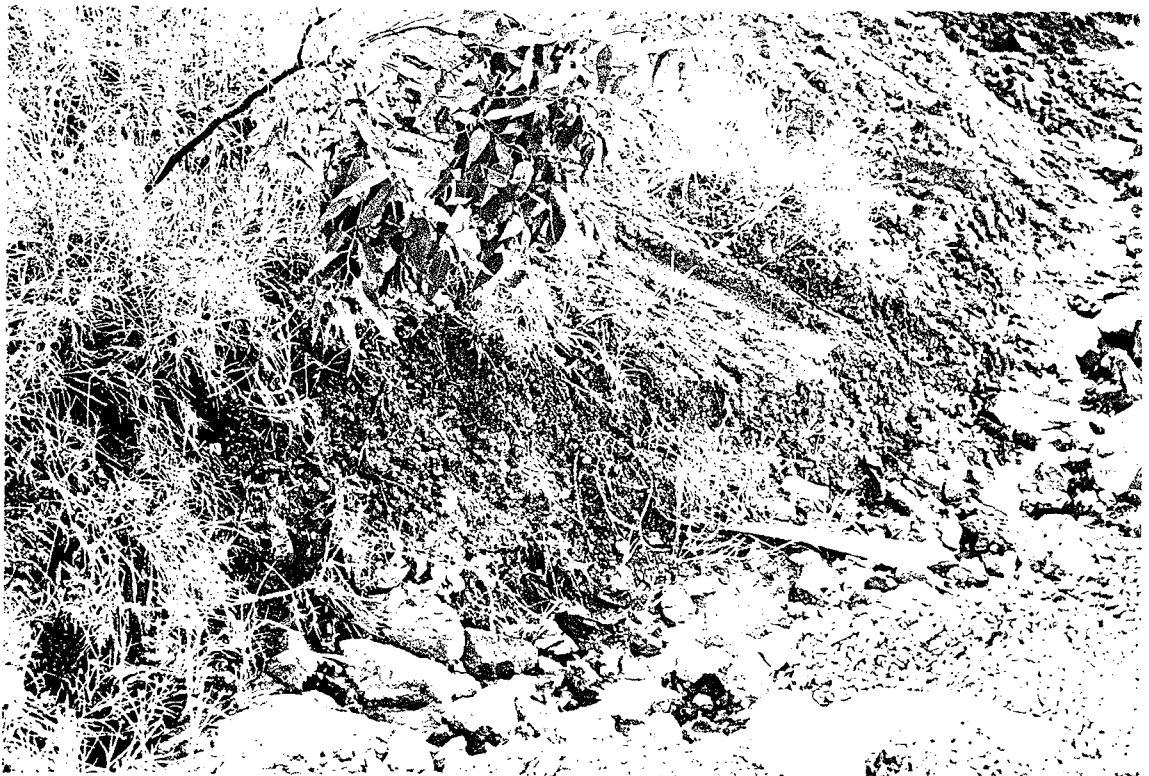
PHOTOGRAPH 1b - View looking west along drainage gully. Note wet soil and seepage to left of drainage gully. (Approx. Ch 260m)

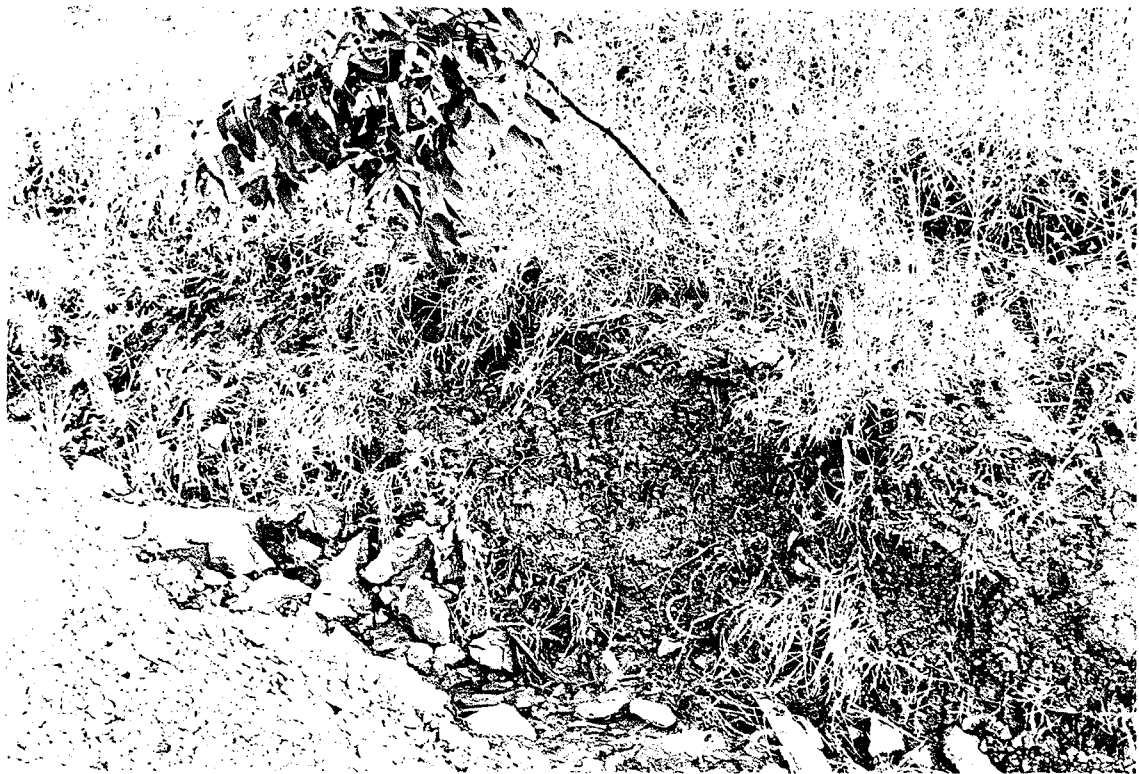
Photograph 1c - View of seepage emerging at toe of north western corner of existing playing fields. The seepage emerges near to the boundary between the fill and residual breccia soil. (Approx. Ch 260m)

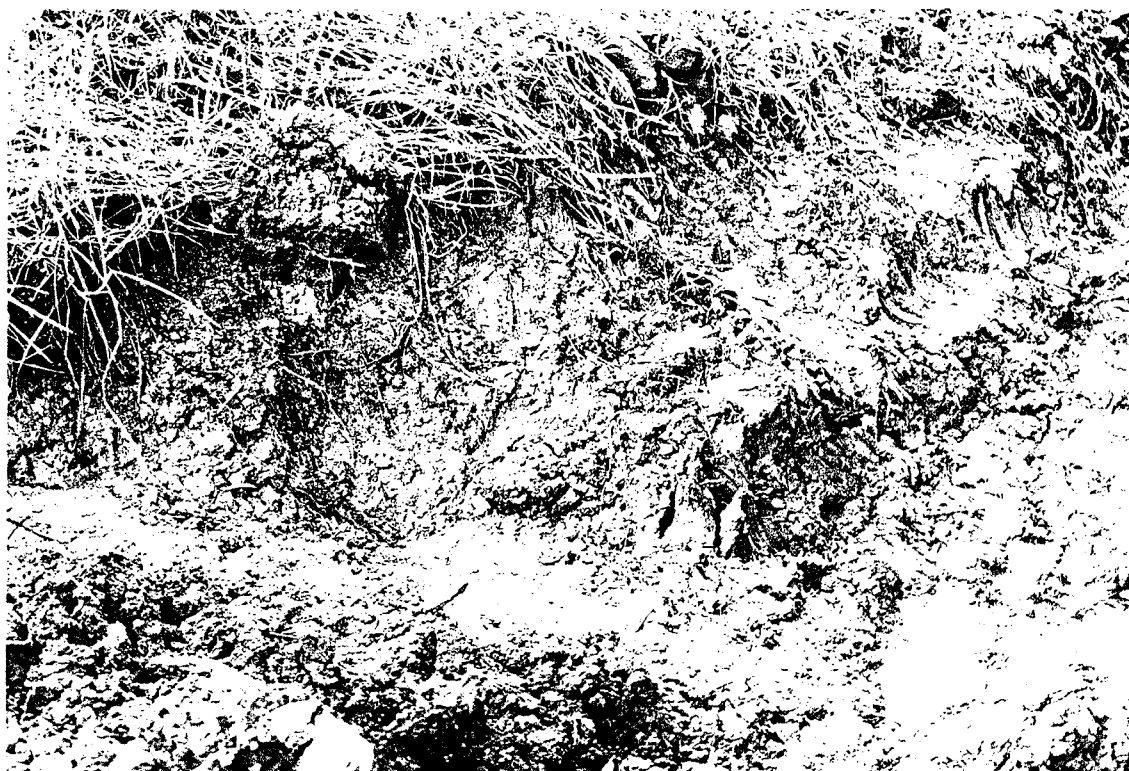
Seepage was also noted at the toe of the filled slope of the existing fill near BH7 (Photographs 2a and 2b). As described below, a toe "key" was constructed along the toe and BH7 was drilled just uphill from the key and a standpipe was installed to check if water was ponding behind the key (Figures 1 and 5). This standpipe showed a water level at about the natural ground surface. A second standpipe was installed at BH8 just downhill from the toe. This standpipe showed a much lower water level. It is possible that there is a time lag in the response but it is also possible that the water level in BH7 is ponded in the residual/extremely weathered breccia behind the "key", while the water level in BH8 represents that in the underlying highly to moderately weathered breccia. More standpipes would be required to decide this issue.

Photograph 2a - Seepage emerging at western toe of existing playing fields at approximately Ch.220m.

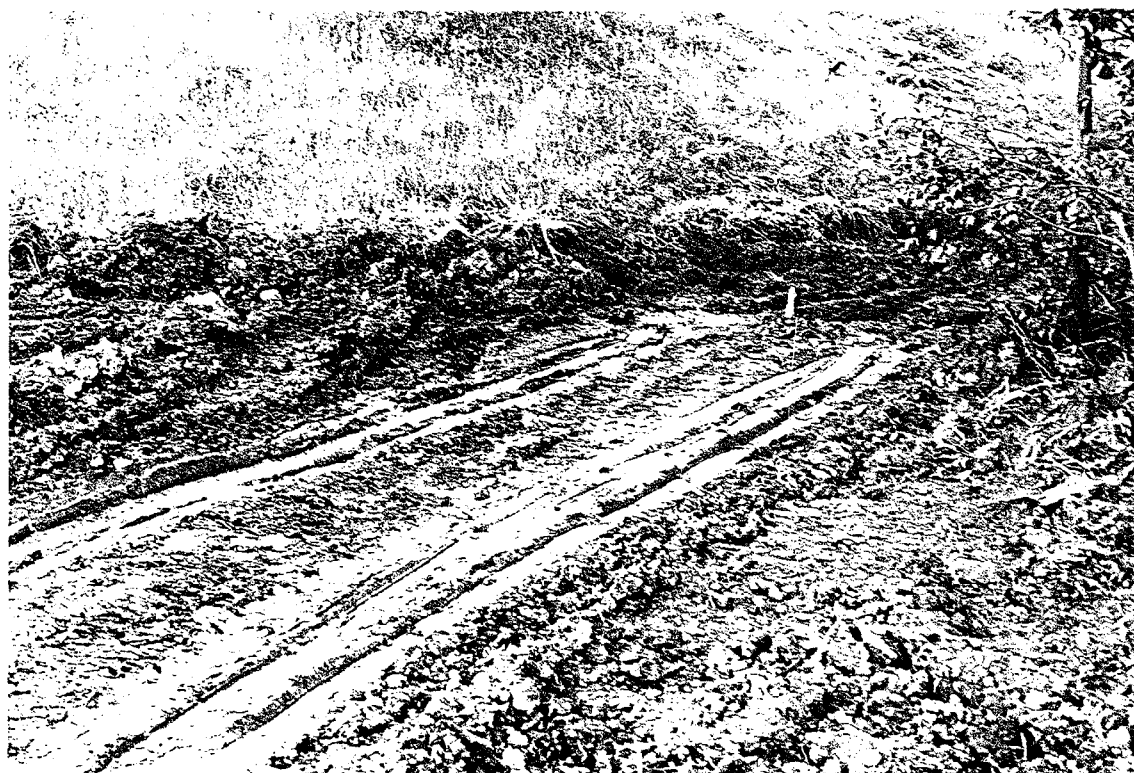
Photograph 2b - View of boreholes BH7 and BH8 (white pipes). Note water siting on surface in foreground. This area was dry 12 hrs prior to photograph being taken. The water is seepage from fill toe. (Approx Ch 215m to 230m).

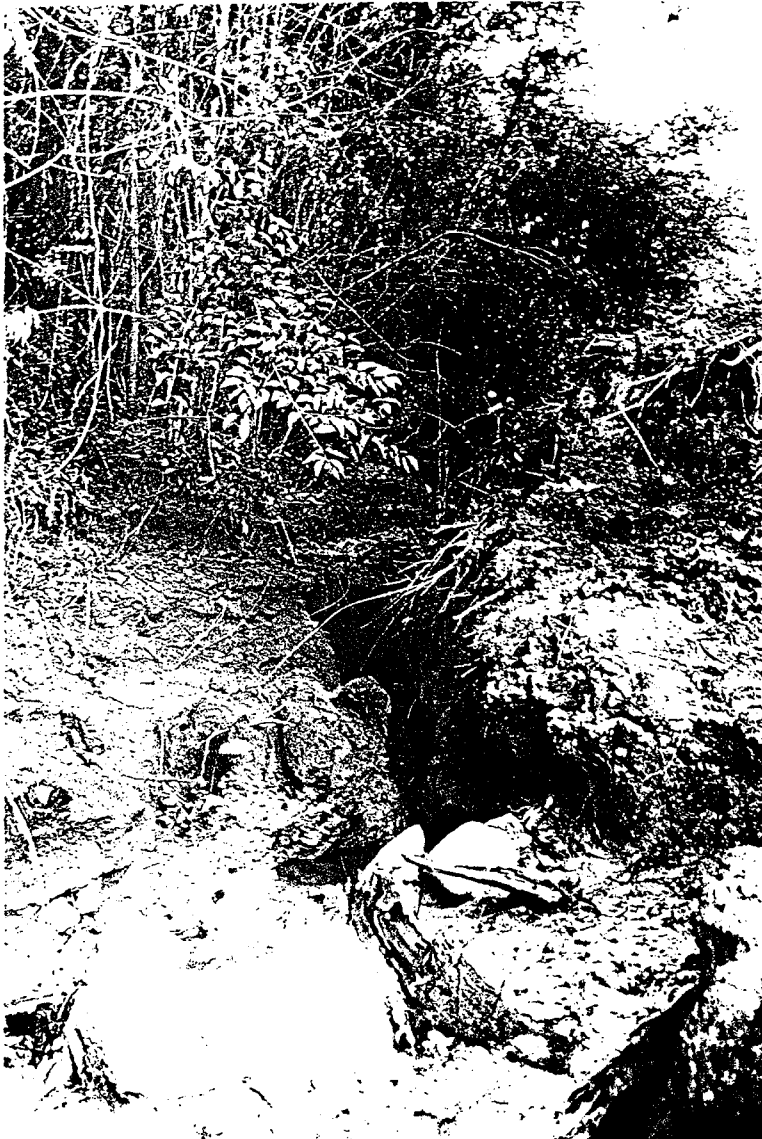
← Approximate level of creek before lowering of culvert invert level.

← Boundary between alluvium, brown (top) and residual clay/breccia yellow-brown (bottom).

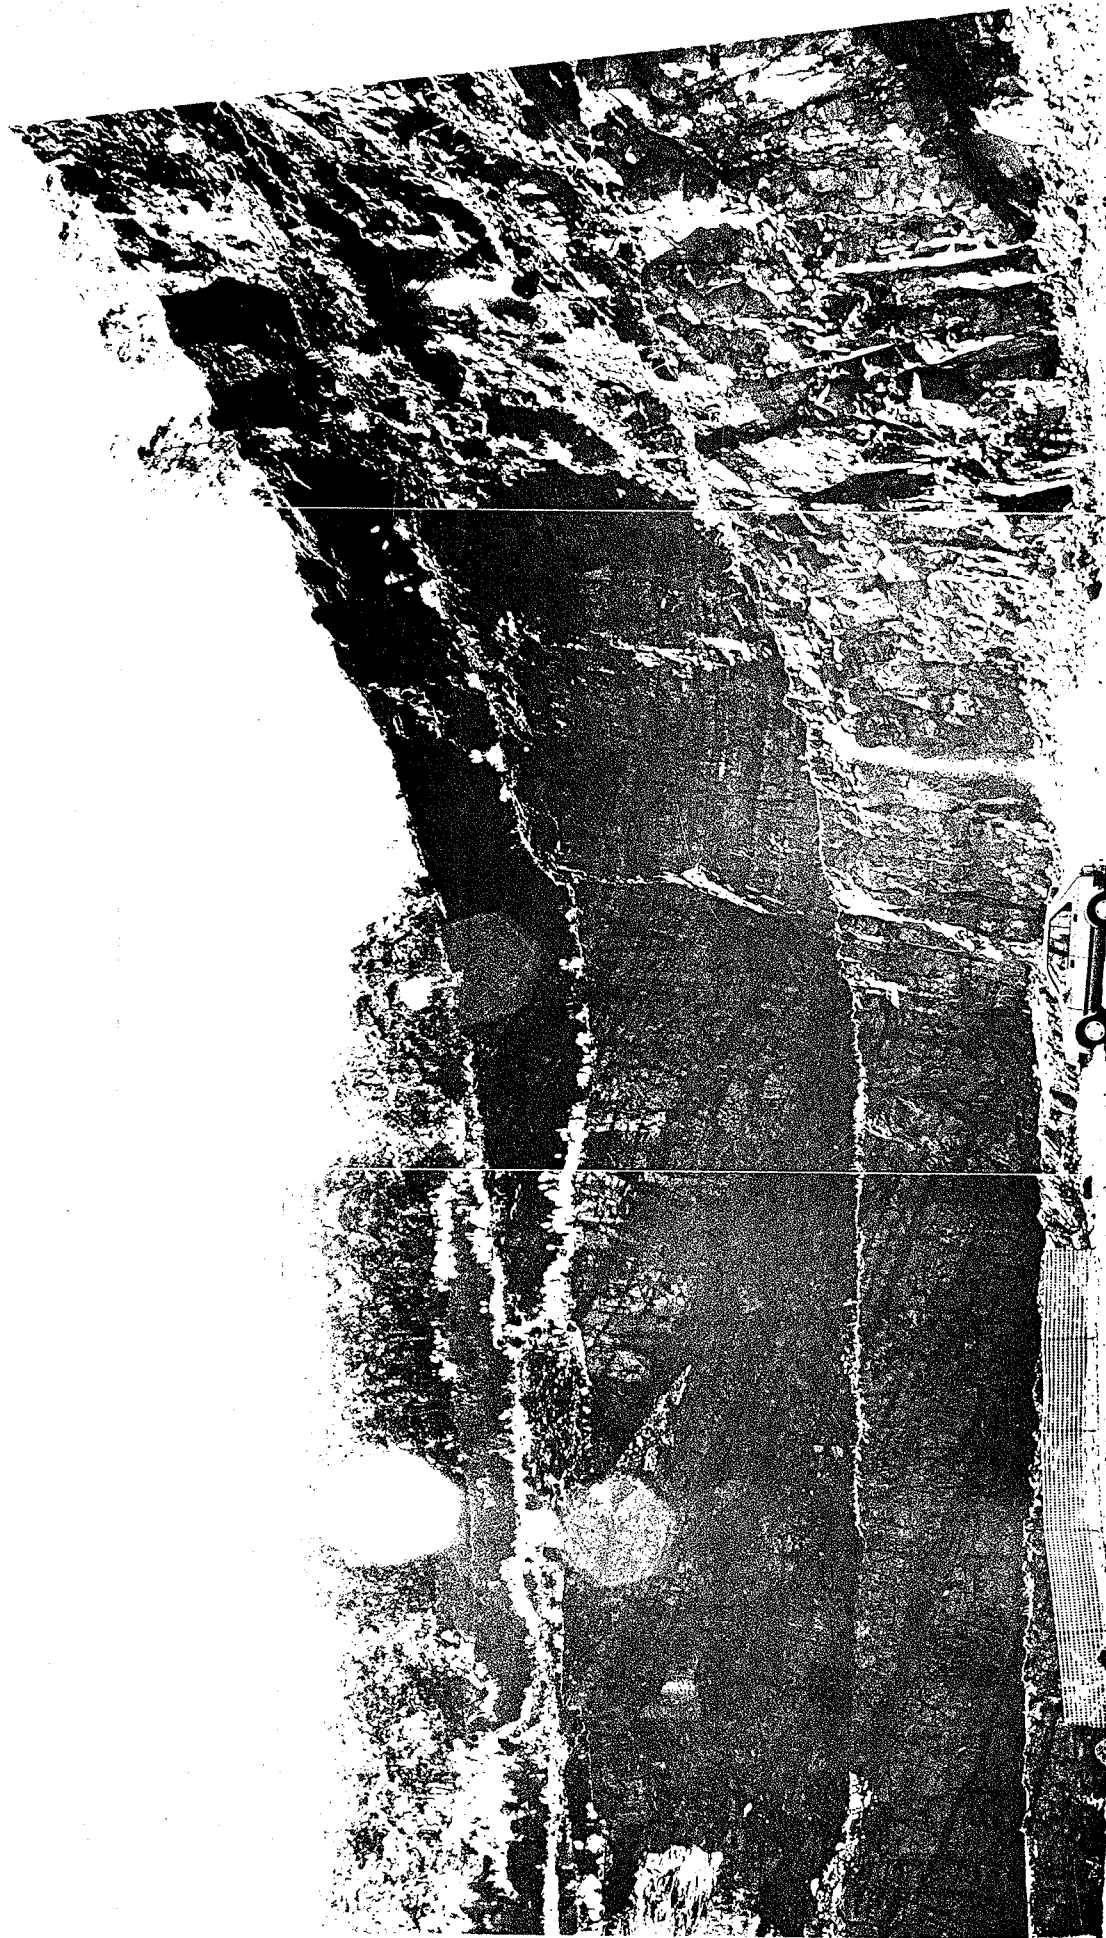
Exposures of the Hornsby Diatreme in Hornsby Quarry indicate a basinal layering of the diatreme. This basinal layering is particularly well defined in the eastern face of the quarry (see Photographs 5a and 5b). According to Crawford et al (Ref. 1) "although the original crater deposits probably had a slight centroclinal dip, the exaggerated basinal structure observed here is probably due to peripheral drag as the volcanic breccia subsided within the surrounding ring fault".

PHOTOGRAPH 5b - View of north east corner of pit - note bedding dipping into east face.

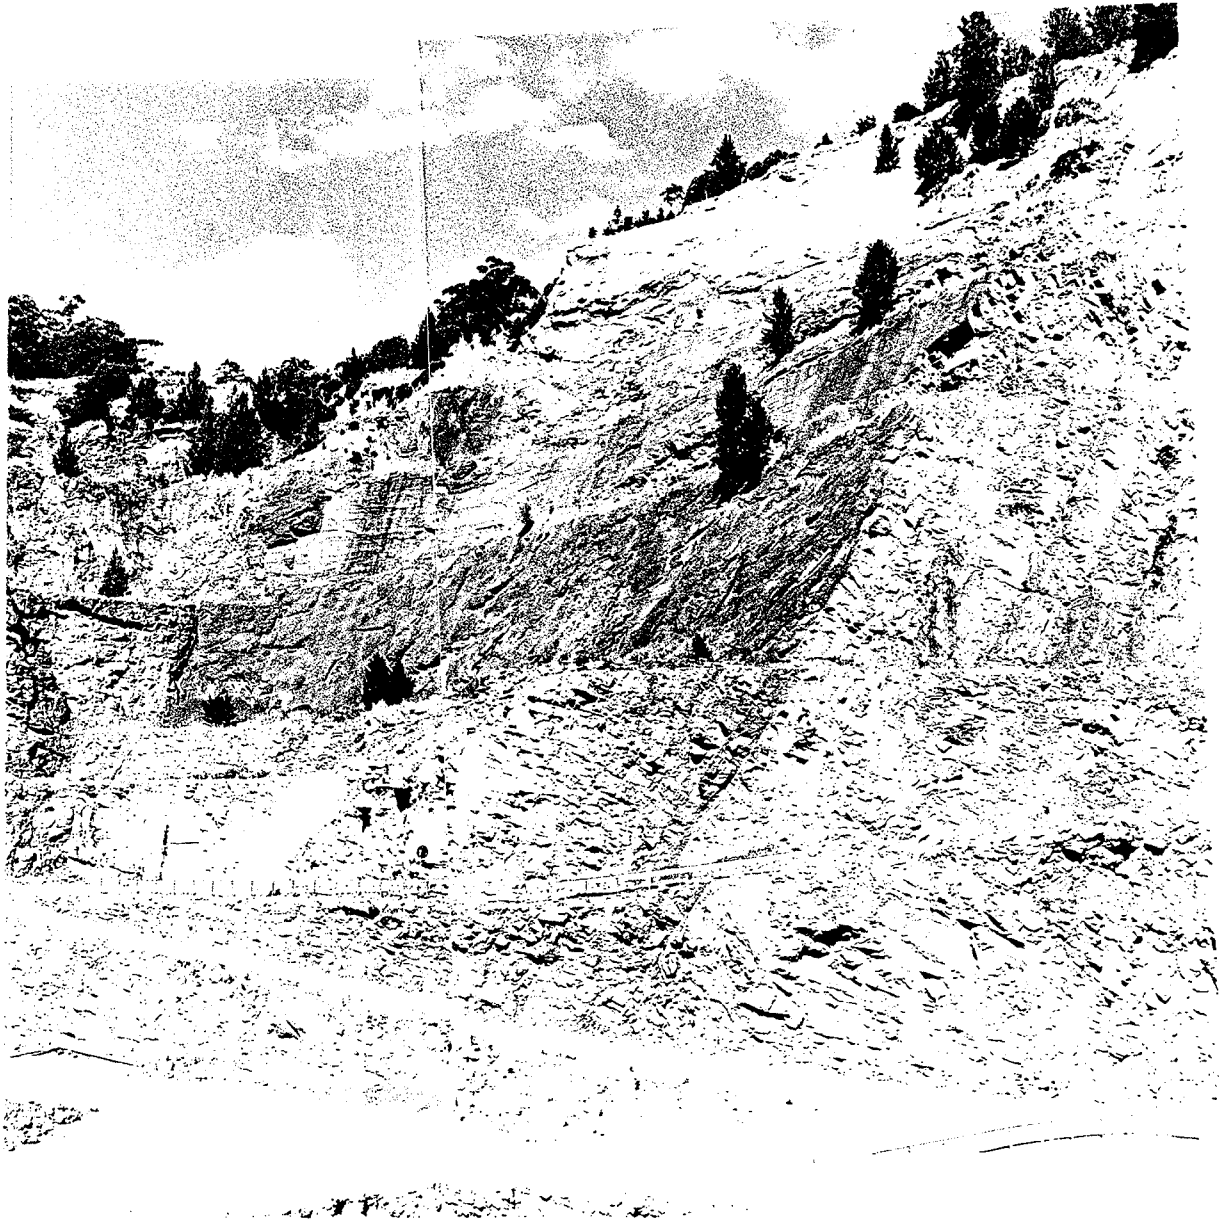
PHOTOGRAPH 6 - Bedding plane exposed by slide  
on south east corner of pit.
