Crosslands Reserve Site Plan NTS
Project - Proposed Master Plan for Crosslands Reserve, Hornsby Shire Council

Access Road Report,
Ray Dowsett Traffic and Transport Planning
Pty Ltd, June 2005

**'CROSSLANDS RESERVE',
SOMERVILLE ROAD,
HORNSBY HEIGHTS**

**PRELIMINARY ASSESSMENT
OF ACCESS ARRANGEMENTS**

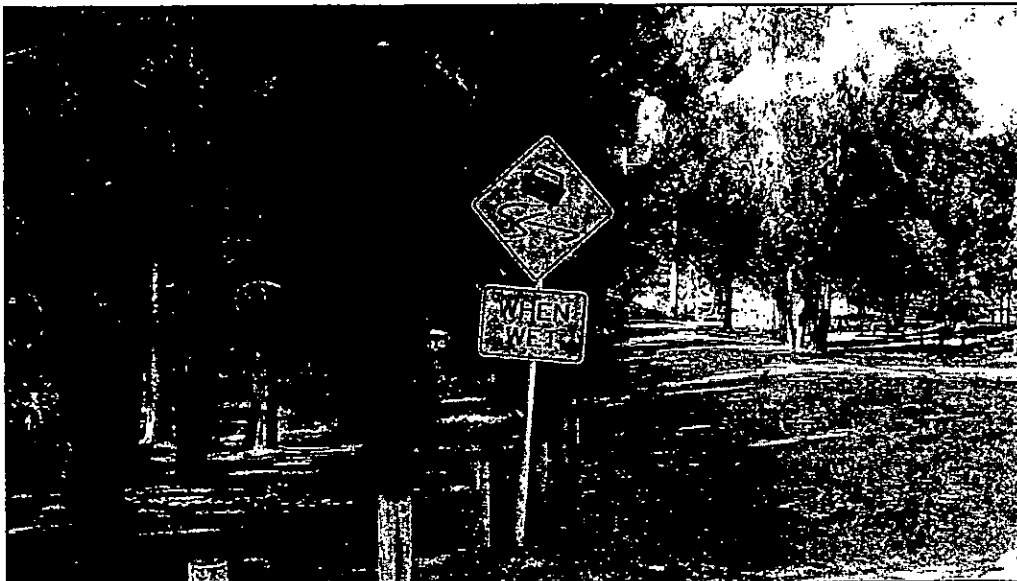
Photograph 4

WARNING SIGNS AT RESERVE EXIT

- Provide 'Bicycle' [W6-7] and 'Pedestrian' [W6-1] warning signs at the entry gate to the park and at the exit from Crosslands Reserve.
- Relocate the 'Reduce Speed' warning sign 60m south of the curve and install 'Curve Left' sign [W1-3 (L)] sign approximately 30m in advance of the 'Reduce Speed' sign (this action was also recommended in the Road Safety Audit Report).
