Hornsby Heritage Study Review Stage 5, 2012

Volume 3—Appendix G Part 2: Sites D31–E78 and Appendix H

Report prepared for Hornsby Shire Council
March 2013

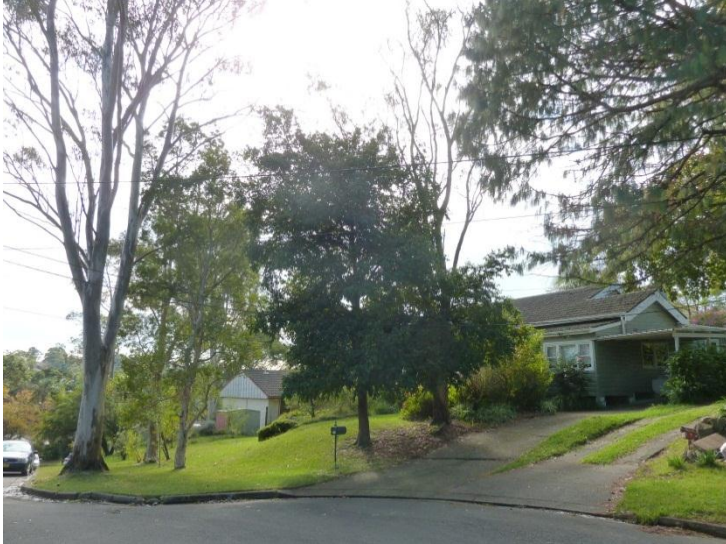
Physical Condition: Eucalypts in front garden and nature strip of 5 Wanill Place had very sparse canopies at time of inspection. Other trees appeared to have healthy canopies but detailed analysis of condition requires assessment by arborist.

Caption: Trees in garden and nature strip of 5 Wanill Place with part of canopy of *Pinus patula* in front garden of 7 visible at right.

Recommended Management: Remove from LEP schedule but include trees on Significant Tree Register.

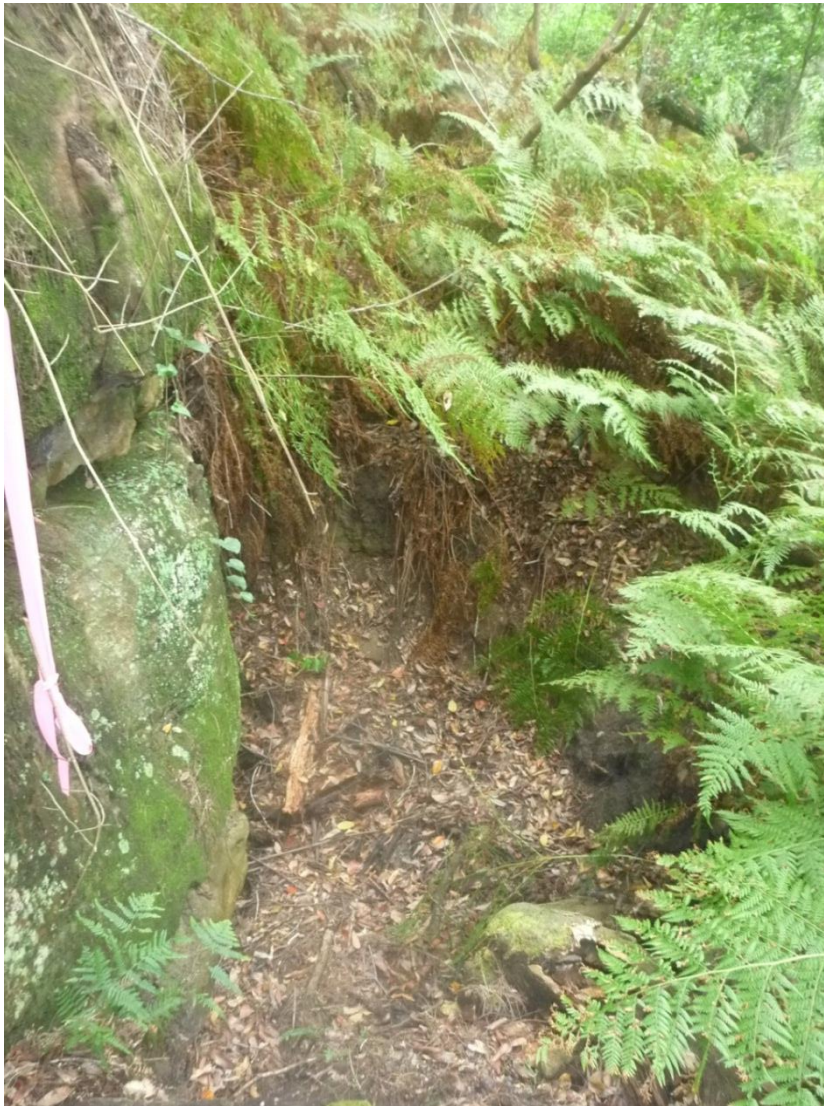
All archaeological remains are overgrown and the well is full of leaf litter. Some sections of the stone boundary wall are in fair condition whilst most areas of walling and the building have collapsed.

**Caption:** The semicircular well, Crosslands Reserve.**Copyright:** GML, 2012**Image by:** GML**Image Date:** April 2012**Image Number:****Image Path:****Image File:****Thumb Nail Path:**

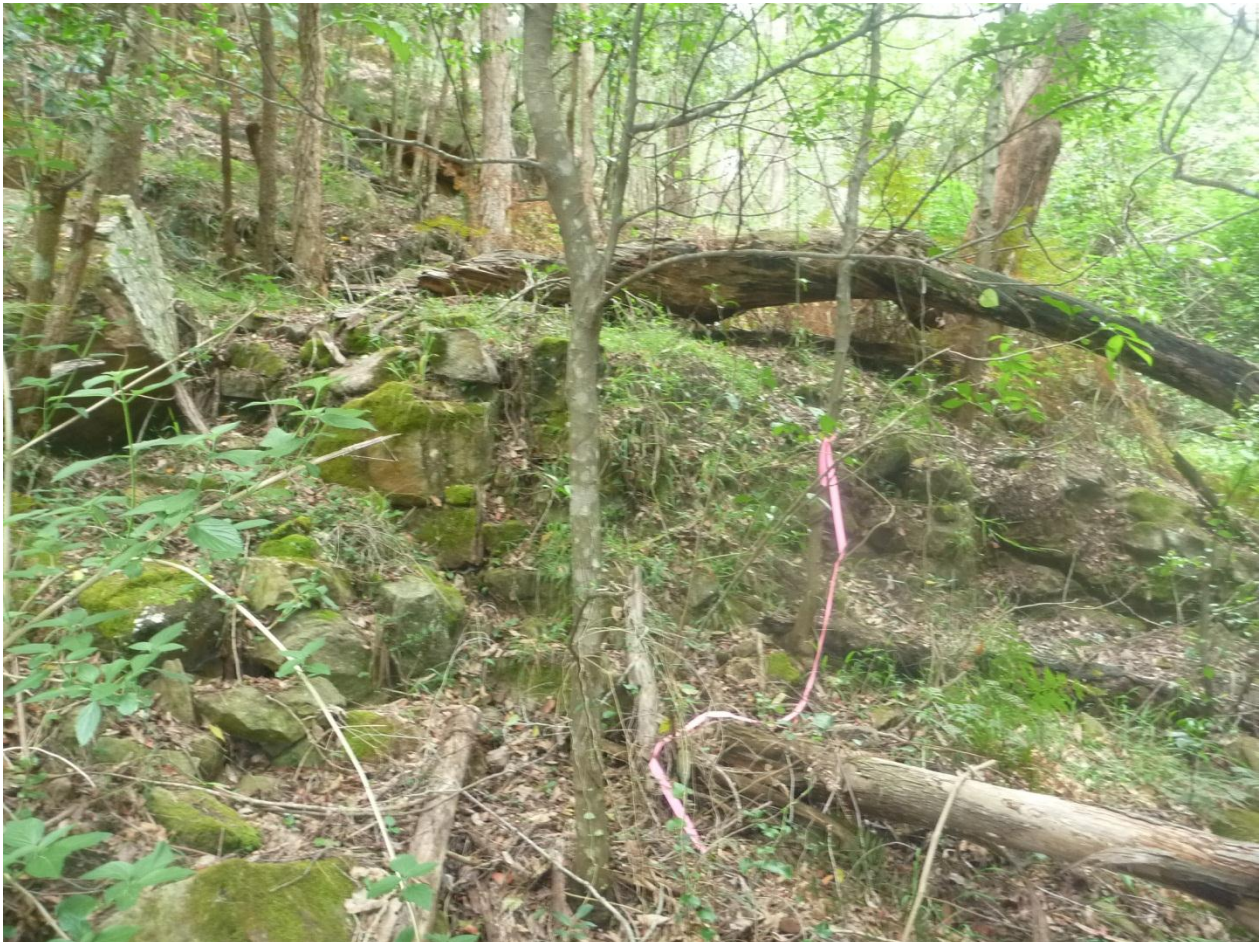
Caption: Collapsed sandstone building, Crosslands Reserve.

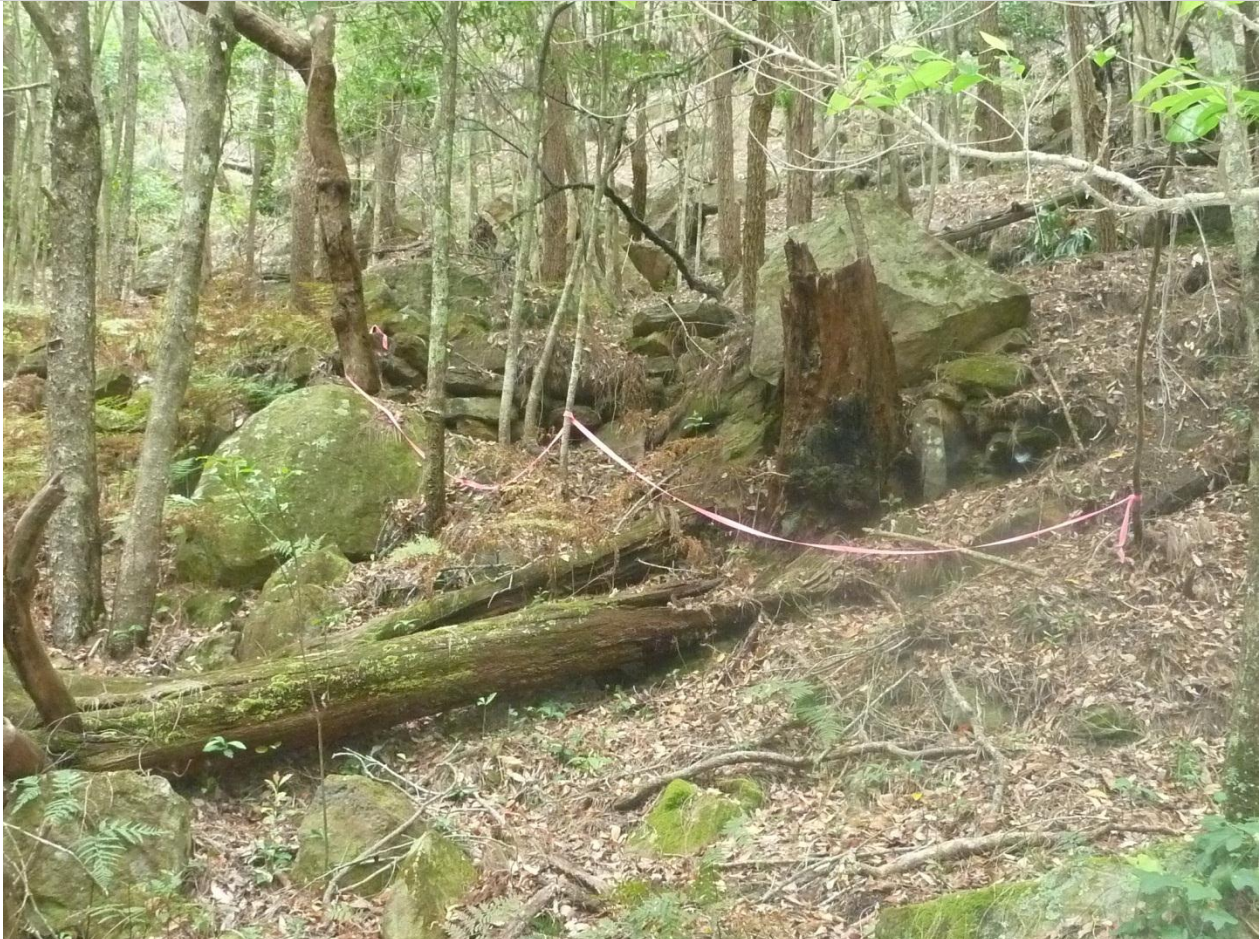
Caption: Dry stone wall (constructed of natural sandstone), Crosslands Reserve.

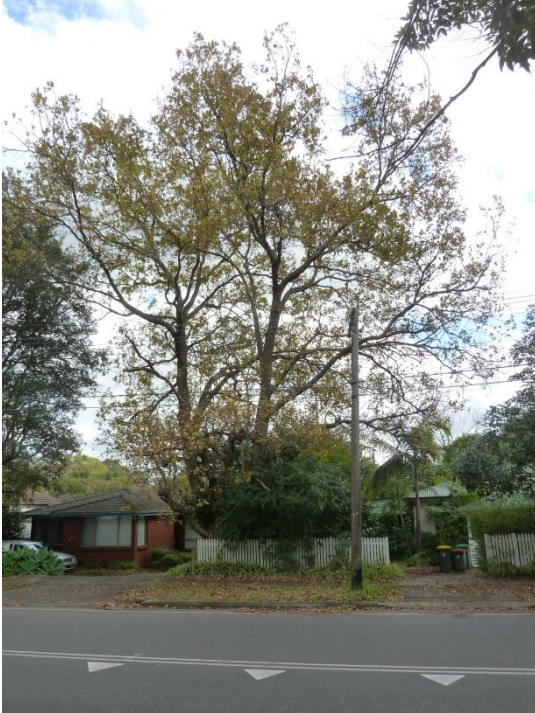
Caption: View across Royston Parade to No.27 showing *Quercus robur* with two main trunks. Lateral branch over adjoining driveway at left has been lopped.

Recommended Management: Requires an arborist report when in leaf to determine condition and public risk.

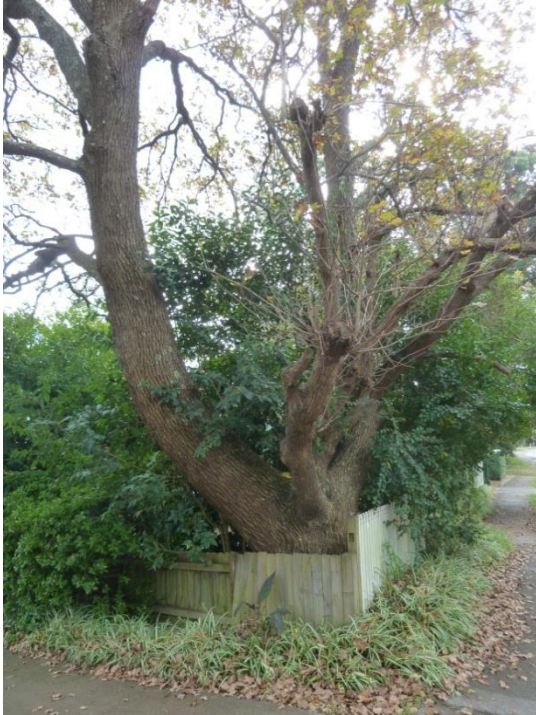
Caption: View of lower part of *Quercus robur* showing forking at about 1.6 metres above ground.

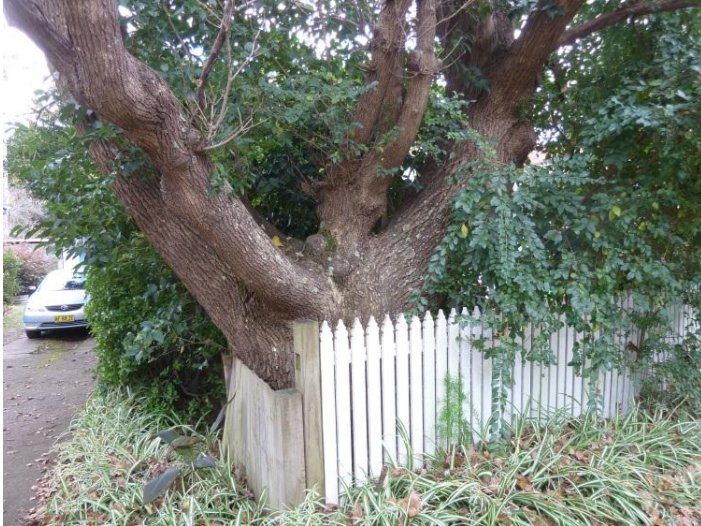
Physical Condition: The large size of this tree and its past management indicate the need for an arborist's assessment of its condition and safe and useful life expectancy, when in leaf.

Caption: Base of tree showing evidence of past lopping.

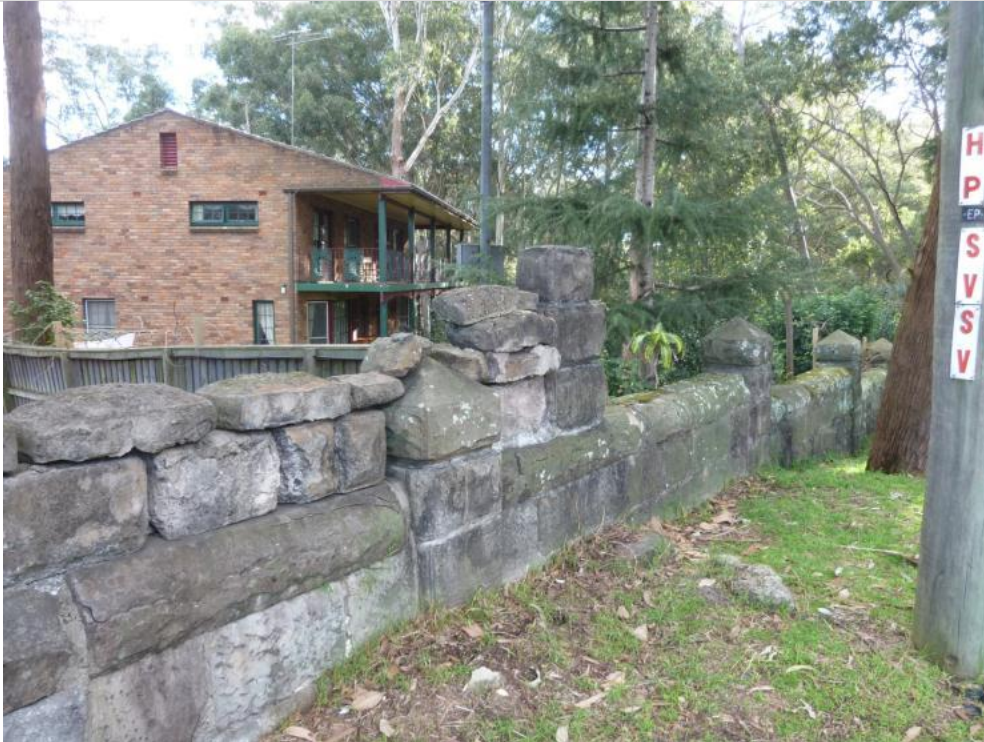
Physical Condition: Fence is generally fair but some blocks loose.

Caption: No. 2 Beecroft Road with part of the sandstone boundary fence that possibly relates to the original curtilage of 'Blackwood House', which is now on a reduced curtilage at No. 6-8 Beecroft Road.

Recommended Management: Conserve and maintain.

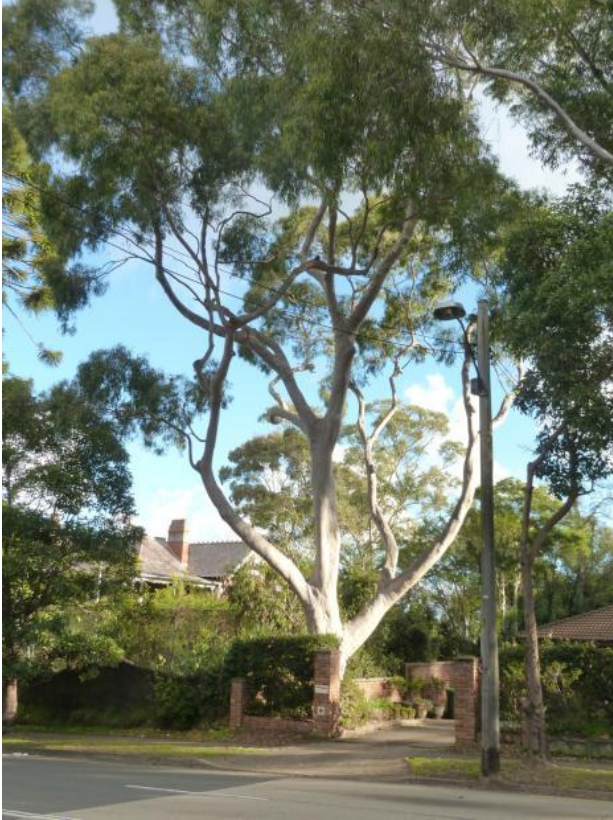
Caption: Fine specimen of *Corymbia citriodora* (Lemon-scented Gum) in front garden of 4 Beecroft Road with part of 'Blackwood House' visible at left. The original stone fence appears to have been removed from this property.

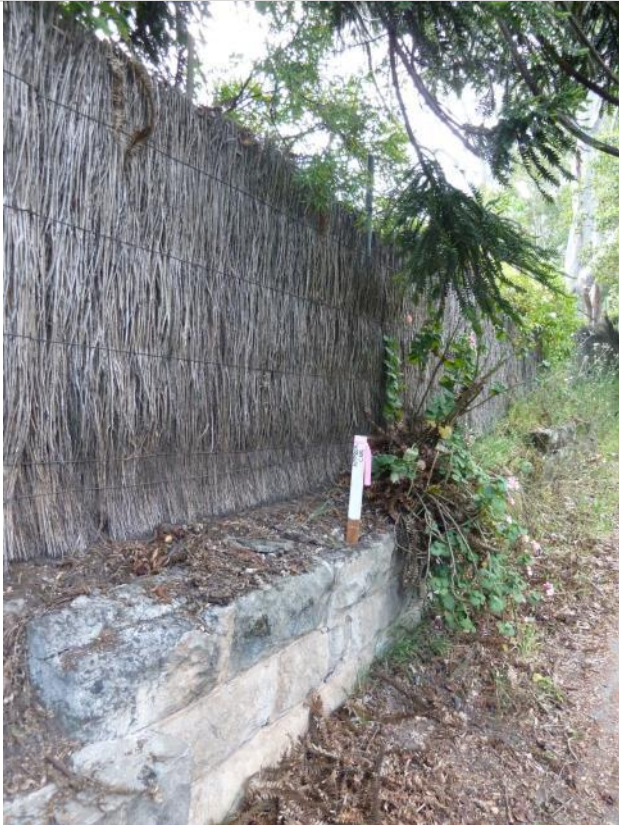
Caption: Surviving base of stone front fence at 'Blackwood House', 6-8 Beecroft Road.

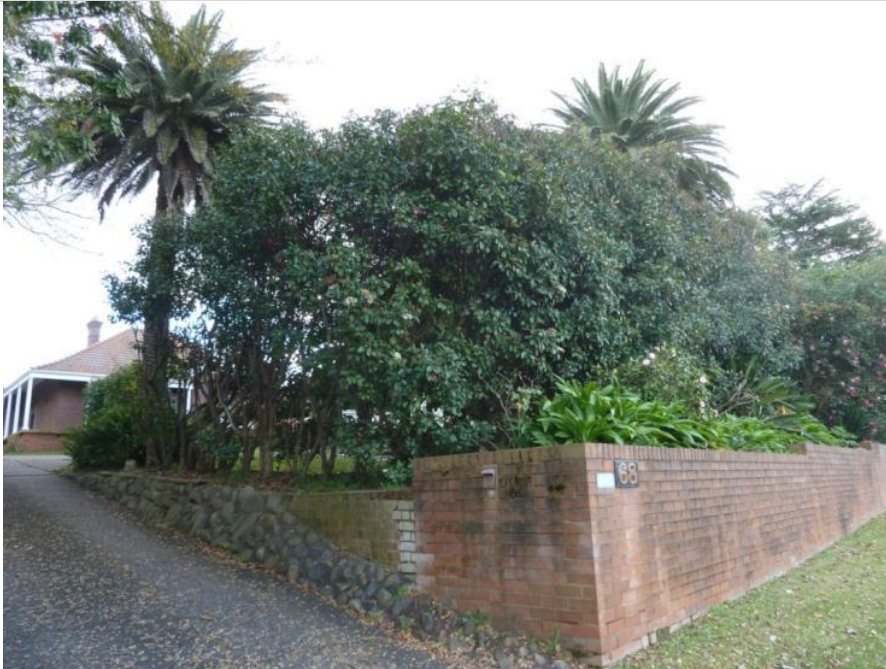
Caption: Vehicle entrance to 68 Beecroft Road showing brick retaining wall to front boundary, Photinia hedge and two mature Phoenix canariensis palms.

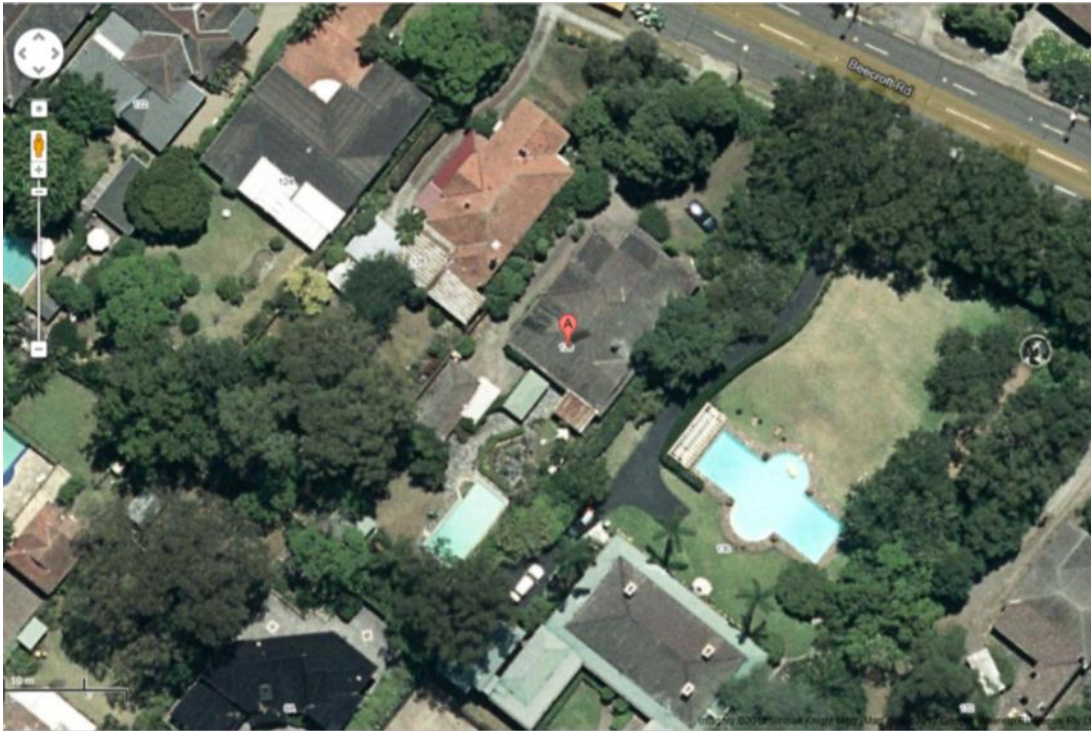
Caption: Aerial photo of 128 Beecroft Road (house marked with 'A' in red dot), showing dense tree growth in front garden.

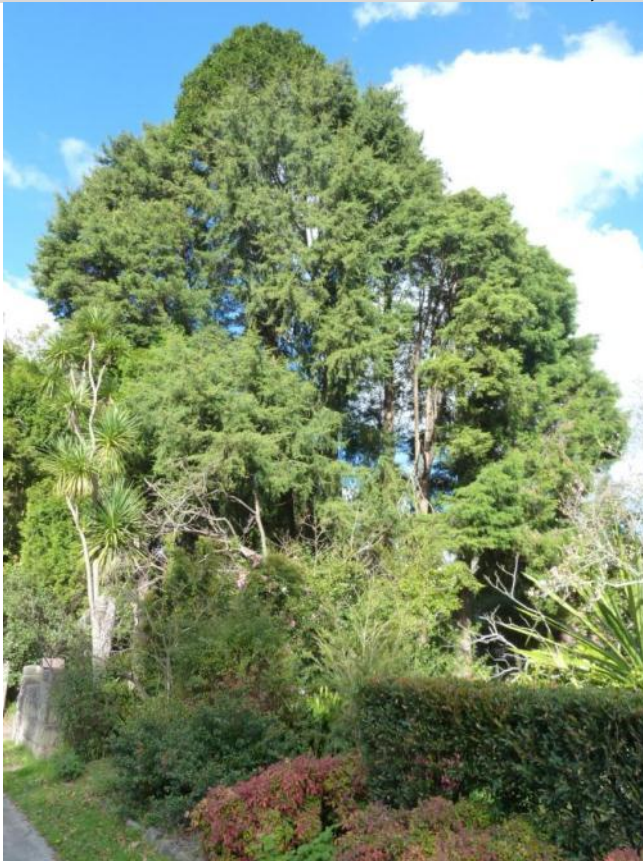
Caption: Vehicle entrance showing sandstone block gateposts and row of cypresses along edge of drive.

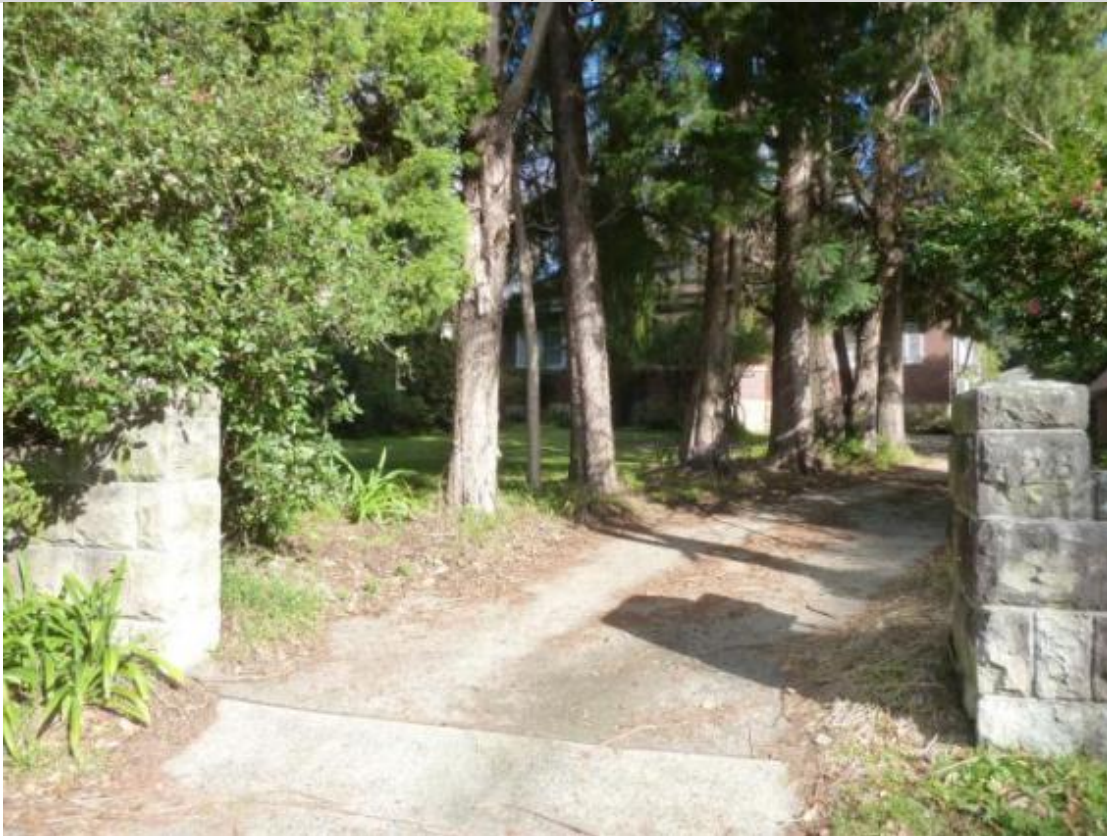
Physical Description: Garden of c1930s / 1940s house on major thoroughfare retaining original landscape elements, including rusticated sandstone block front fence and mature plantings of cypresses and camphor laurels. Lack of pruning of row of cypresses beside drive has resulted in dieback of lower branches and uneven growth.

Caption: View towards 128 Beecroft Road from northeast showing dieback in cypresses along drive.

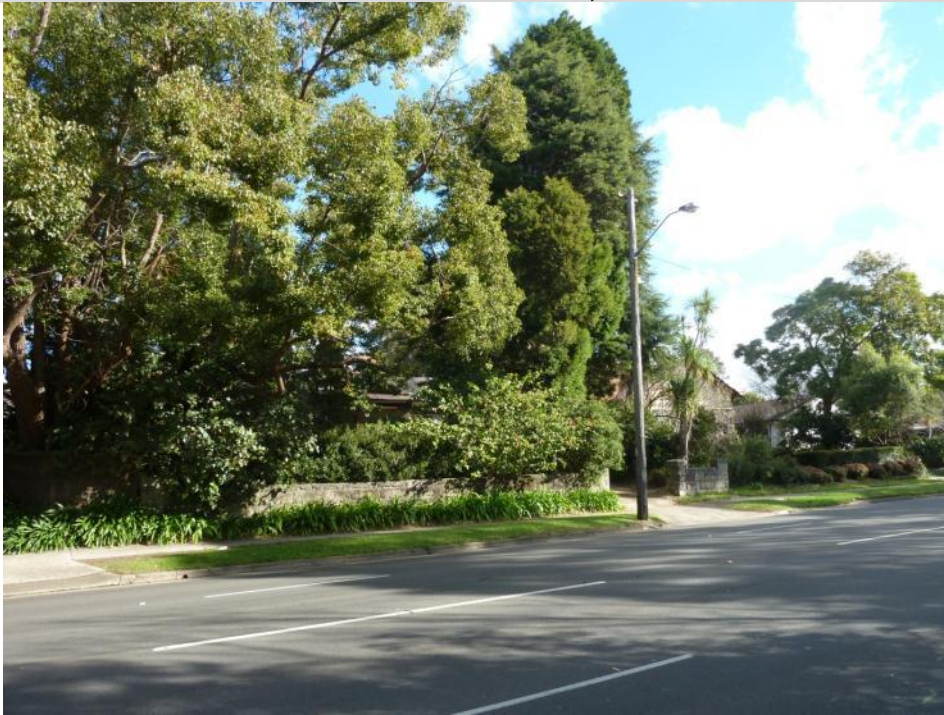
Caption: View across Beecroft Road to No.128 showing large mature camphor laurel (left) and cypresses (right) in front garden.

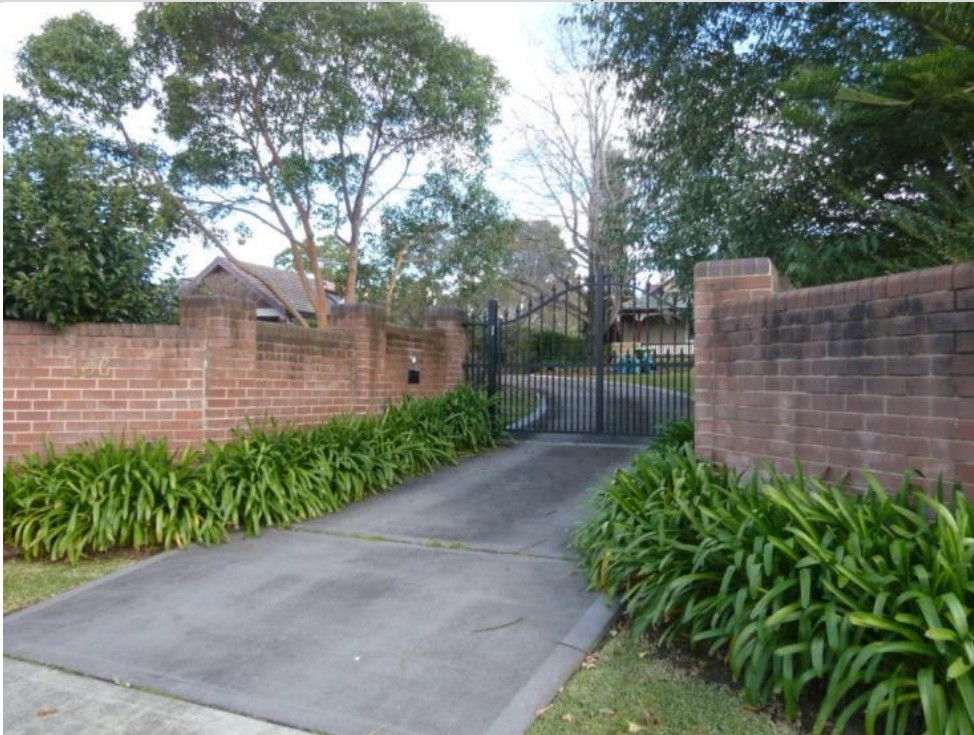
Caption: Vehicle entrance to 136 Beecroft Road, showing recent concrete drive, metal gates and multi-stemmed Brush Box at left.

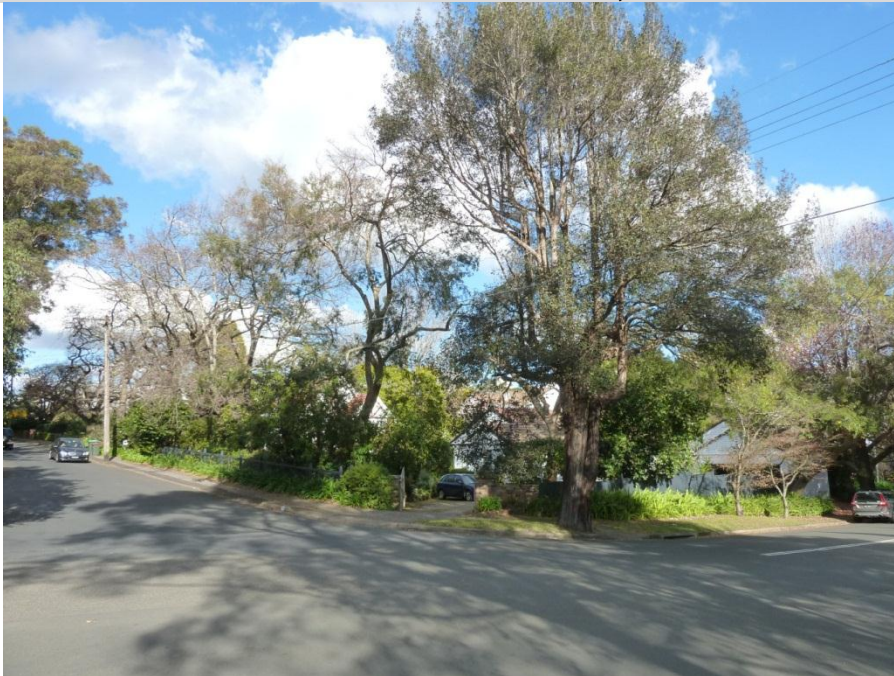
Caption: Lopped specimen of Turpentine on corner and deciduous exotic trees in front gardens of 2 and 4 Boronia Avenue.

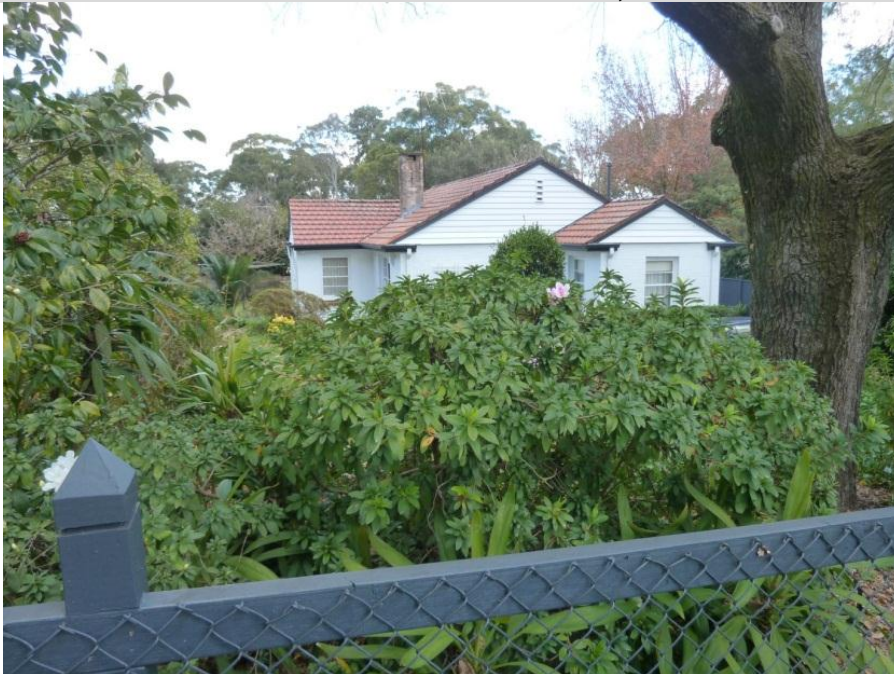
Caption: View of 2 Boronia Ave from Kirkham Street boundary. Fence in foreground is not original.

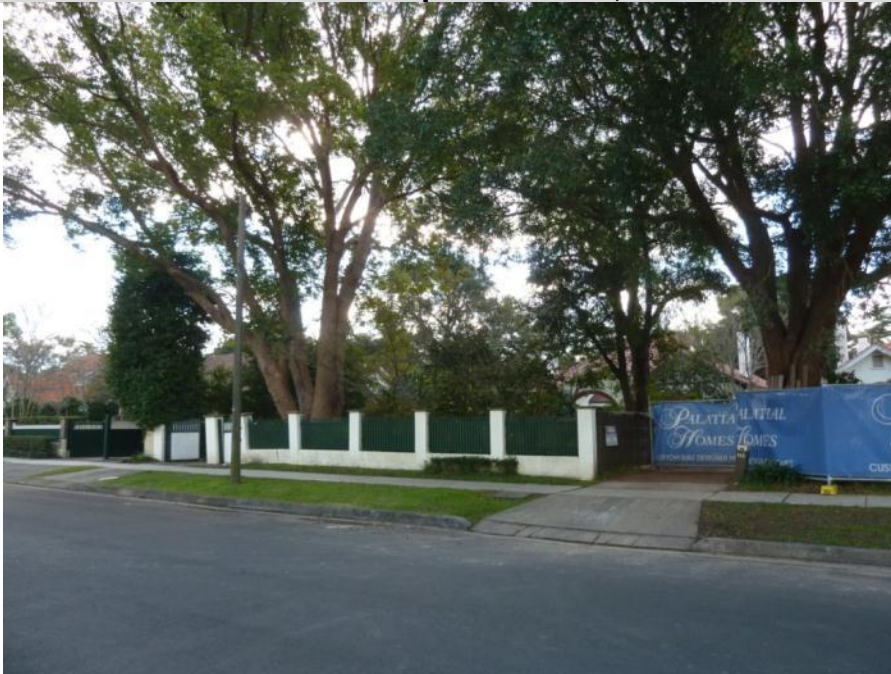
Caption: Street boundary of 149 Copeland Road East showing recent fence of masonry dwarf wall and piers with panels of timber pickets and large trees in front garden.

Physical Condition: Recent front fence is an inappropriate design for the period of the house.

Recommended Management: Manage to retain and conserve significant features. Investigate house and arched structure for significance.

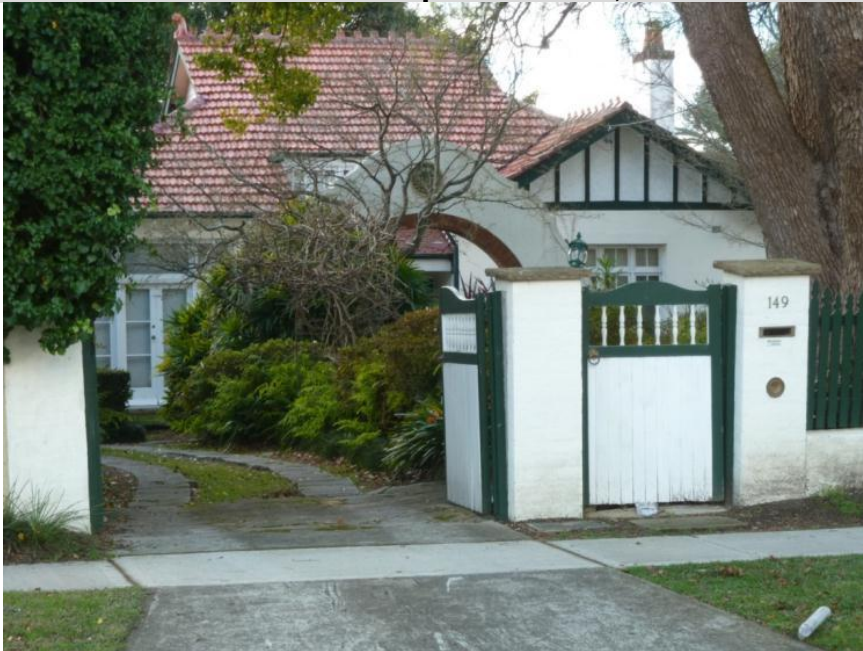
Caption: Flagstone tyre strips with grassed centre to drive, dense shrubbery of massed azaleas and arched structure in front of entrance porch.

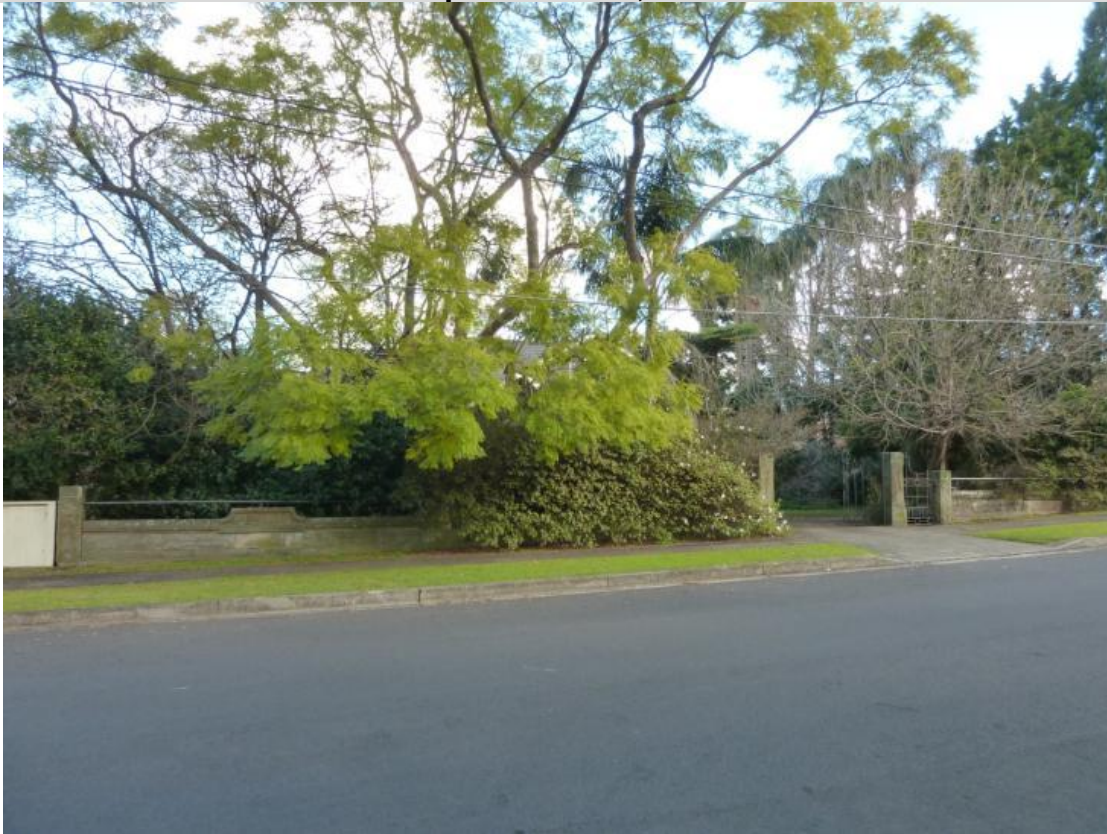
Caption: Part of boundary of 156A Copeland Road showing stone fence and plantings in front garden.

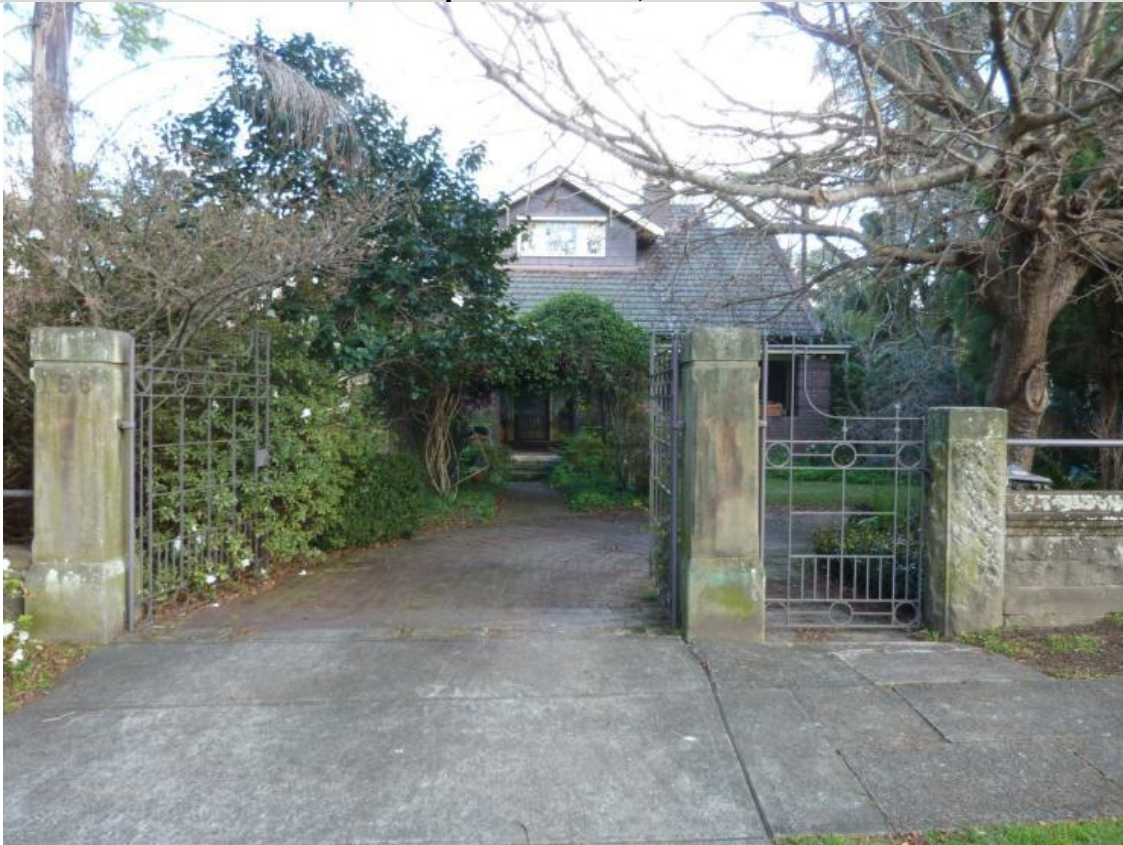
Caption: Vehicle entry to 156A Copeland Road East showing elegant gate posts and gates,

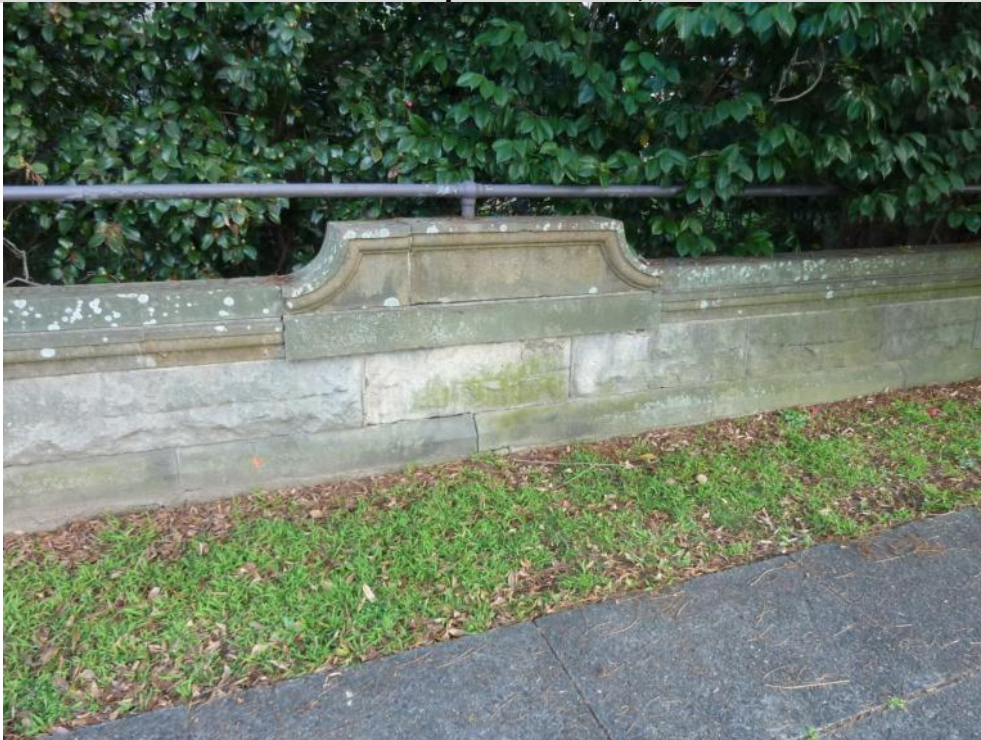
Caption: Detail of front fence which previous Heritage Study assumed may have been recycled from a historic building. Fact that moulding on higher centre section does not align with that on fence capping supports this theory.

Recommended Manage so as to retain and conserve significant features.**Management:** Investigate origin of front fence.**Management:** Retain on LEP schedule.**Further Comments:****Criteria a)****Criteria b)****Criteria c)** Garden with fine front fence and gate and mature ornamental plantings with aesthetic significance at a local level.**Criteria d)****Criteria e)****Criteria f)****Criteria g)****Integrity / Intactness:** Garden has altered since last Heritage Study but retains significant elements including front fence and mature ornamental plantings.**References:**

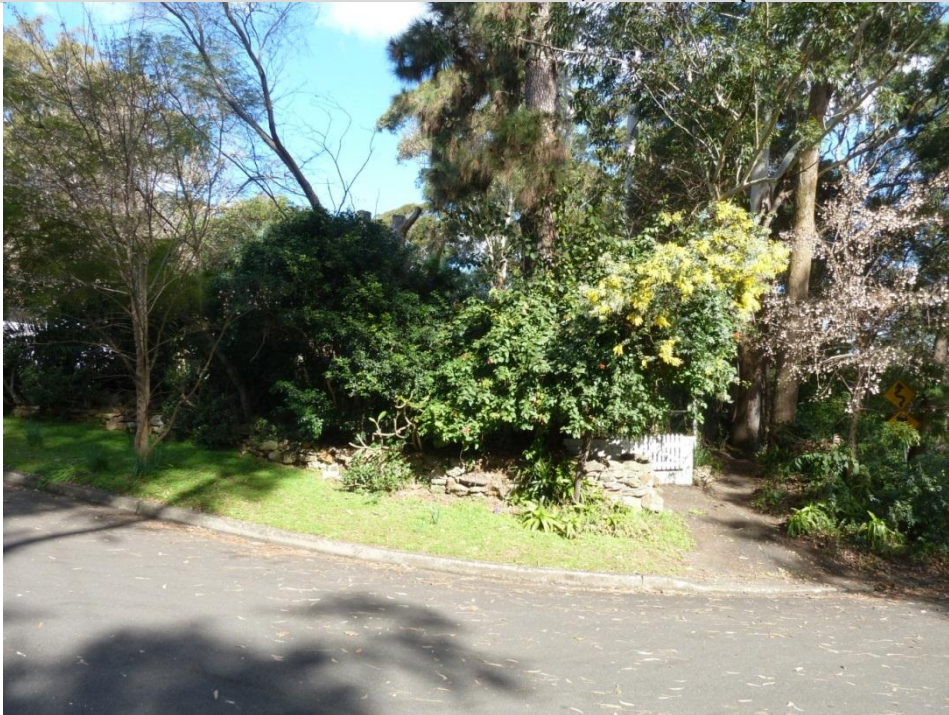
Caption: View to garden from northeast showing original vehicle entrance which was closed off when Parker Close (at left) was created. Yellow blossom is Acacia sp, with tall mature Pinus sp. to its left

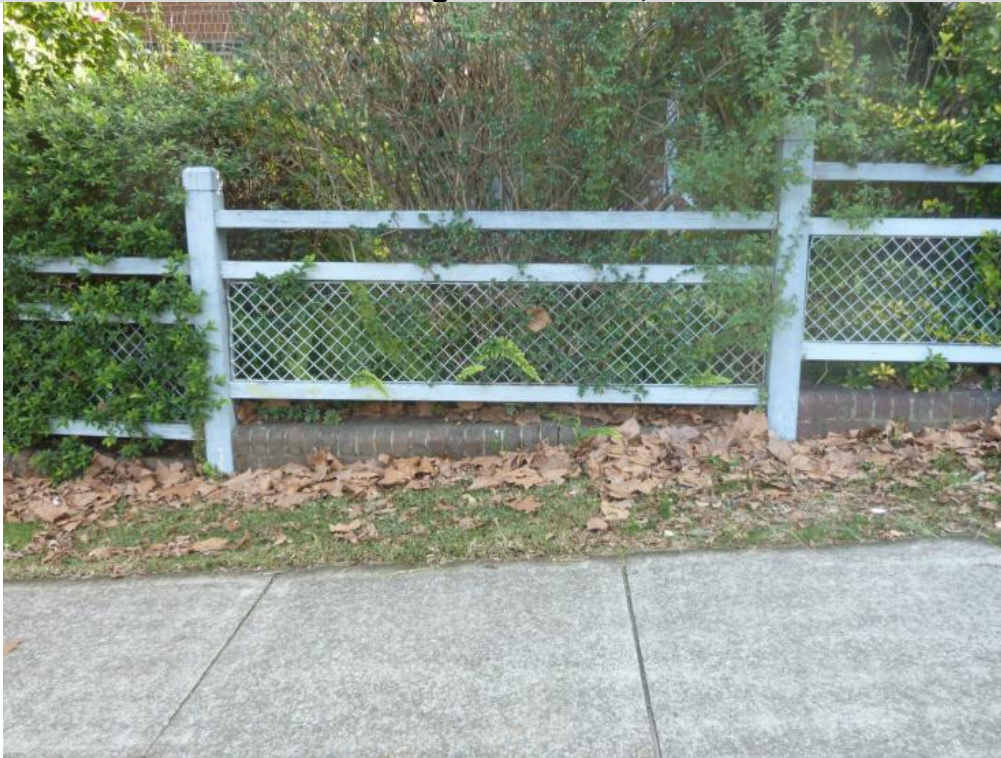
Caption: Fine timber post and wire mesh panel front fence on bullnose brick dwarf wall.

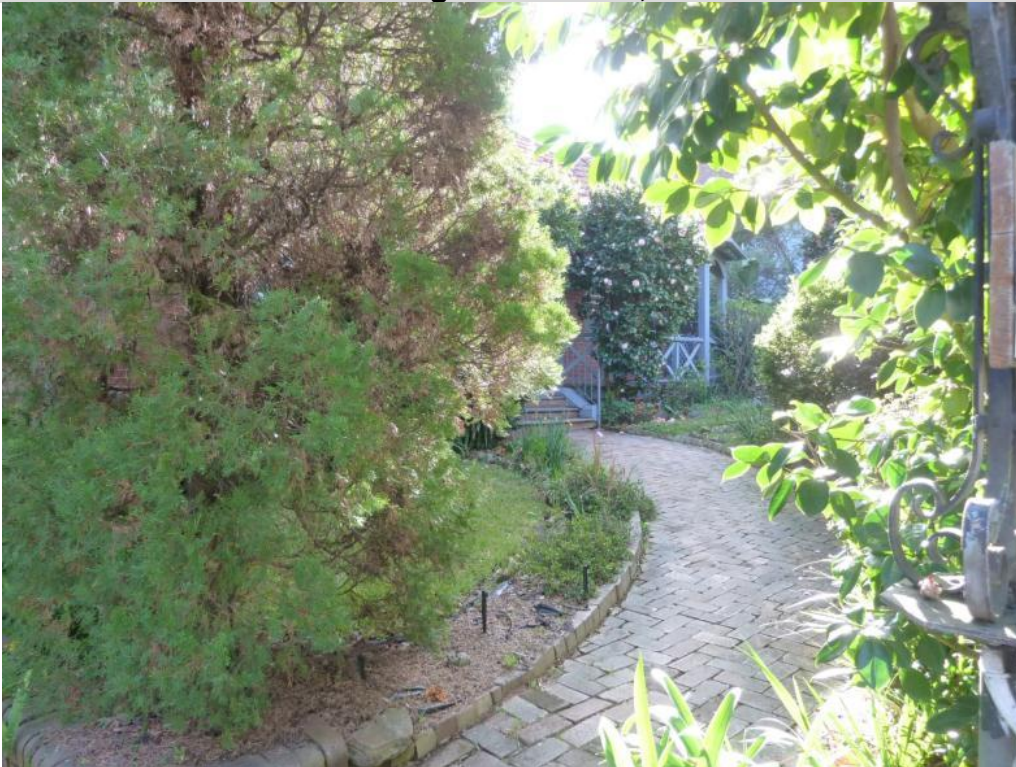
Caption: Brick path probably not original but curvilinear form and garden beds with brick edging are typical features of Federation gardens. Wrought iron feature at right is part of a lamp standard with a doctor's surgery red light.

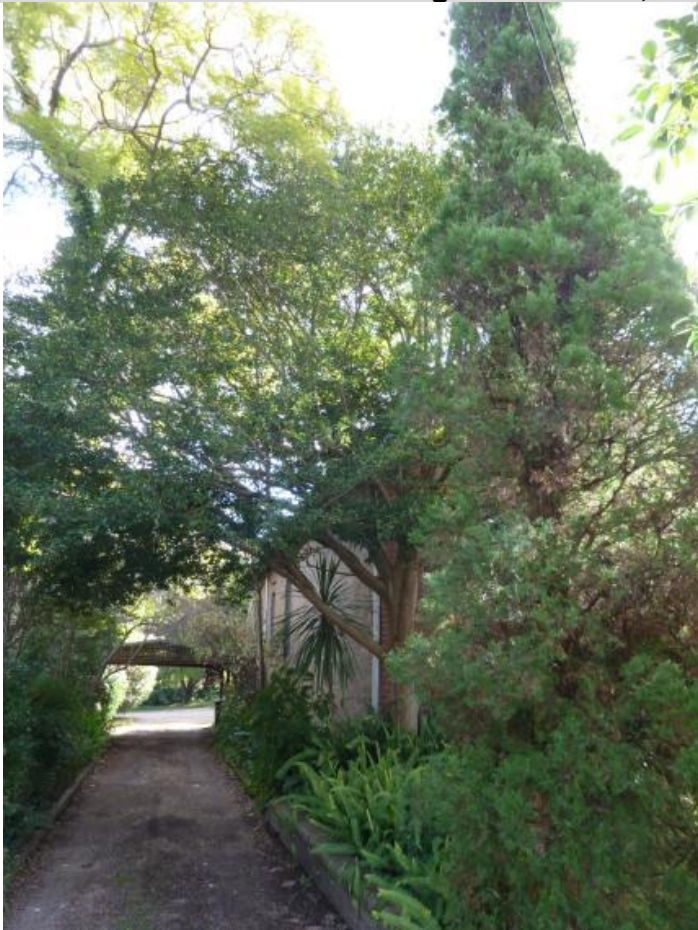
Caption: View along drive towards rear of property showing large specimen of *Camellia sasanqua* at south-eastern corner of house and timber carport structure at rear. Brick dwarf wall is probably original.

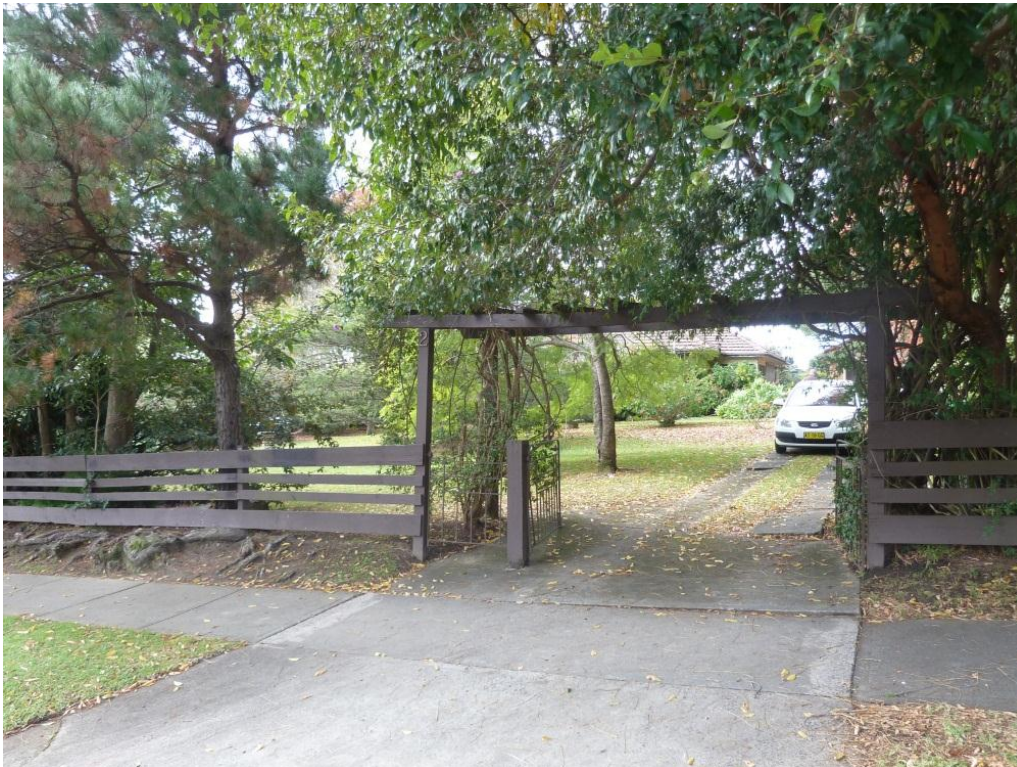
Physical Condition: Timber garden structures in need of repair. Some plants require formative and remedial surgery.

Caption: Front boundary showing timber post and 4 rail fence and timber arbour over vehicle entry.

Retain garden layout and plantings and manage in accordance with best horticultural practice. Retain and conserve rare rotary clothes hoist. House and interior require further investigation. Recommend archival recording of garden.

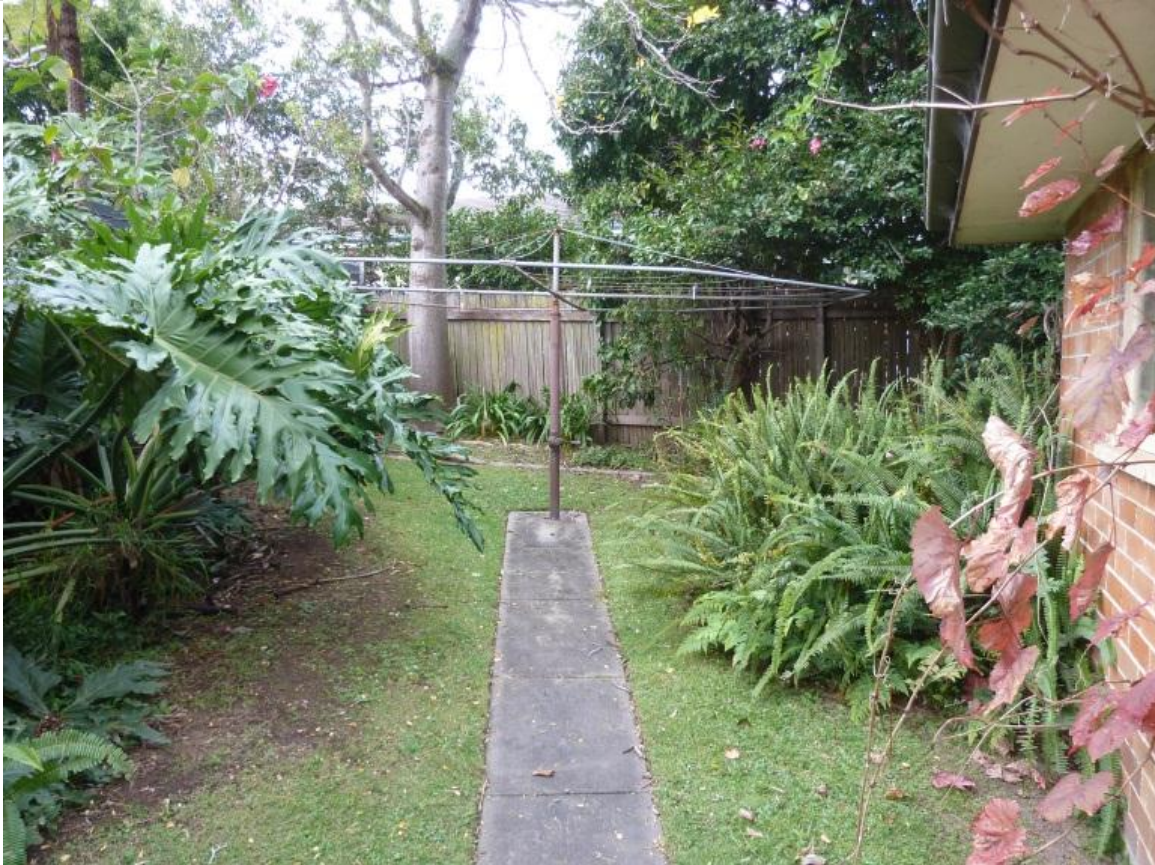
Caption: Southeast corner of garden showing unusual rotary clothes hoist.

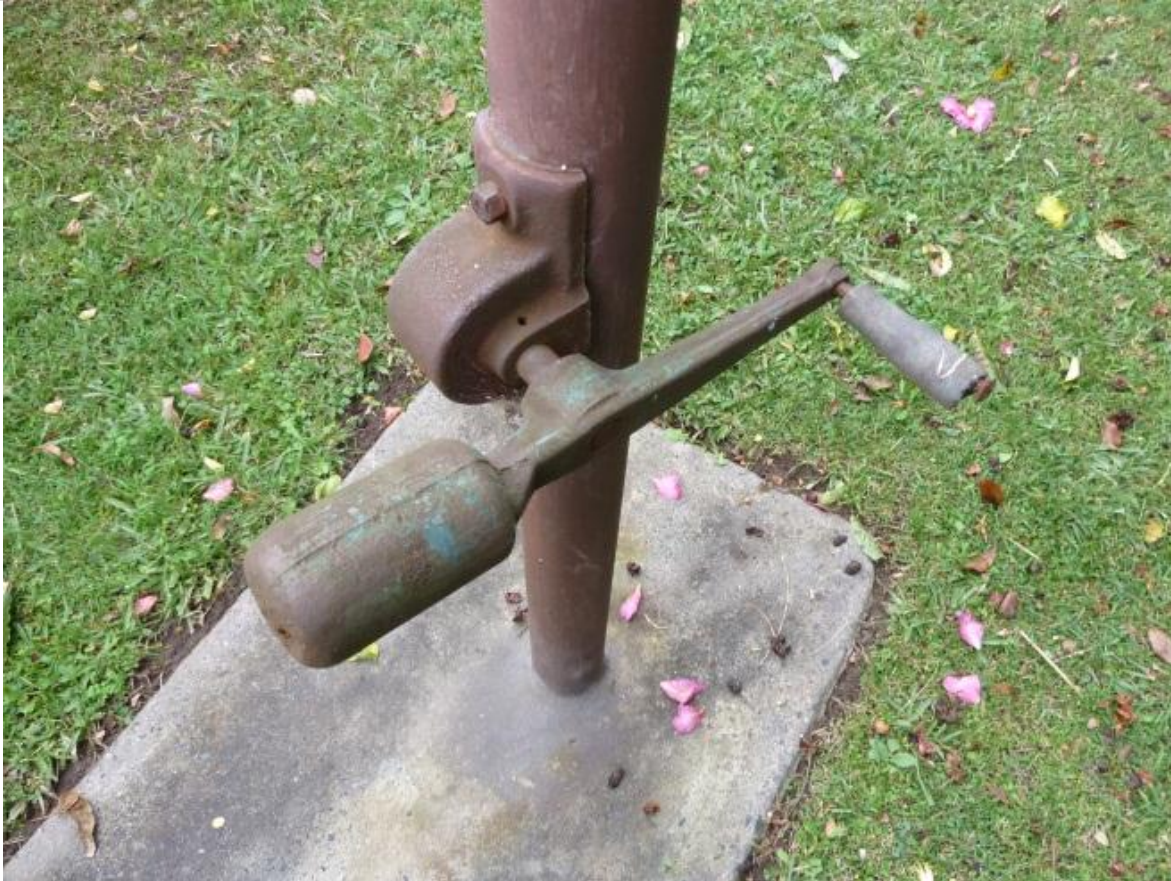
Caption: Detail of winding mechanism of clothes hoist.
