Hornsby Heritage Study Review Stage 5, 2012

Volume 3—Appendix G Part 2: Sites D31–E78 and Appendix H

Report prepared for Hornsby Shire Council
March 2013

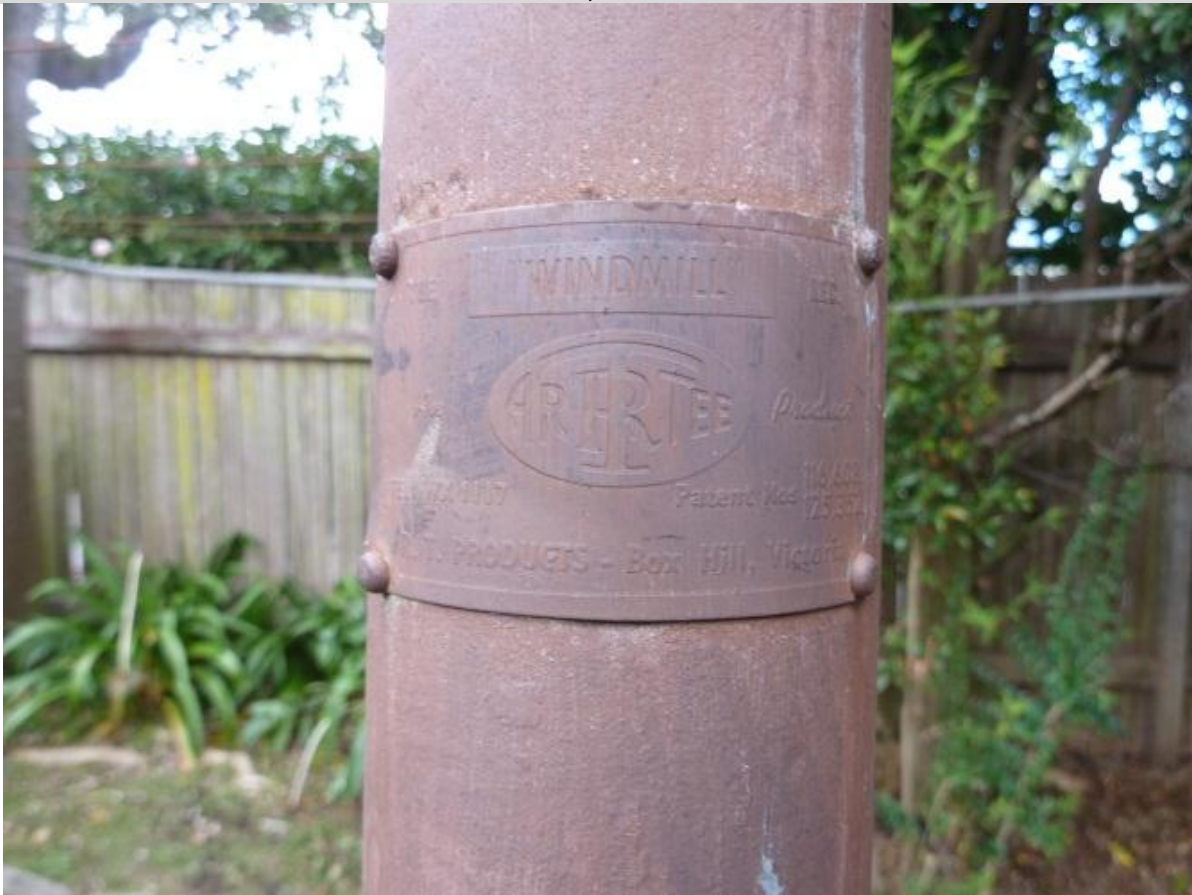
Caption: Details of label of 'Artee' clothes hoist.

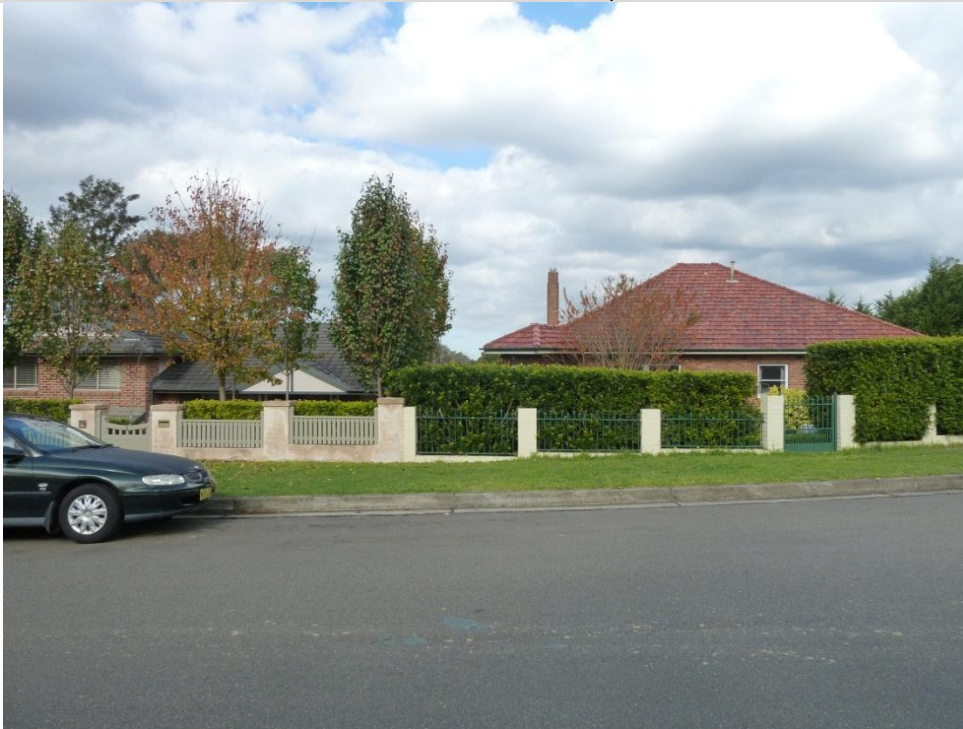
Physical Condition: Site subdivided and garden significantly modified since last Heritage Study.

Caption: New house at 11 Yallambee Road (left) with specimen of Silky Oak at rear of 9 Yallambee Road visible in background at far left. Circa 1940s house at 15 Yallambee Road requires further review to assess whether its continued listing is warranted given that its garden setting has been compromised by subdivision since 1998.

Recommended Management: Investigate surviving house at No.15 for heritage significance. Defer to Heritage Study Review Stage 6.

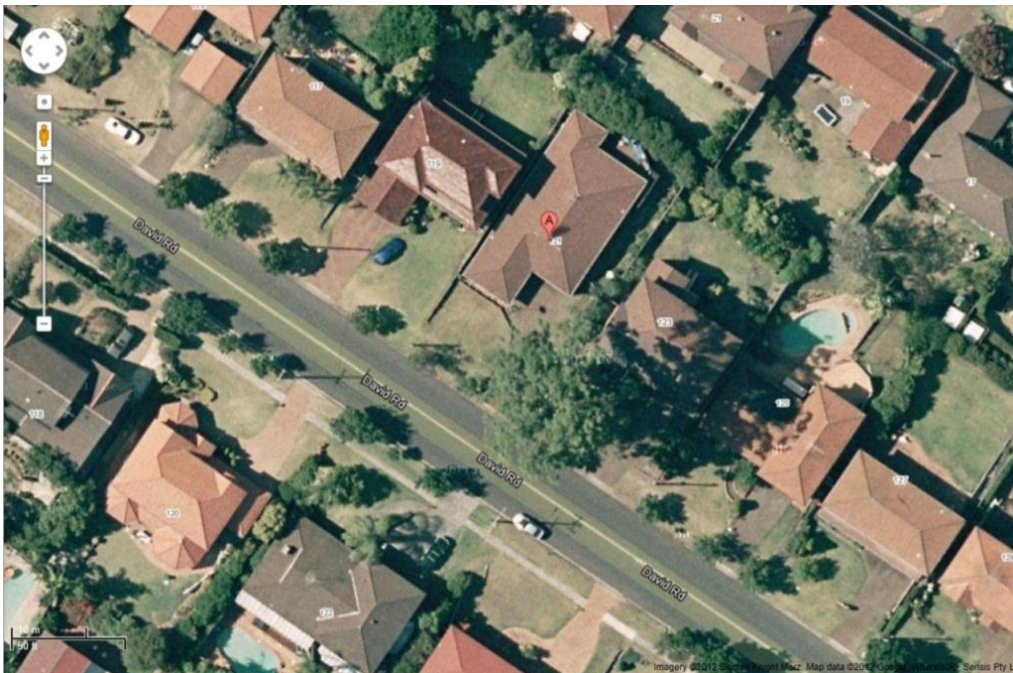
Caption: Aerial photo showing large mature Sydney Blue Gum growing between 121 and 123 David Road, Castle Hill (centre).

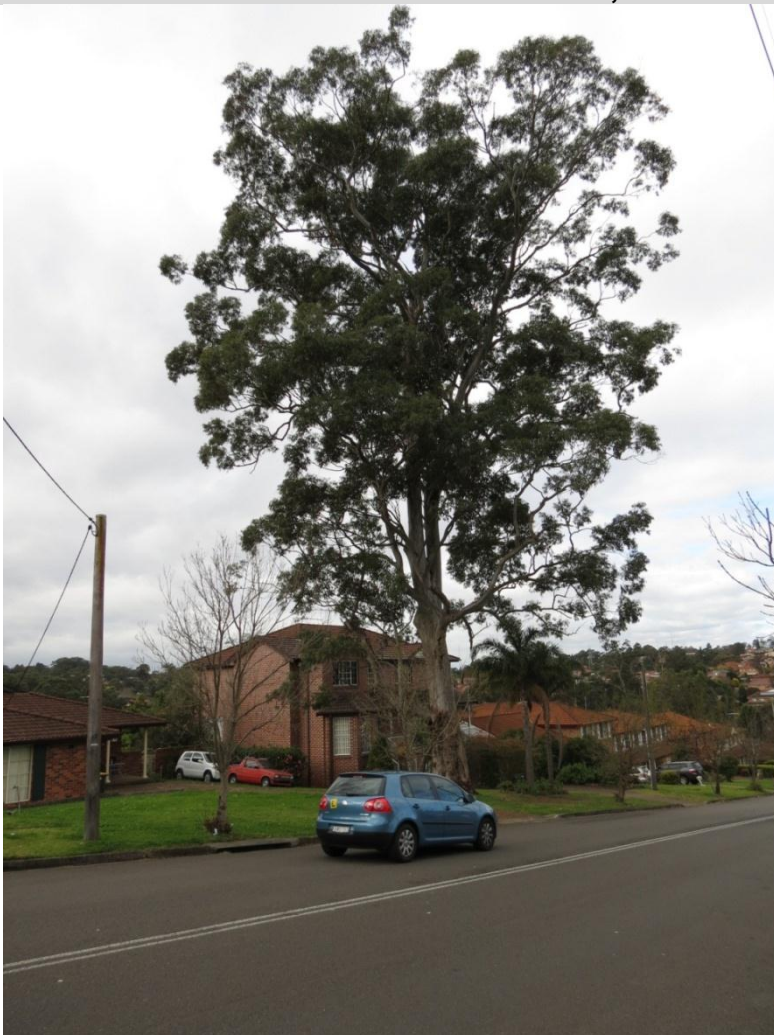
Caption: Large specimen of Sydney Blue Gum between front boundaries of 121 and 123 David Road, Castle Hill, showing its scale when compared with a car and nearby houses.

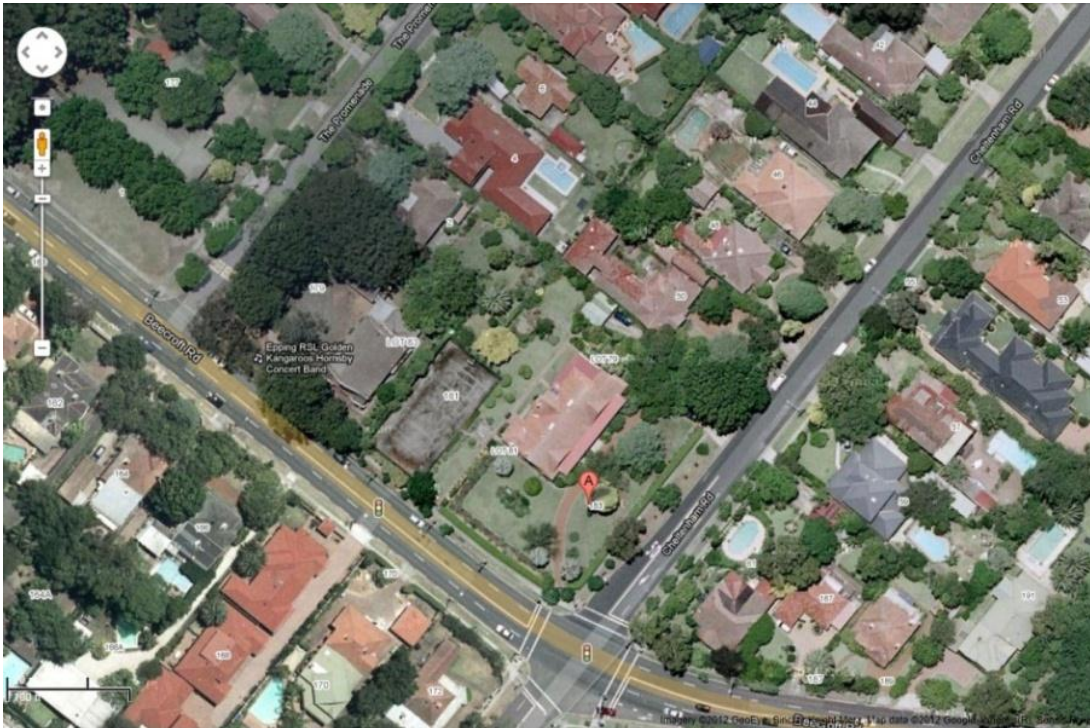
Caption: Aerial photo of 183 Beecroft Road, Cheltenham marked by 'A' in red dot showing large corner lot with curved original drive from corner of Beecroft Road and Cheltenham Road (this entry now disused), tennis court and extensive garden beds and ornamental tree and shrub plantings.

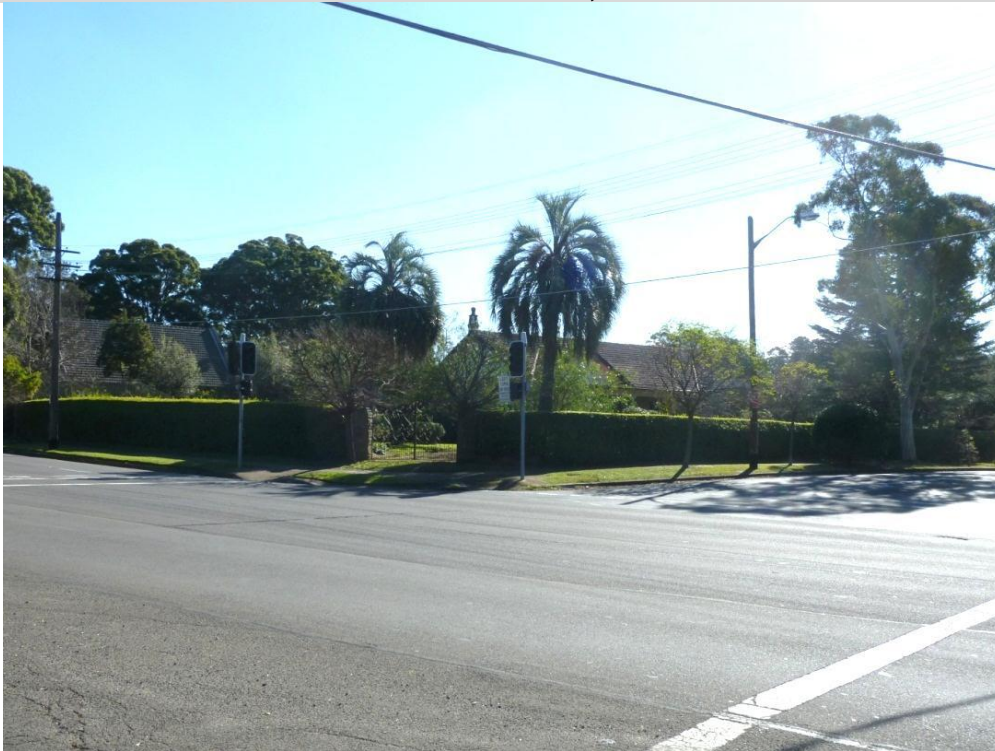
Caption: View across Beecroft Road with Cheltenham Road at right, showing original vehicle entrance on corner (now disused) and specimens of *Butia capitata* palms flanking drive.

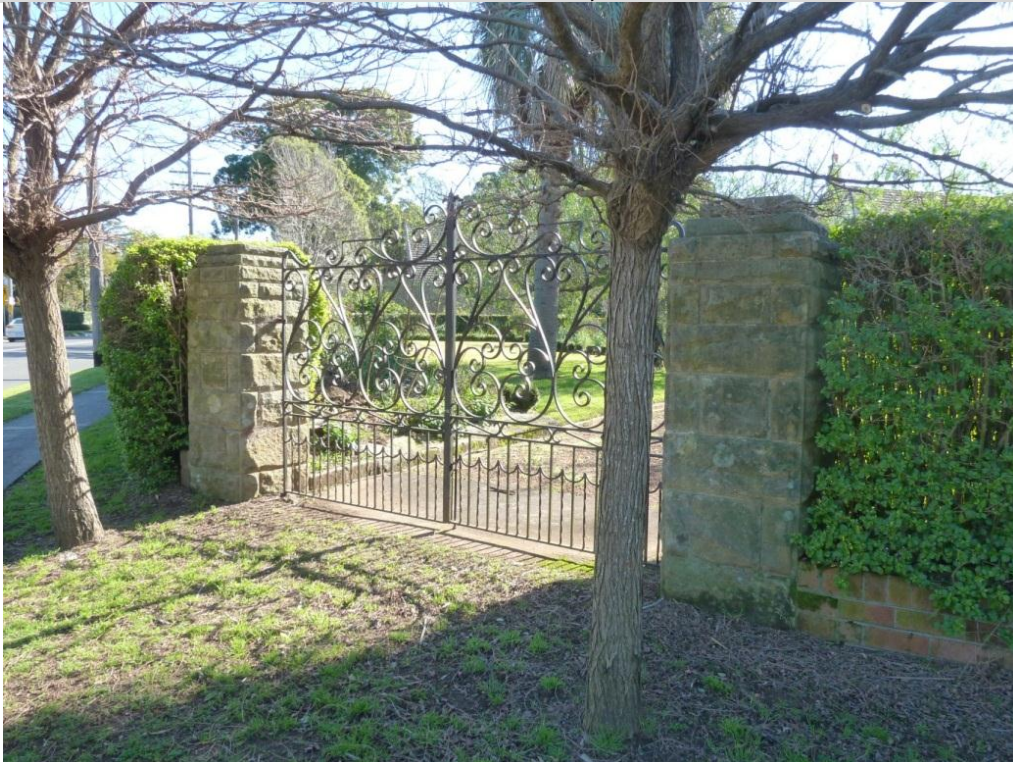
Caption: View through original (now disused) vehicle entry gates to front garden showing deciduous street trees and tall hedge along street boundaries.

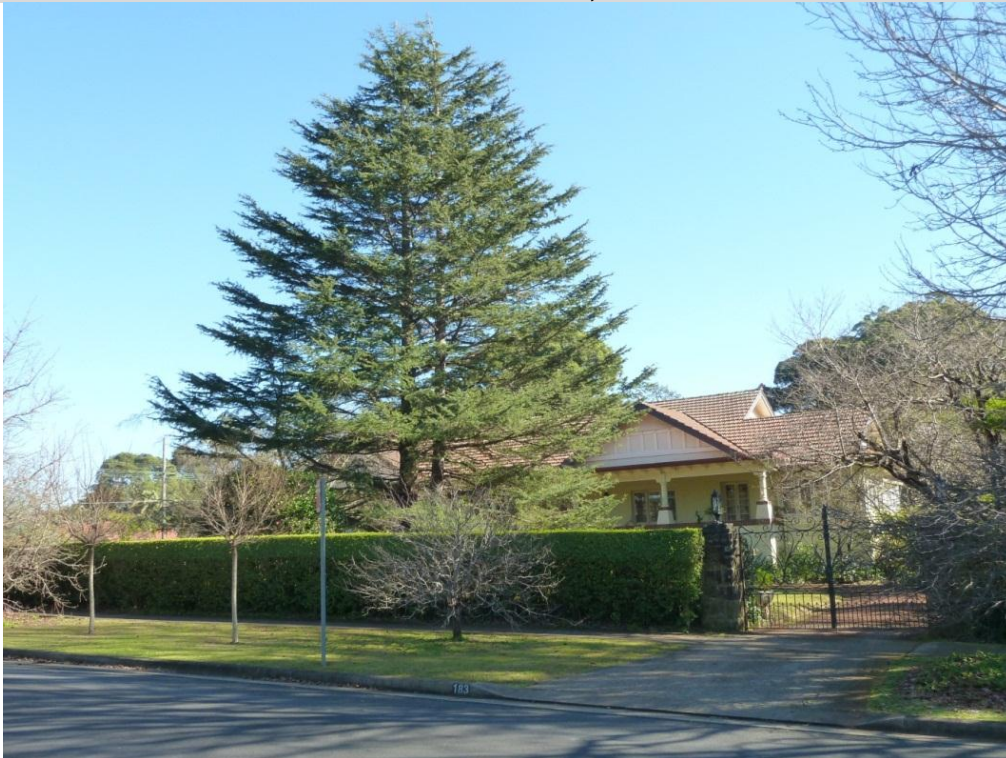
Caption: View showing Cheltenham Road boundary with vehicle entry gates at northeastern end of curved drive and large specimen of *Cedrus deodara* (Deodar) on side lawn.

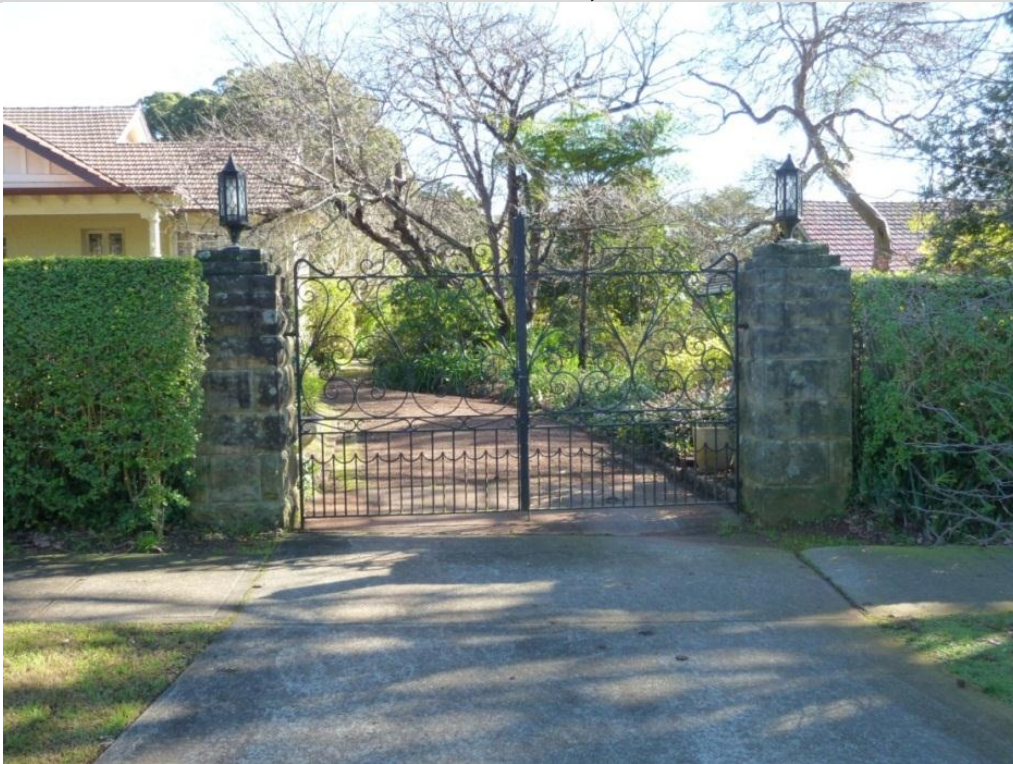
Caption: Fine entry gates to Cheltenham Road end of curved drive showing sandstone gate posts with lantern surmounts and extensive garden beds beyond with deciduous ornamental trees.

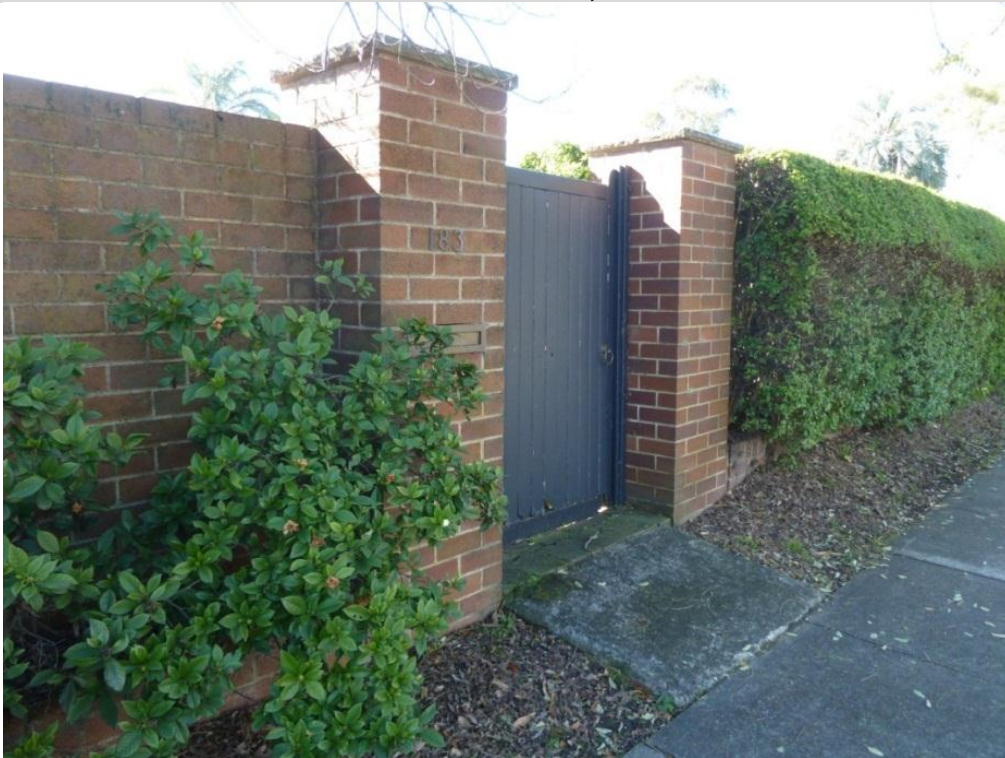
Caption: Tall brick privacy fence along northern part of Beecroft Road boundary with pedestrian entry door.

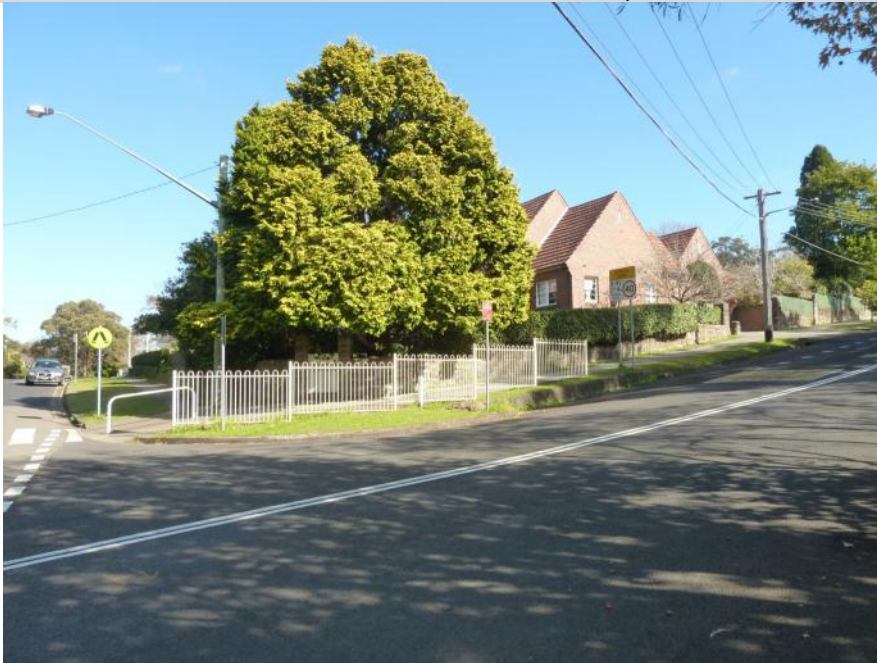
Physical Condition:	White-painted pool fencing on The Crescent nature strip for pedestrian safety detracts from

Caption: 22 Cheltenham Road viewed from across The Crescent showing prominent golden cypresses flanking the corner pedestrian entry. White 'pool' fence is discordant element in streetscape.

Modification Dates: DA for alterations and additions 1995
Recommended Management: Retain and conserve significance. Owner to consider painting pool fence black or other recessive colour.
Management: Retain on LEP Schedule.

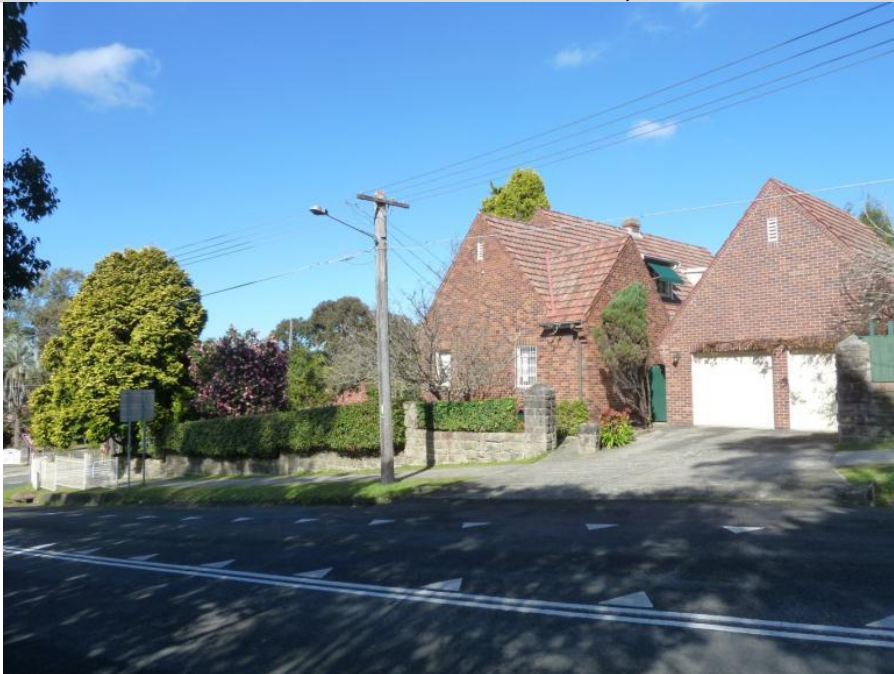
Caption: Side view of garden at 22 Cheltenham Road showing sandstone block fence with hedge above. Double garage matches architectural style of the house.

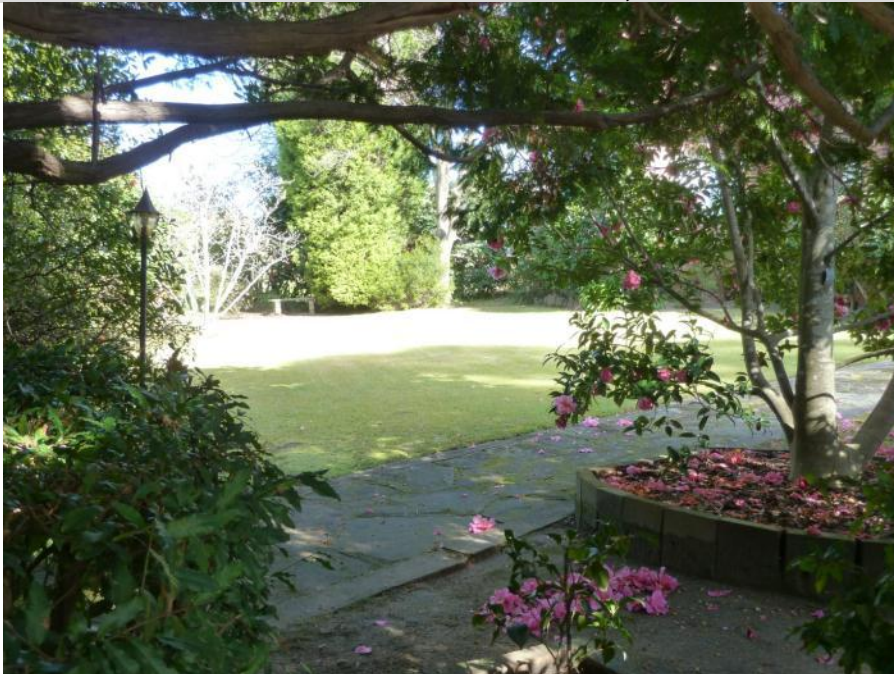
Caption: View into front garden showing old *Camellia japonica* in a brick edged planter, sandstone 'crazy' paved path, lawn and perimeter plantings.

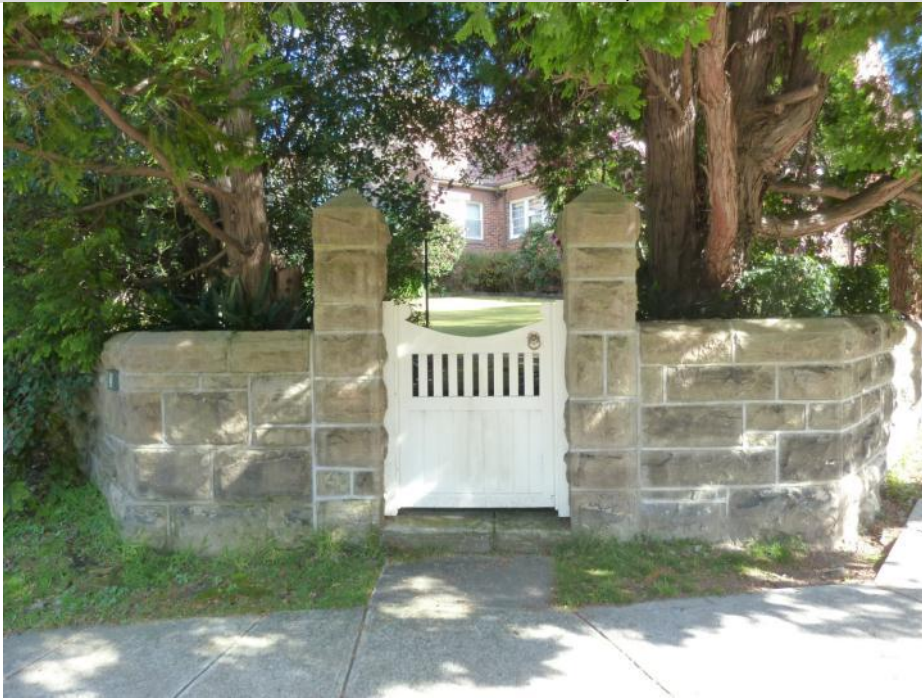
Caption: Sandstone block boundary fence with timber gate to pedestrian entrance at corner of Cheltenham Road and The Crescent.

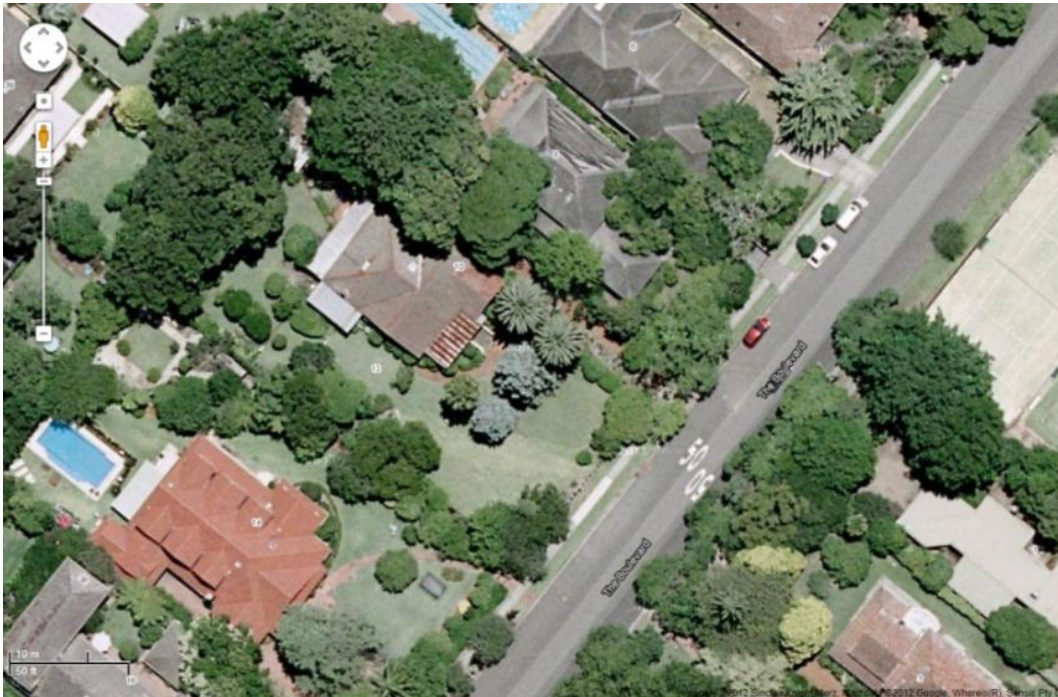
Caption: Air photo of 10-12 The Boulevard, Cheltenham, showing mature palms and conifers. Since this image was captured, alterations include a new front fence, drive and double garage.

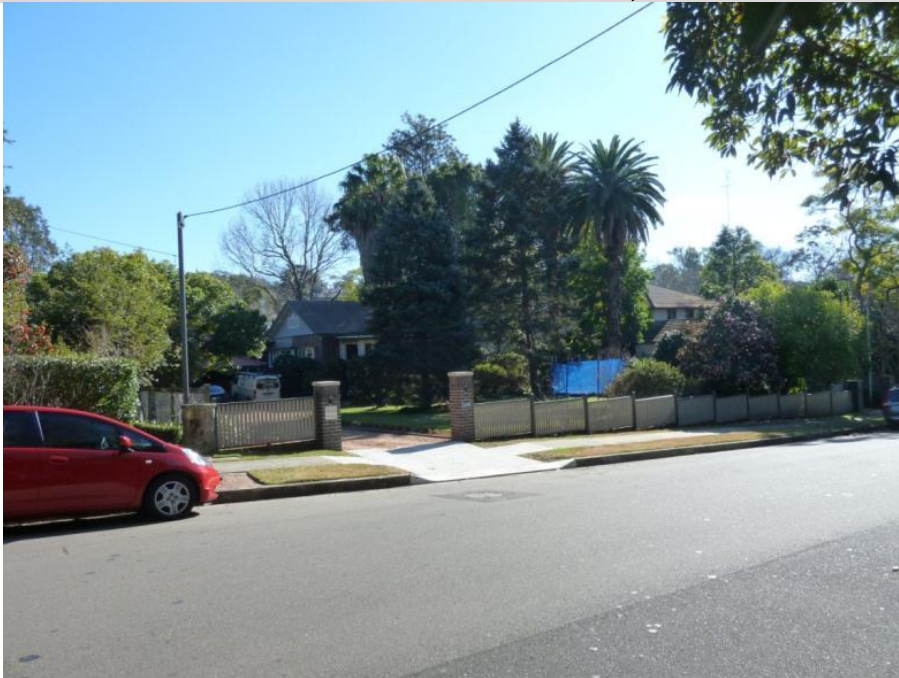
Caption: 10-12 The Boulevard, Cheltenham, showing recent front fence and group of mature palms and conifers on front lawn. Blue structure is a trampoline.

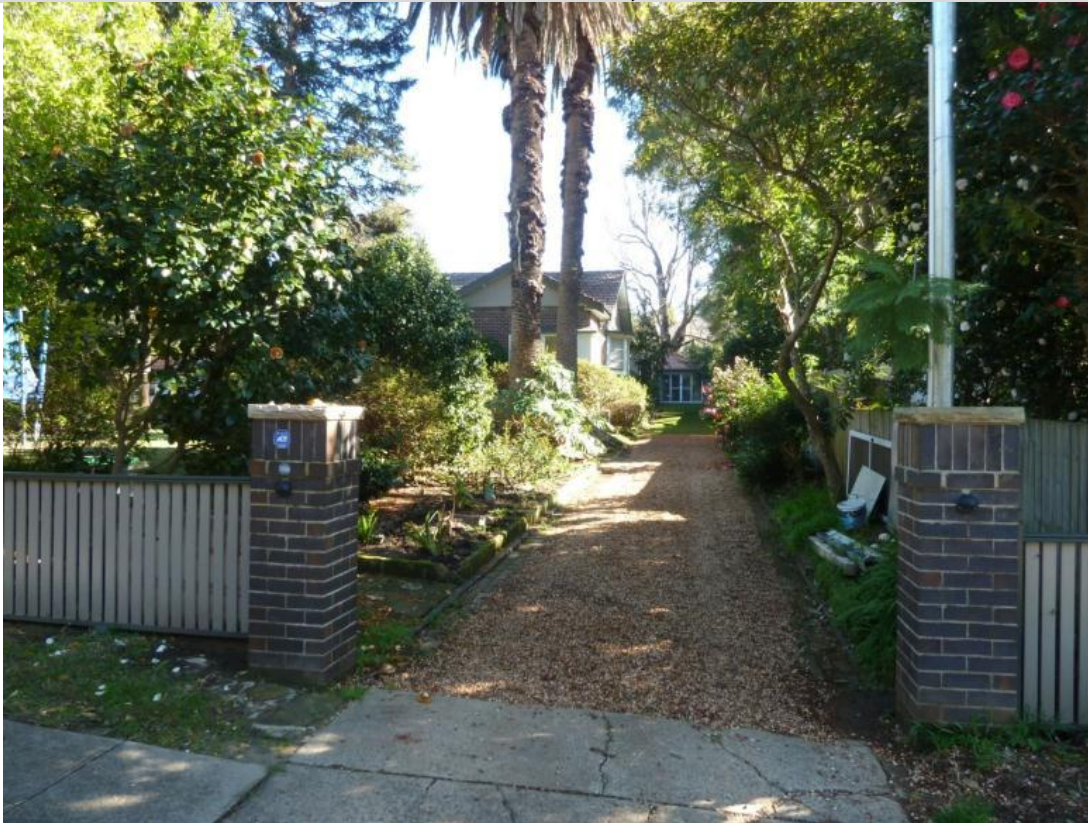
Caption: Driveway on eastern side of property showing recent brick gateposts and timber picket fence.

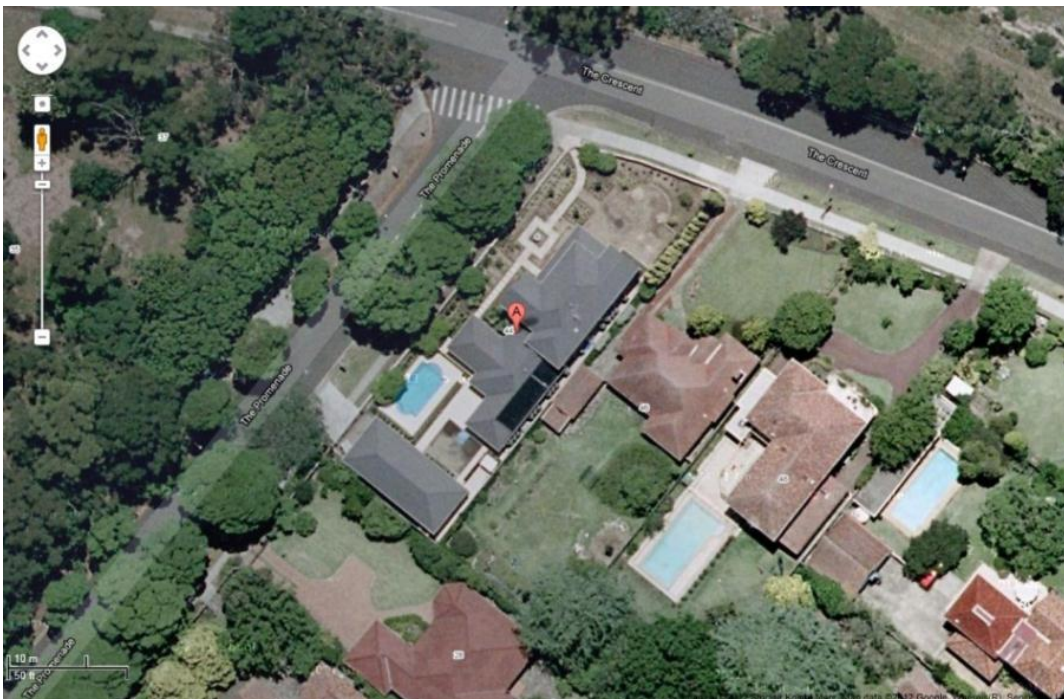
Caption: Aerial photo showing 44 The Crescent (house marked with 'A' in red dot) showing large new house with large garage, in-ground pool and modern formal garden that replaces former listed garden.

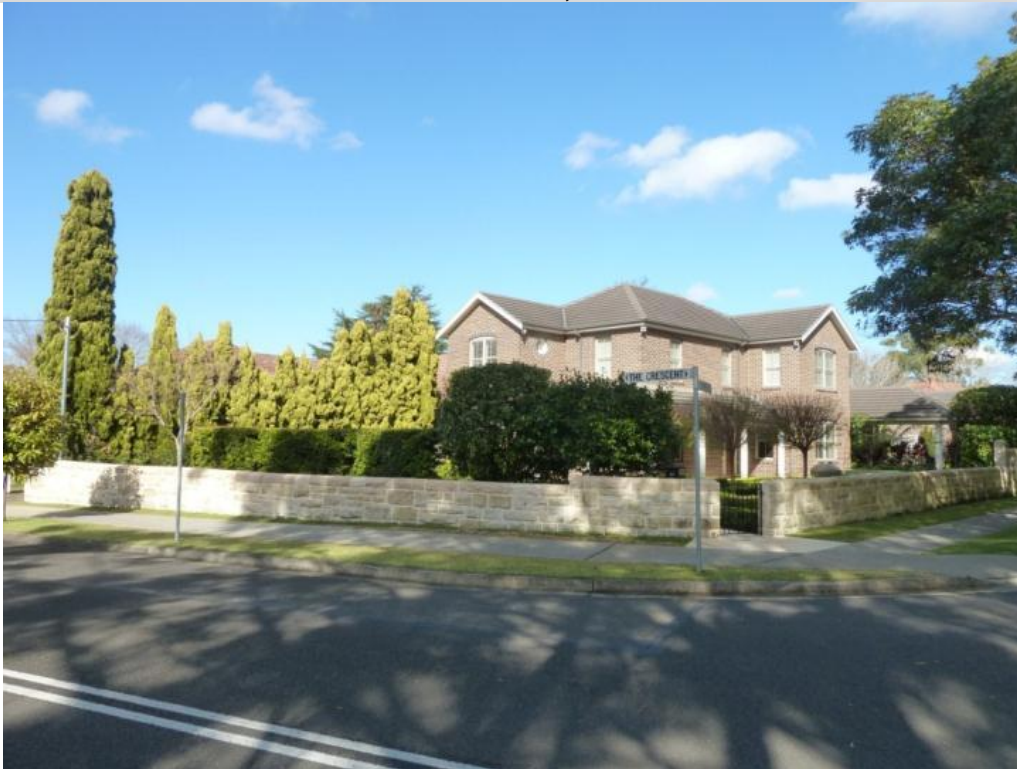
- Physical Condition:** Fence of 44 The Crescent has been rebuilt and / or repointed and is in good condition. Fence along 28 The Promenade appears original and has not been repointed.

Caption: View across the intersection of The Promenade (right) and The Crescent (left) showing new two-storey house and original fine sandstone fence.

- Recommended Management:** Maintain boundary fence to conserve heritage values. Where necessary, repoint with appropriate mortar to match original.
- Management:** Modify LEP listing to include boundary fence of 28 The Promenade and 44 The Crescent as an archaeological item or specific built element and remove listing of garden.

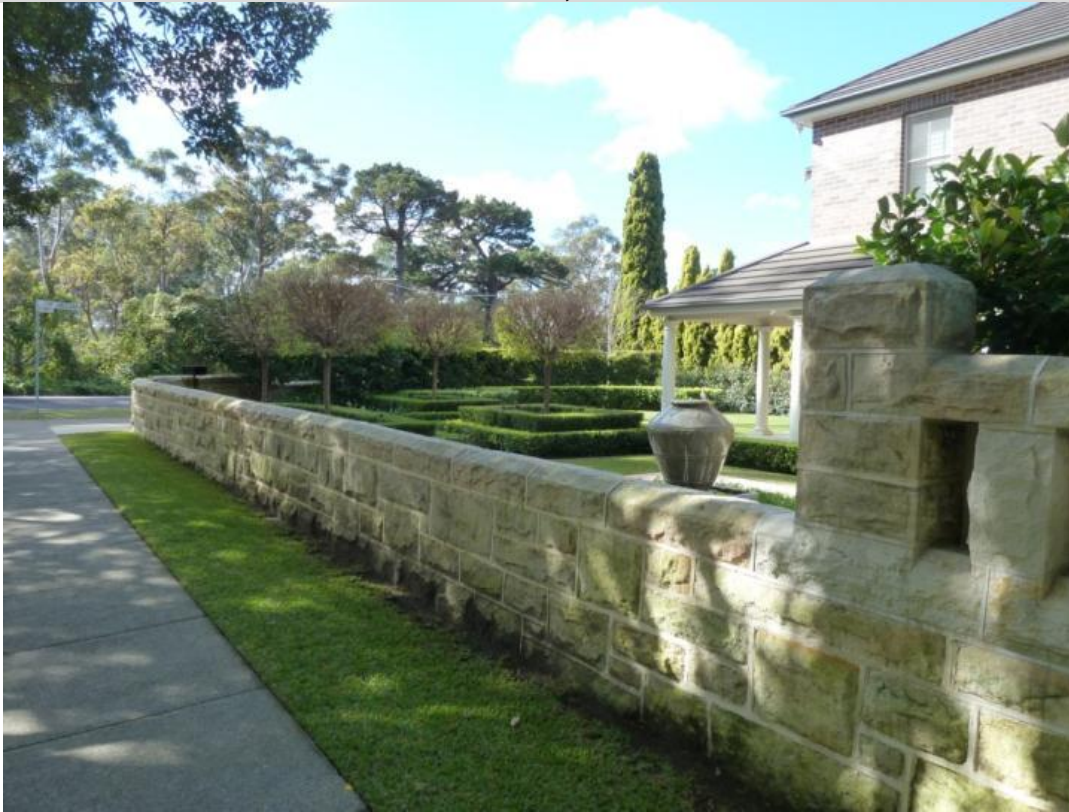
Caption: Side boundary of 44 The Crescent showing rebuilt / repointed fence with castellated section at far left. This style continues along the side boundary to include the front fence of new lot at 28 The Promenade. New garden of No.44 is highly stylised formal garden with geometric squares of box and other hedging and standard deciduous trees (*Robinia* sp.).

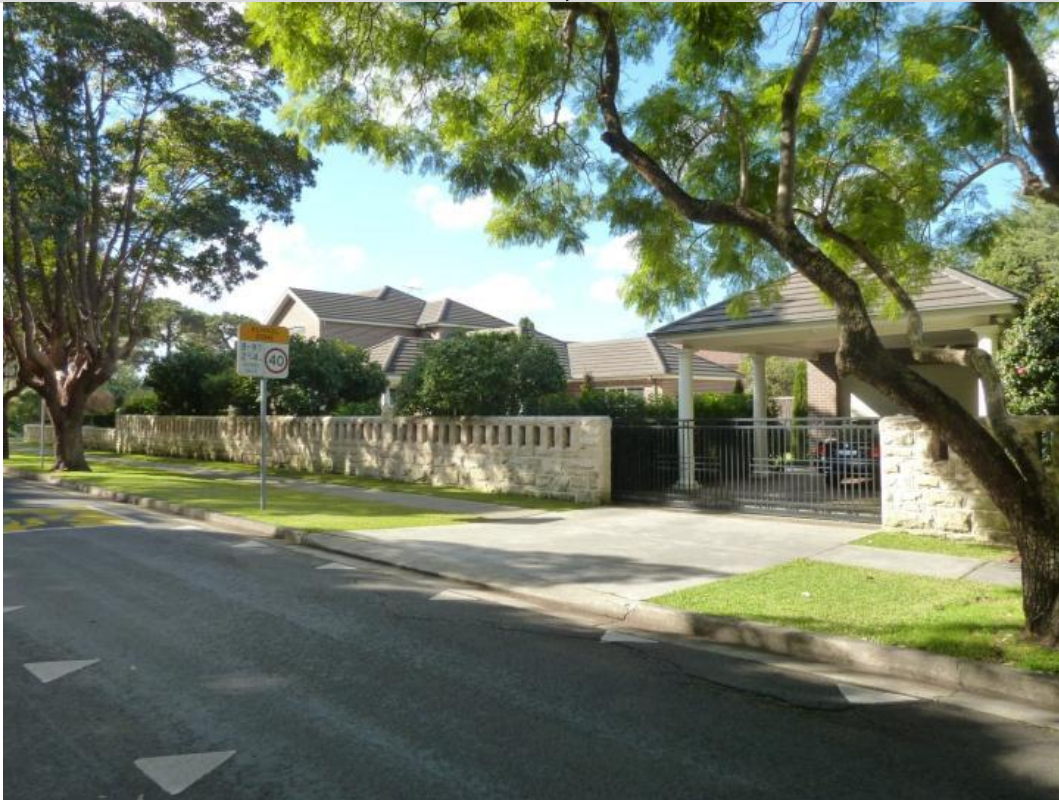
Caption: Side boundary of 44 The Crescent showing the rebuilt / repointed sandstone fence and new carport / garage.

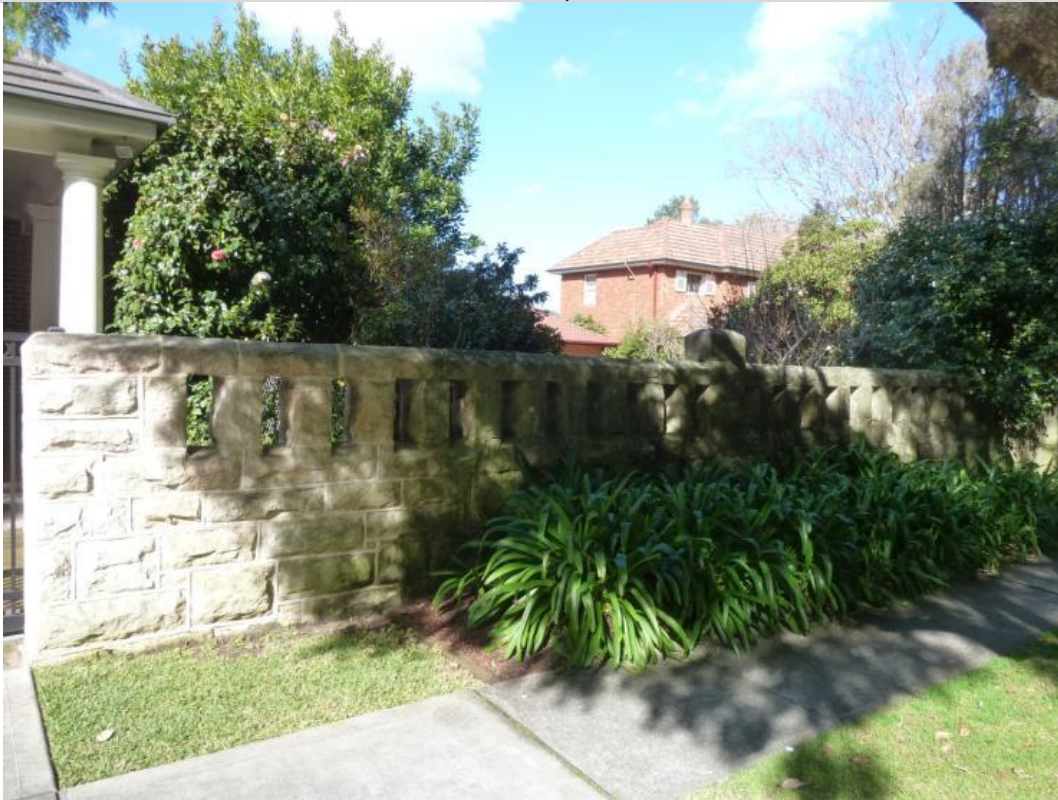
Caption: Former side boundary fence of 44 The Crescent shown continuing along The Promenade to form the front fence of 28 The Promenade. This section has not been repointed.

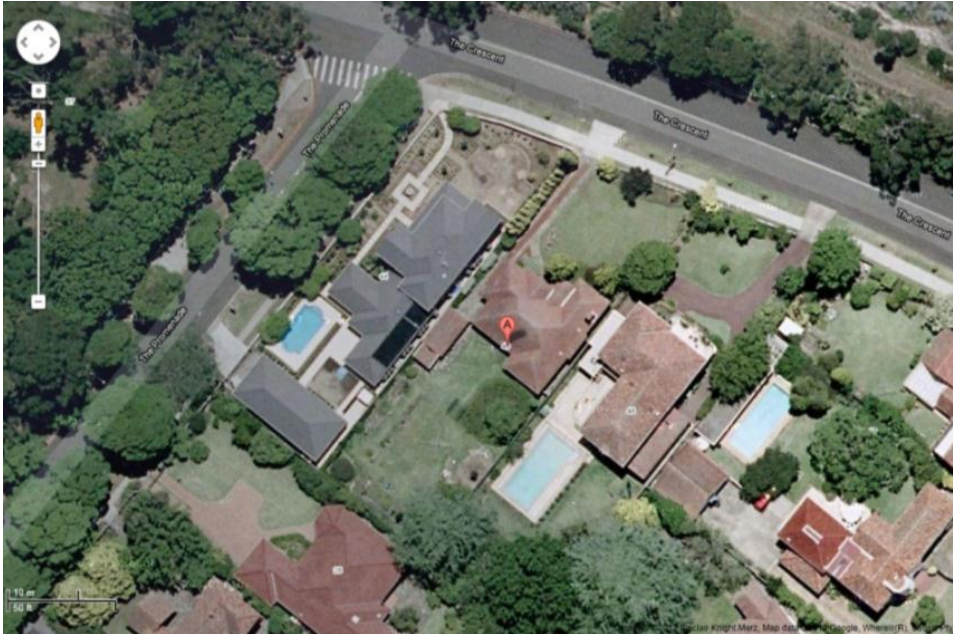
Caption: Aerial photo of 46 The Crescent (house marked by 'A' in red dot, showing row of 'pencil' golden cypress along one boundary)

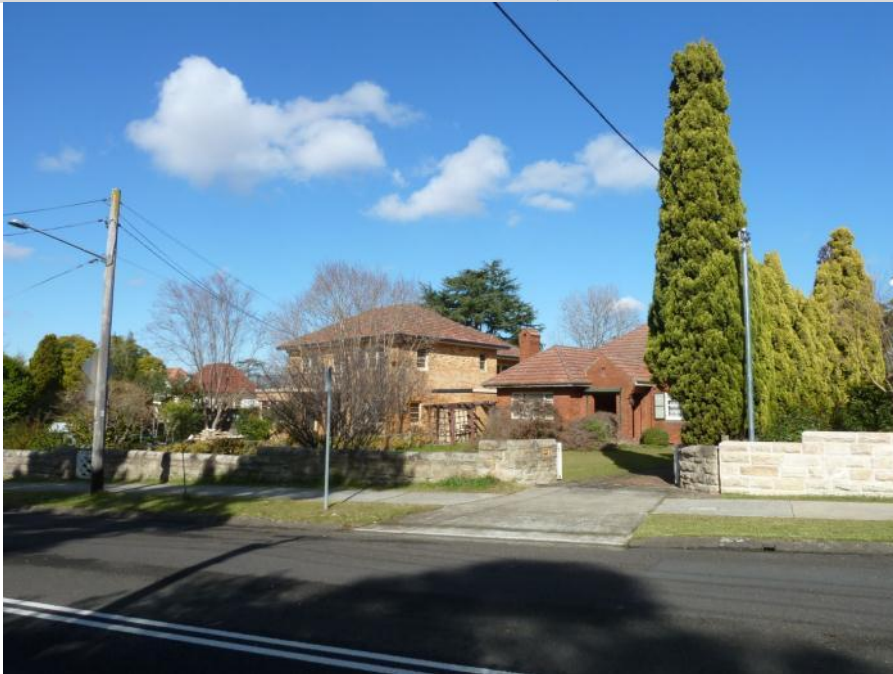
Caption: View of garden from opposite side of The Crescent showing front boundary fence and row of golden cypress (right).

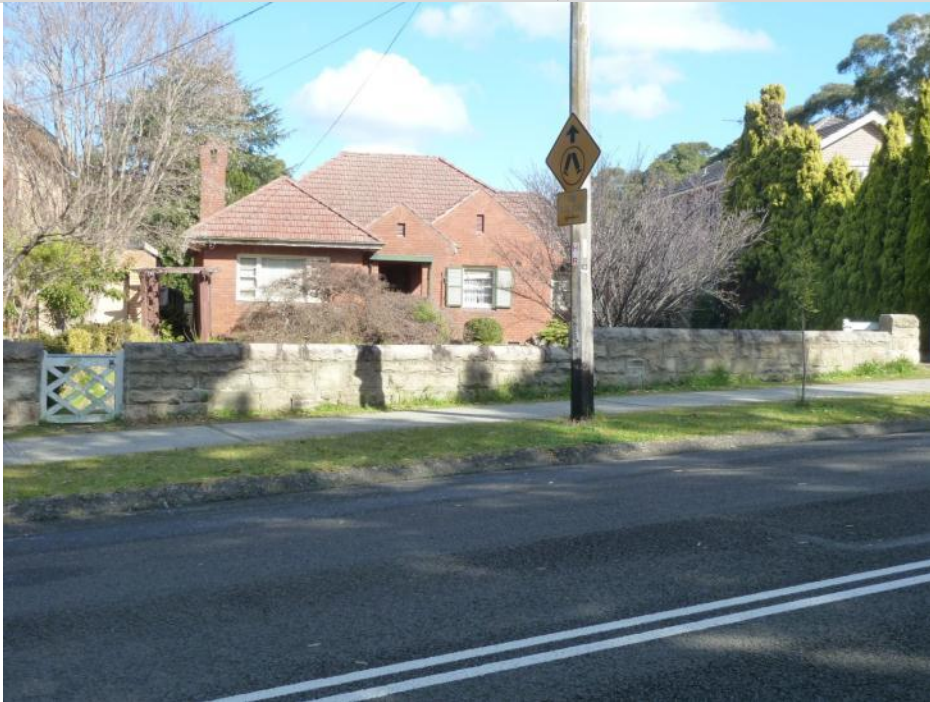
Caption: Intact house with fine sandstone fence and timber gate.

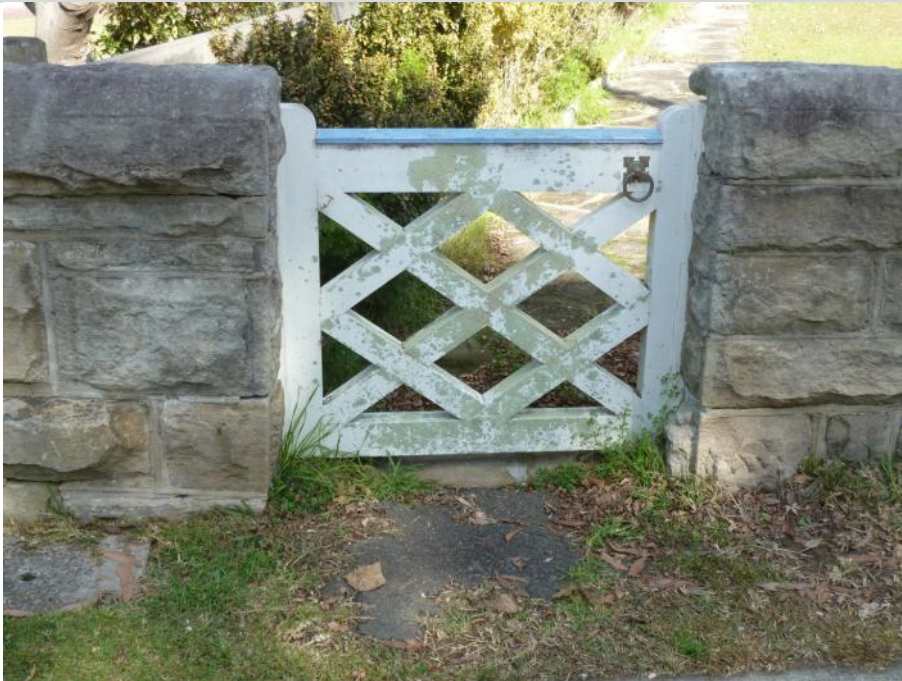
Caption: Original heavy timber diagonal lattice pedestrian gate in need of repainting.

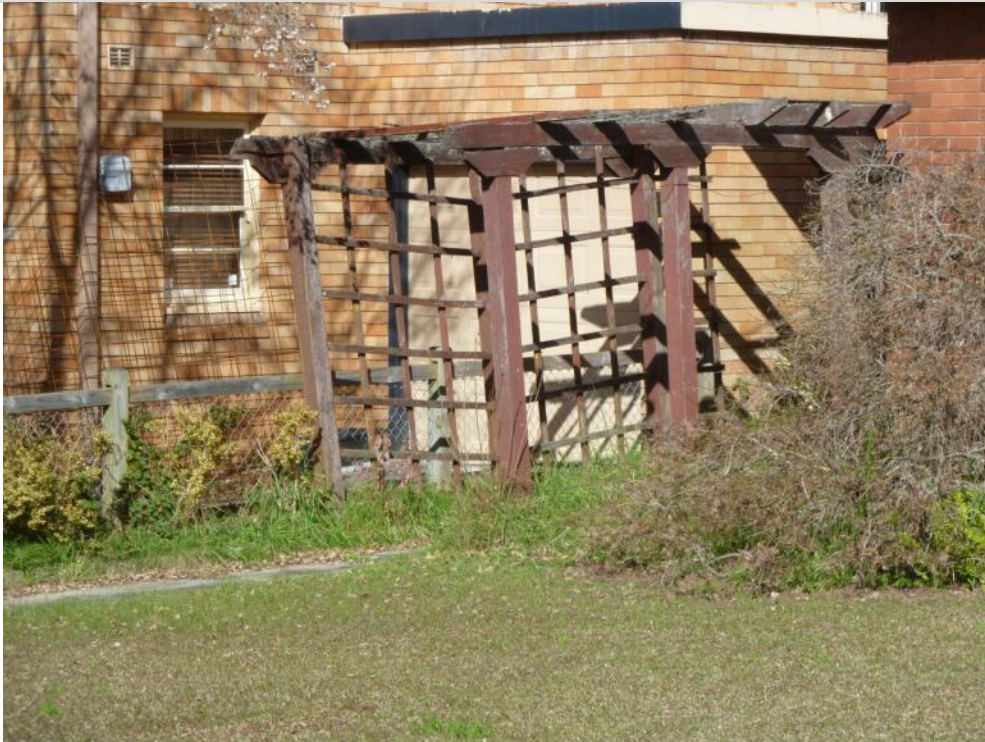
Caption: Relatively rare timber garden arbour in need of repair / restoration. Side fence is original timber-framed type with wire mesh panels.

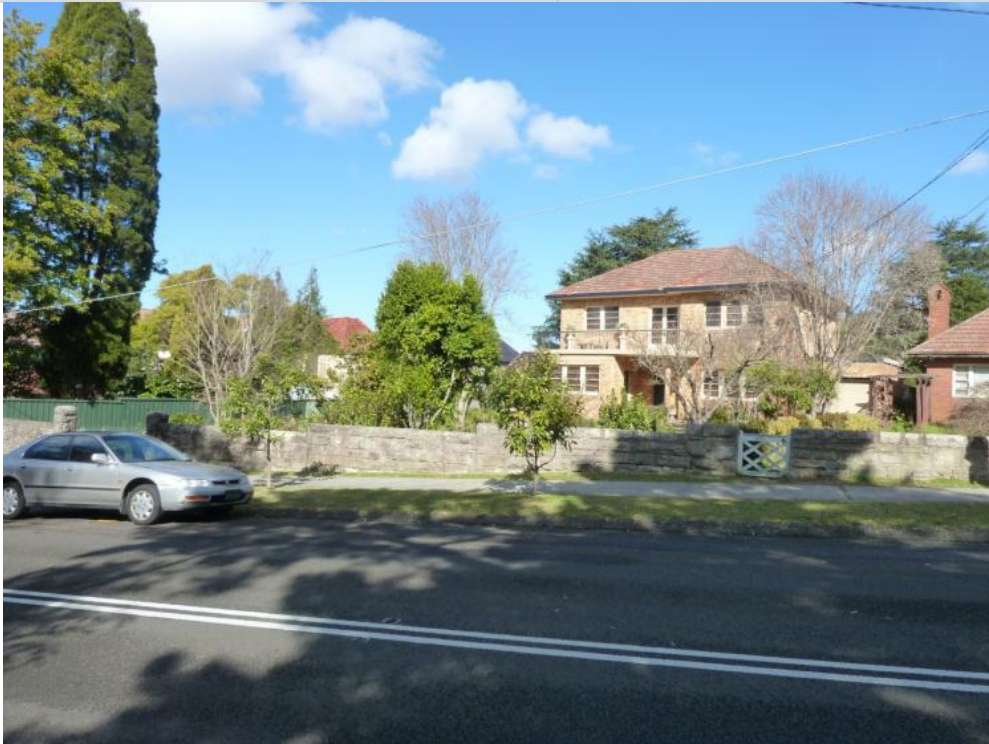
Caption: View to 48 The Crescent from opposite side of street showing c1940s two-storey house with fine sandstone front fence continuing along front of 46.

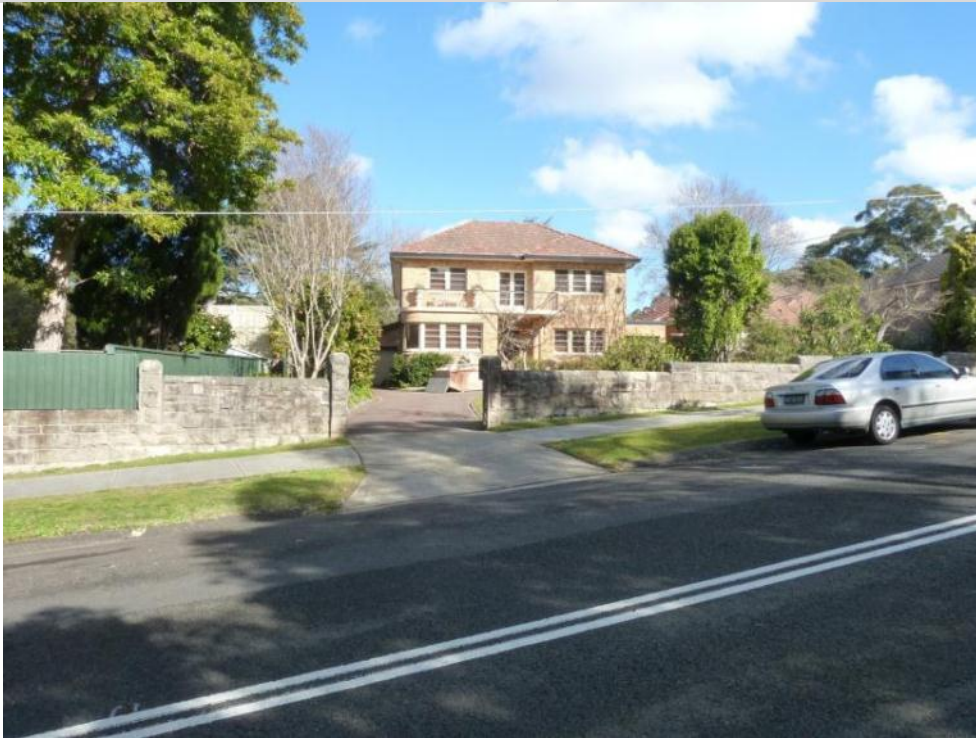
Caption: View to 48 The Crescent from opposite side of street showing c1940s two-storey house with fine sandstone front fence continuing alongside boundary of adjoining property.
