Hornsby Heritage Study Review Stage 5, 2012

Volume 3—Appendix G Part 2: Sites D31–E78 and Appendix H

Report prepared for Hornsby Shire Council
March 2013

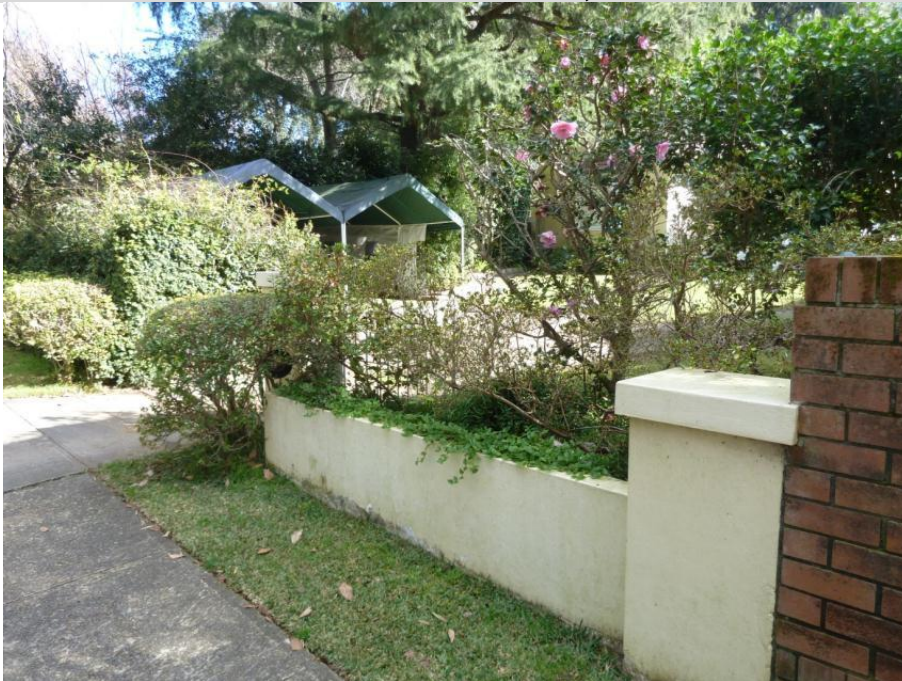
Caption: Front fence with plantings in the foreground, hedge and marquee carports in the background.

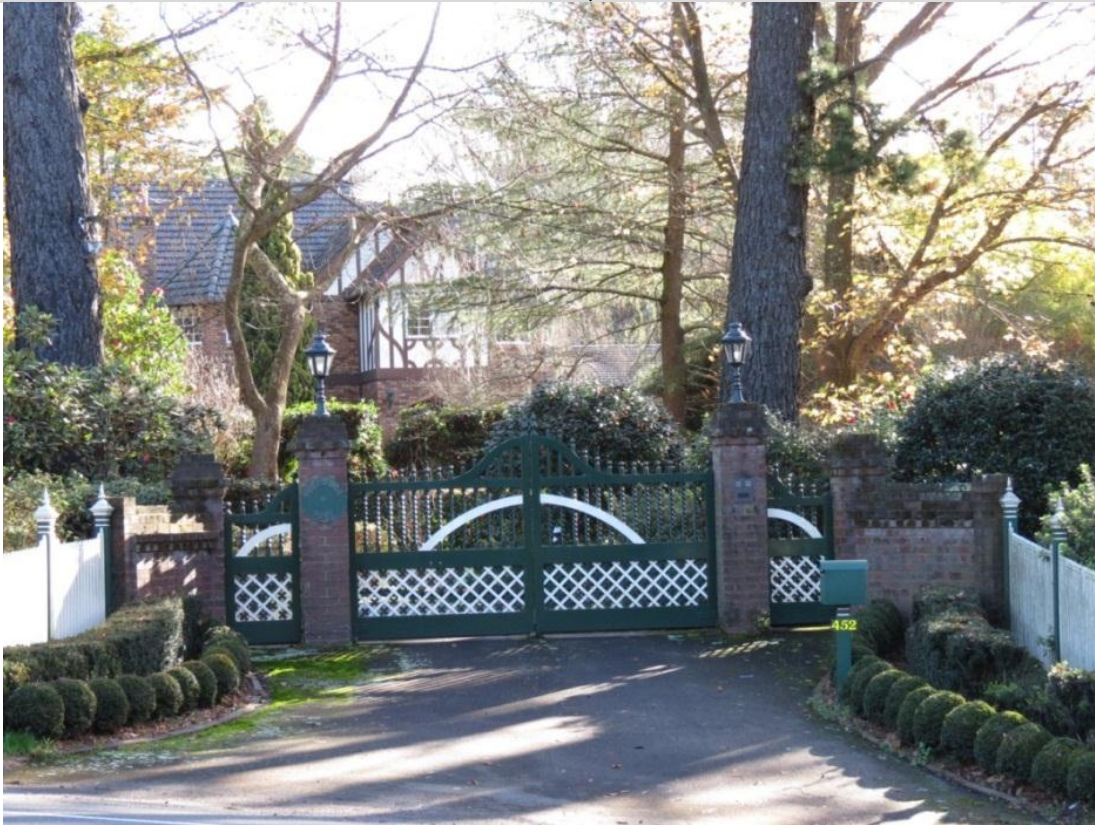
Caption: Elaborate front gates designed by current owner and built c1985, constructed of Huon Pine. Mock Tudor residence built by current owner c1980 visible in background.

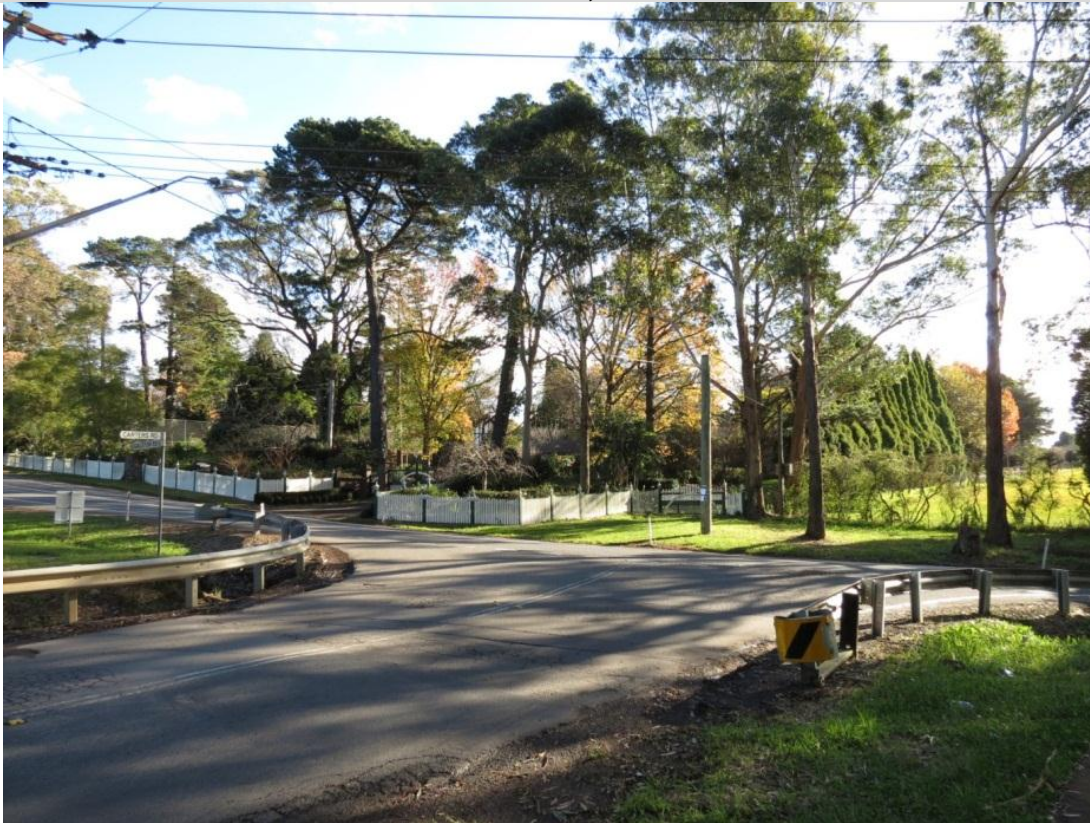
Caption: View from intersection of Carters Road and Galston Road across to 452 Galston Road, showing boundary fence, two mature *Pinus radiata* flanking the entrance drive, remnant indigenous trees on nature strip and *Cupressus torulosa* hedge along northern boundary.

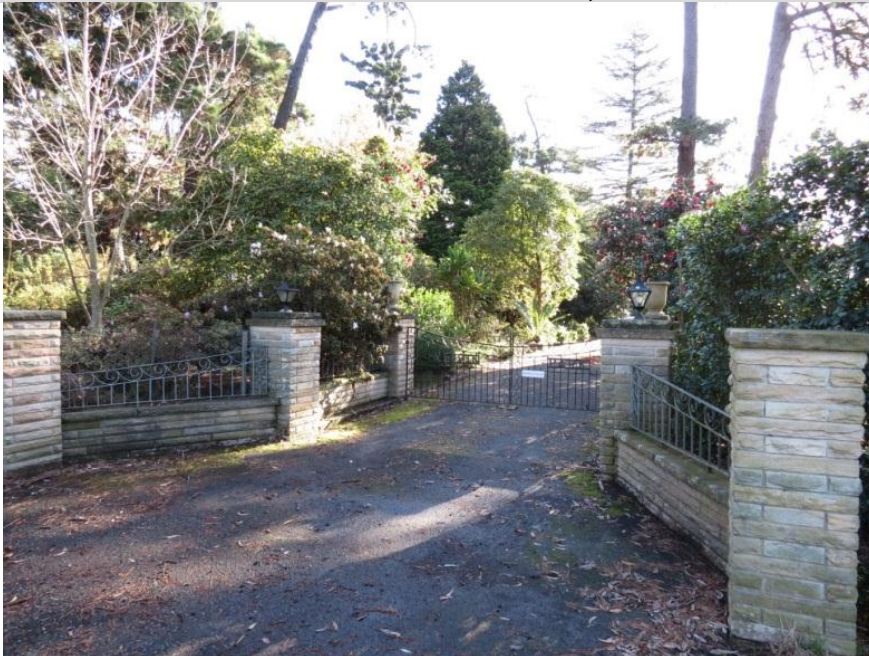
Caption: Vehicle entry to 'Kelvin Park' showing mature trees and shrubberies in the garden with sandstone (bookleaf construction) entry piers (splayed in a series) and ornamental wrought iron gates and fence panels.

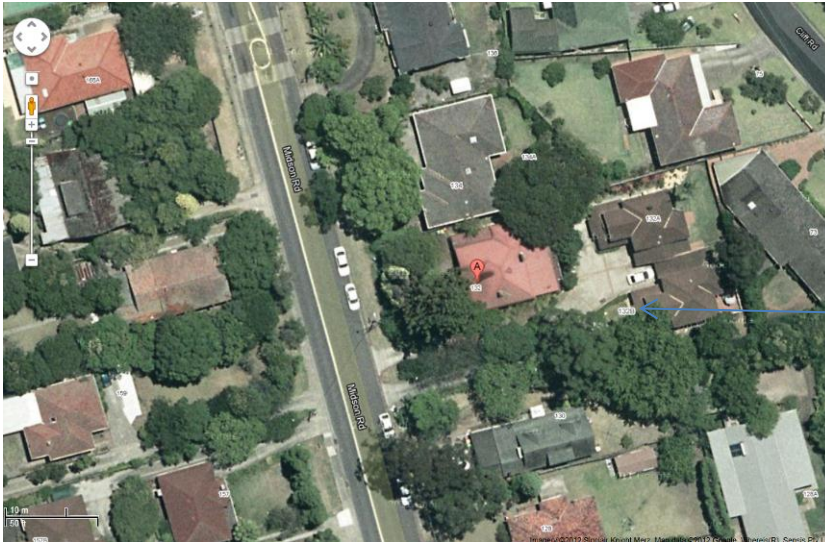
Hoop Pine

Physical Description: Since 1992 the rear of the property has been subdivided, creating two lots, 132A and 132B Midson Road. The front garden is dominated by a huge specimen of *Araucaria cunninghamii* (Hoop Pine) approximately 25m tall and multi-stemmed for about half its height. The golden cypress noted in 1992 no longer appears golden and has severe dieback. The front garden has some privet and a clump of umbrella trees, a species which is becoming an environmental weed.

Caption: Aerial photo of 132 Midson Road, Epping showing lot subdivided to create two new lots at rear (132A and 132 B), with front garden dominated by huge specimen of *Araucaria cunninghamii* (Hoop Pine). (Source: Google Earth)

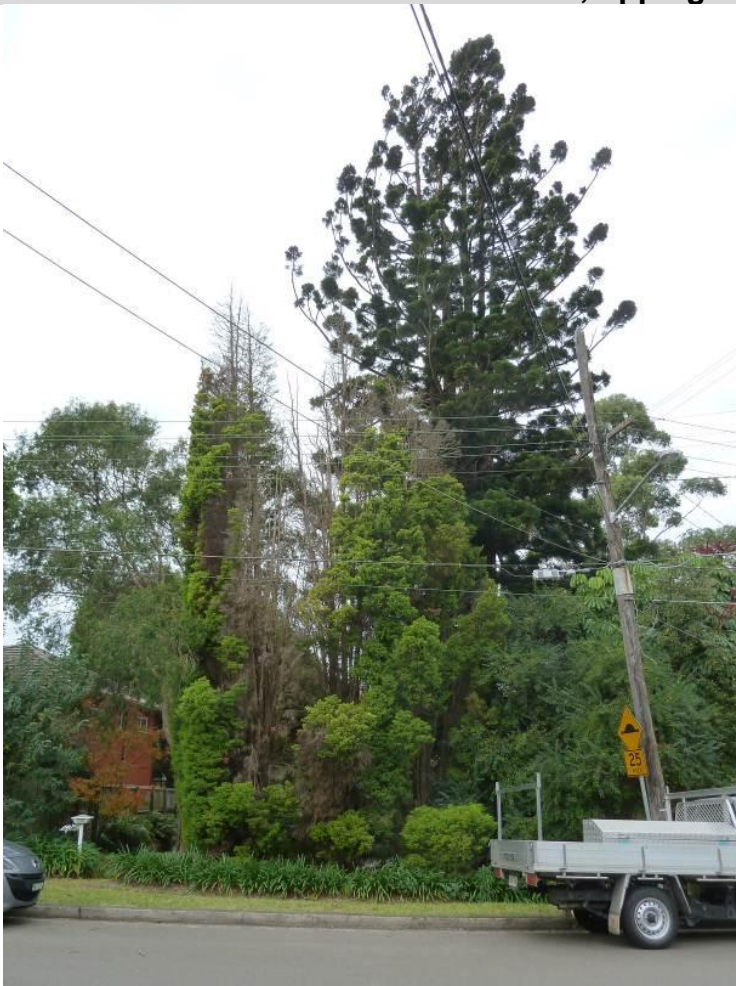
Physical Condition: The row of cypresses has been compromised by dieback and the garden generally is weed infested. The Hoop Pine appeared in good condition at time of review but this needs to be corroborated by a qualified arborist.

Caption: Midson Road frontage of 132 showing dieback in cypresses. (Source: Chris Betteridge, Musecape 2012)

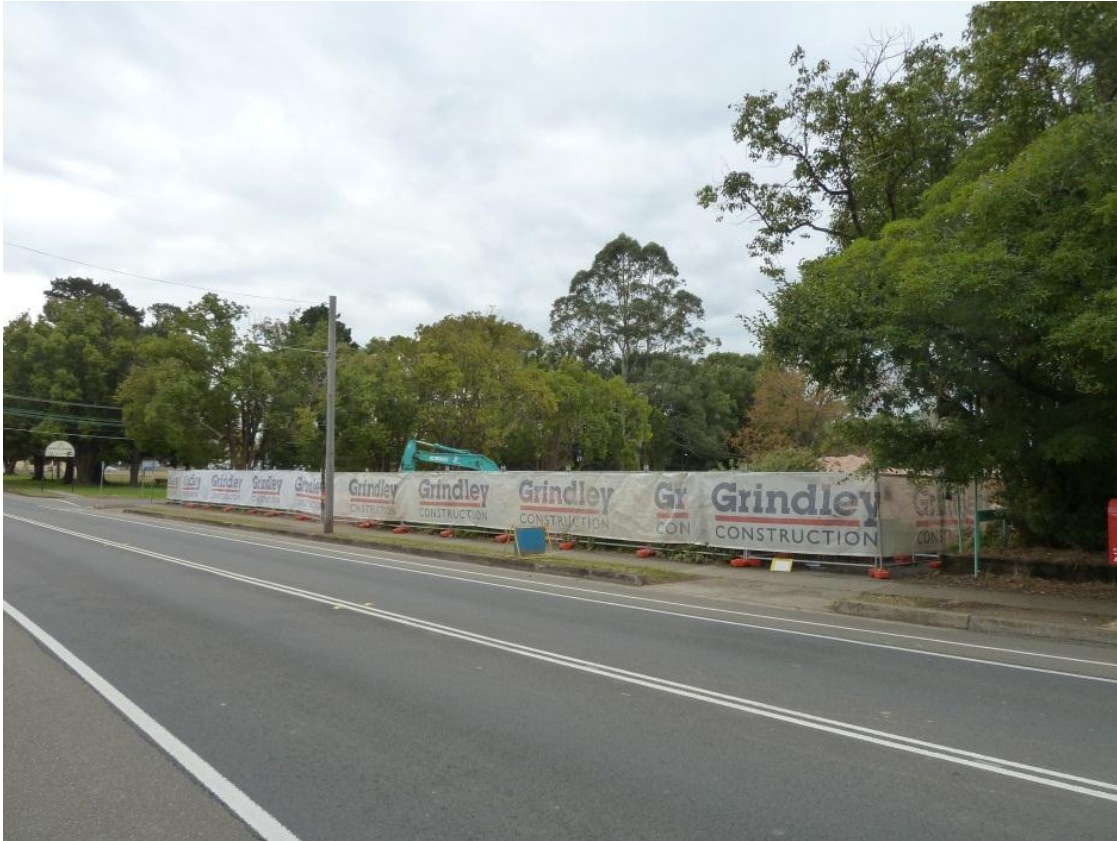
Physical Condition: Former garden cleared for site redevelopment.

Caption: Norfolk Road boundary of 64-66 where trees have been removed. Trees at far left are in Epping Park.

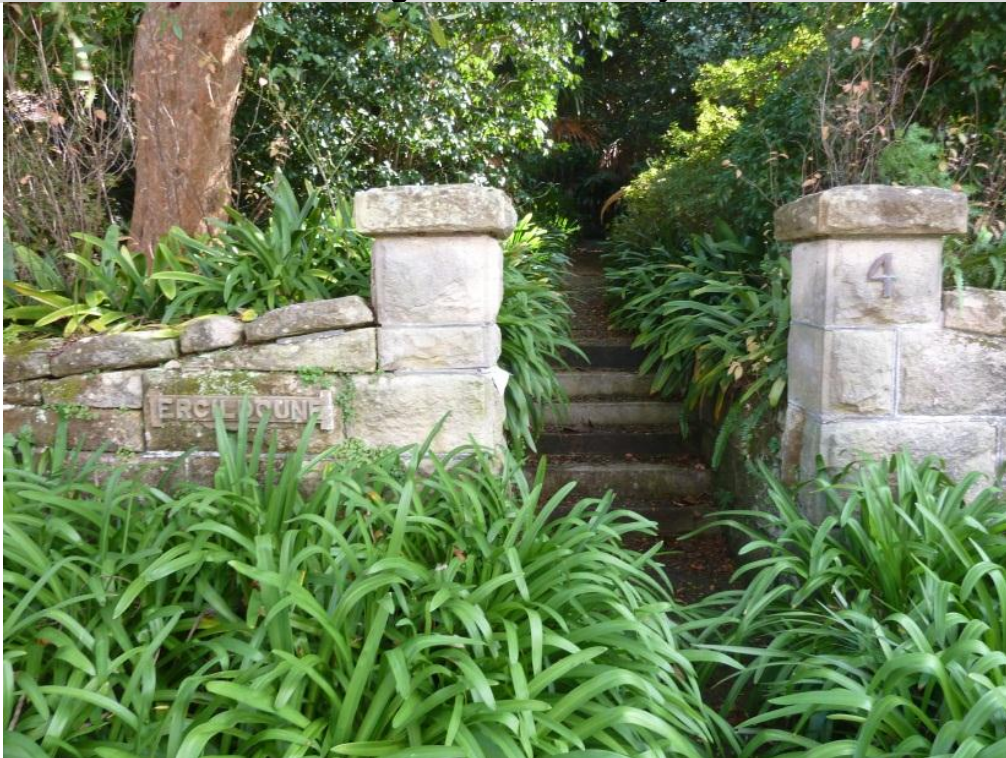
Caption: Pedestrian entry to 'Ercildoune' showing fine capped sandstone wall.

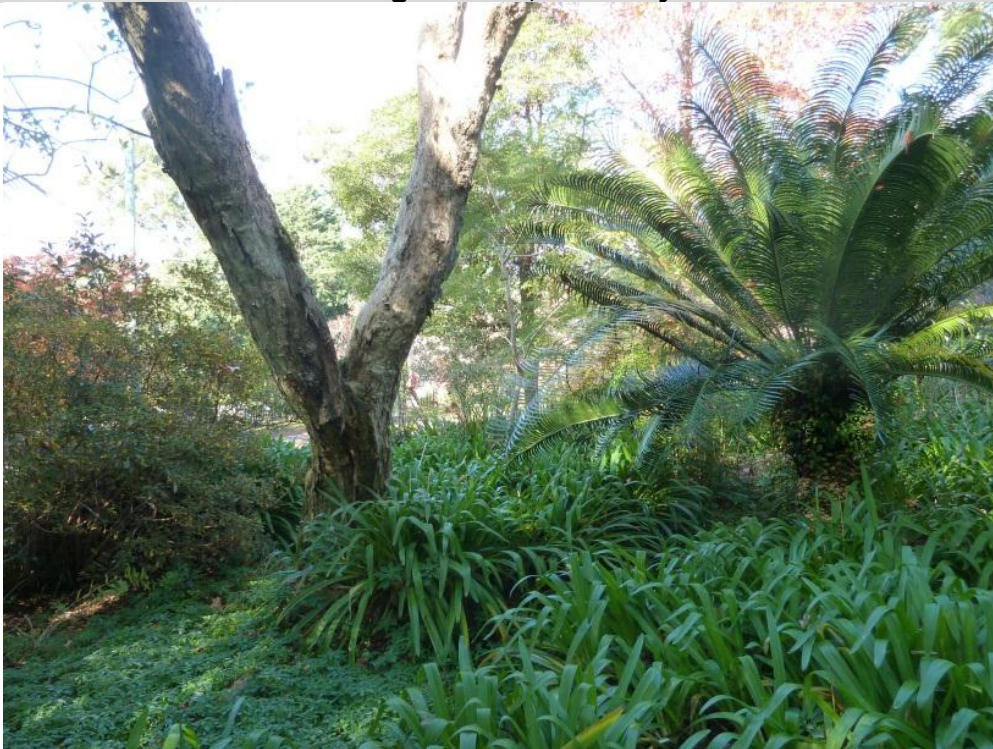
Several trees are in poor condition and the garden beds are being overgrown by *Agapanthus* and other invasive rhizomatous species.

Caption: Front garden showing mature cycad and diseased jacaranda.

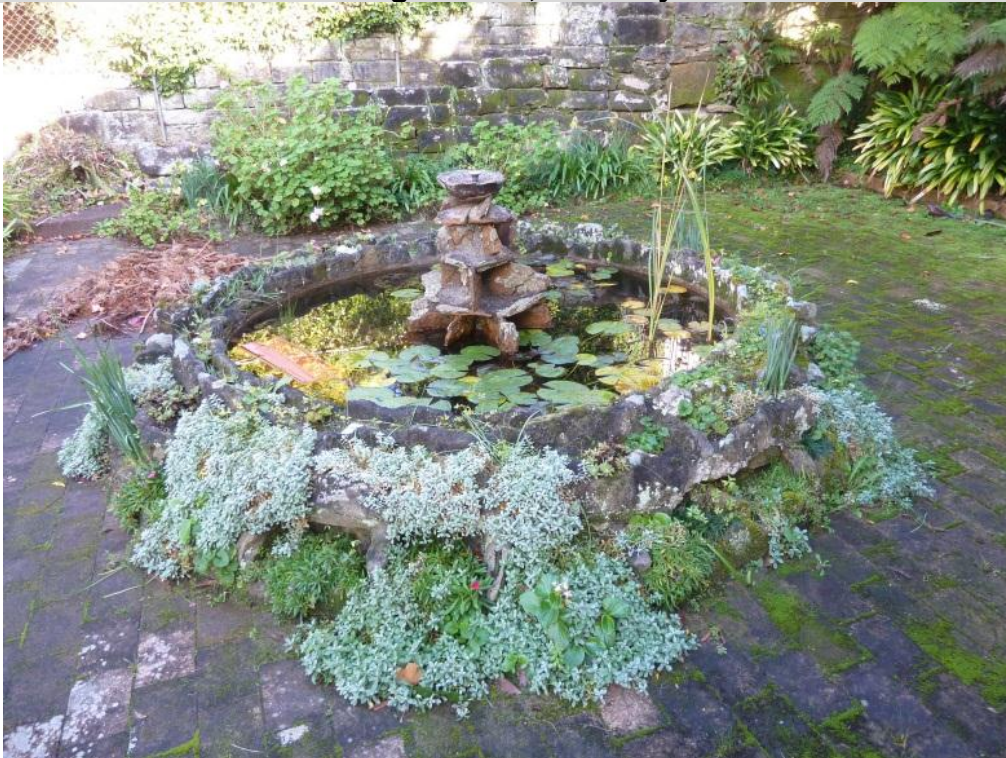
Caption: Intact sandstone lily pond with ornamental central fountain.

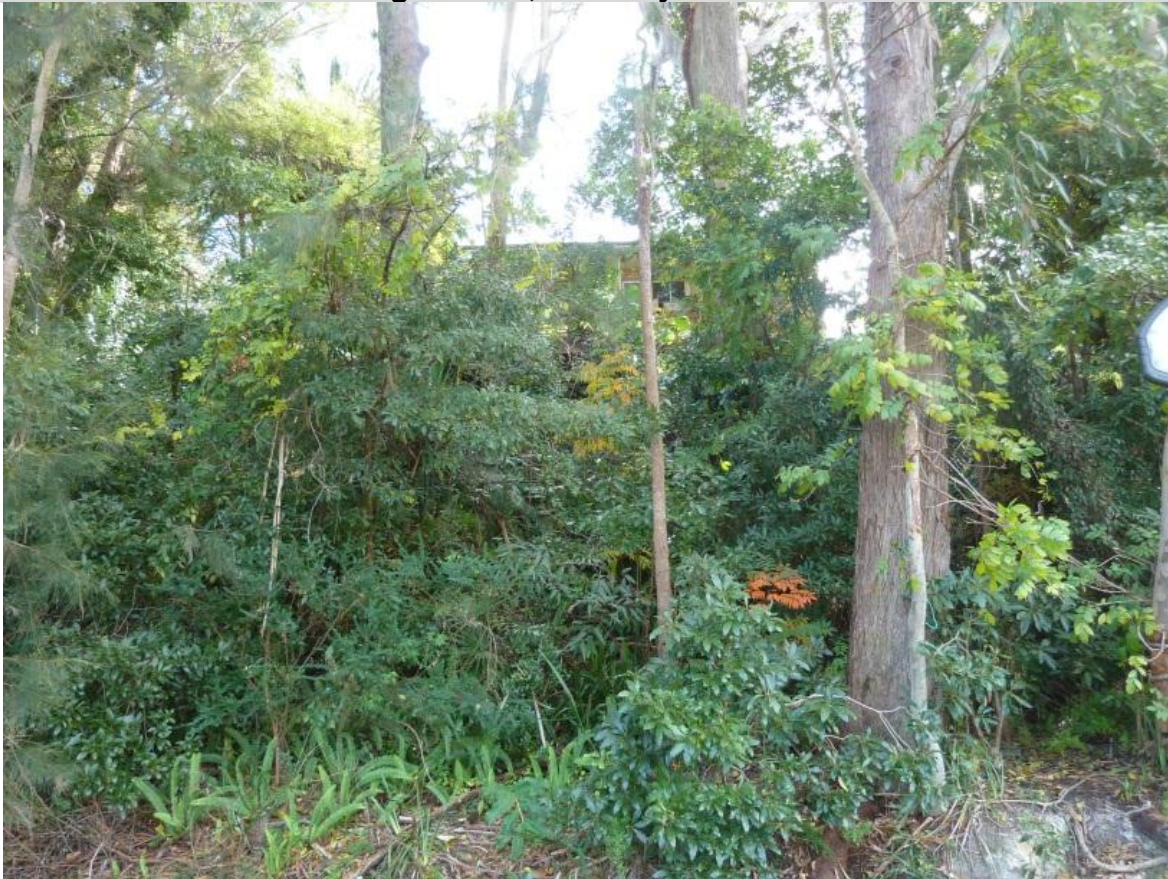
Caption: View from Lisgar Road into front garden of 8 Lisgar Road, showing Blackbutt and Pittosporum, with invasive Fishbone Fern and Wisteria growing up native trees.

Recommended Management: Encourage owner to control invasive species, some of which may be growing in road reserve.

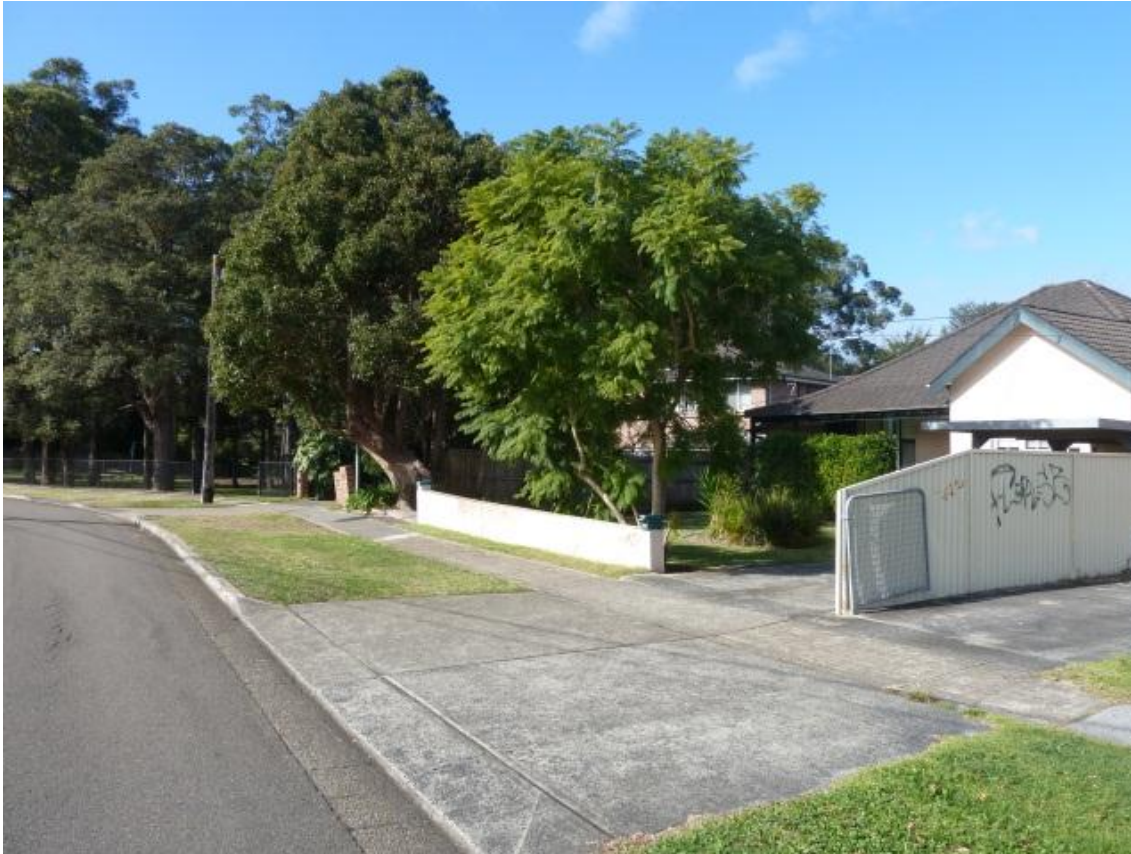
Physical Condition: The removal of four of the five camphor Laurel trees and the cedar and unsympathetic treatment of the remaining specimen has destroyed any heritage values.

Caption: 61 Pretoria Parade, Hornsby (right) with jacaranda in front garden and heavily lopped specimen of Camphor Laurel in front garden of No.59/61.

Study Number
Hornsby Heritage Study
Stage 5Item Name: **Gardens**Location: **61-63 Pretoria Parade, Hornsby****Modification Dates:****Recommended
Management:****Management:** Remove from LEP Schedule.**Further Comments:**

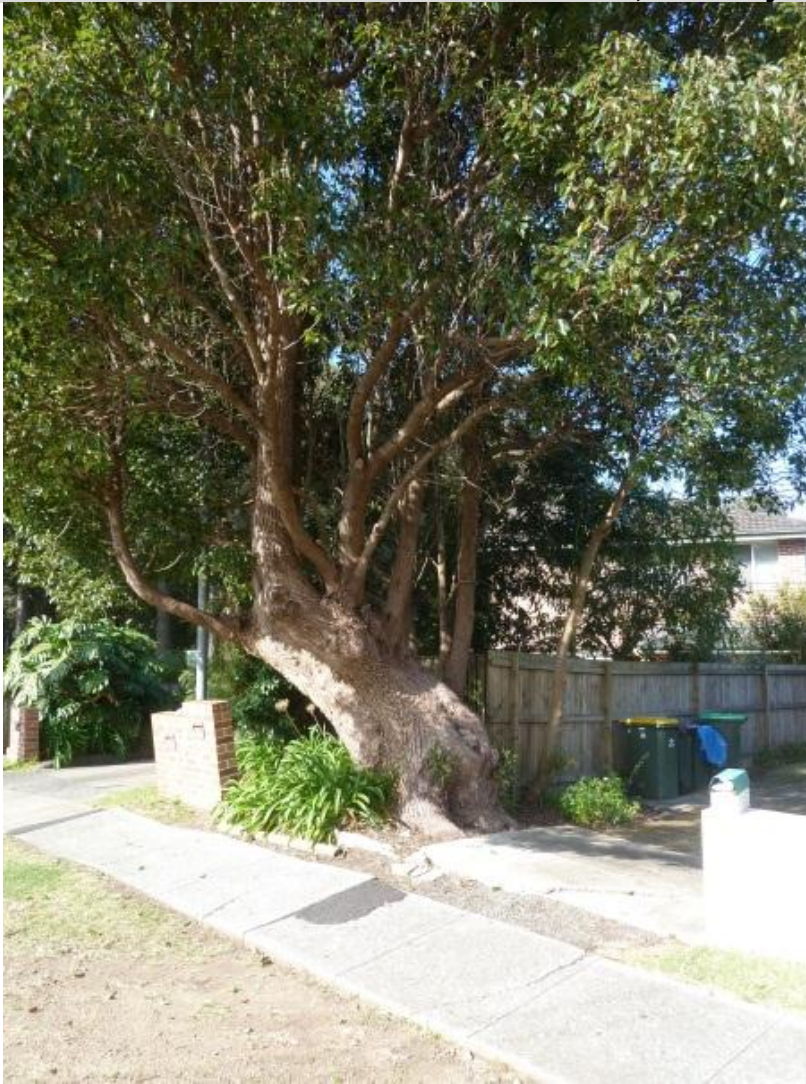
Caption: Only remaining Camphor Laurel has poor form and has been heavily lopped.

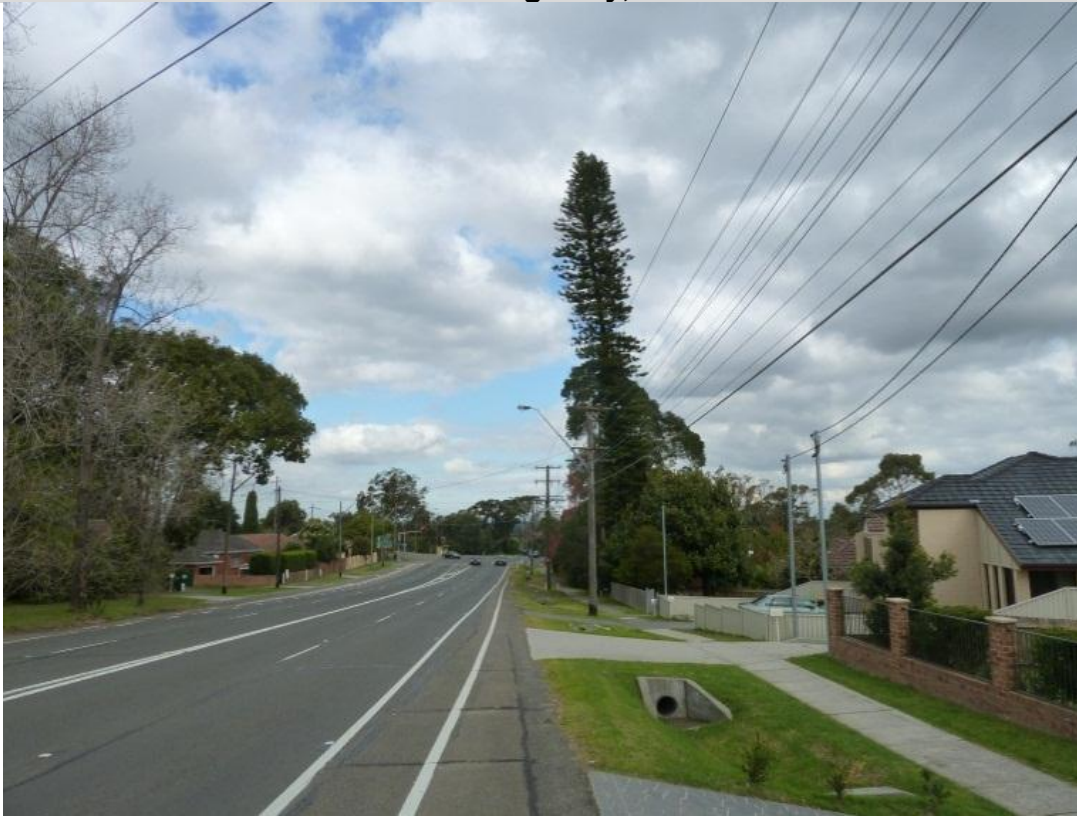
Caption: Norfolk Island Pine viewed from north, showing its height and slight lean over footpath and nature strip.

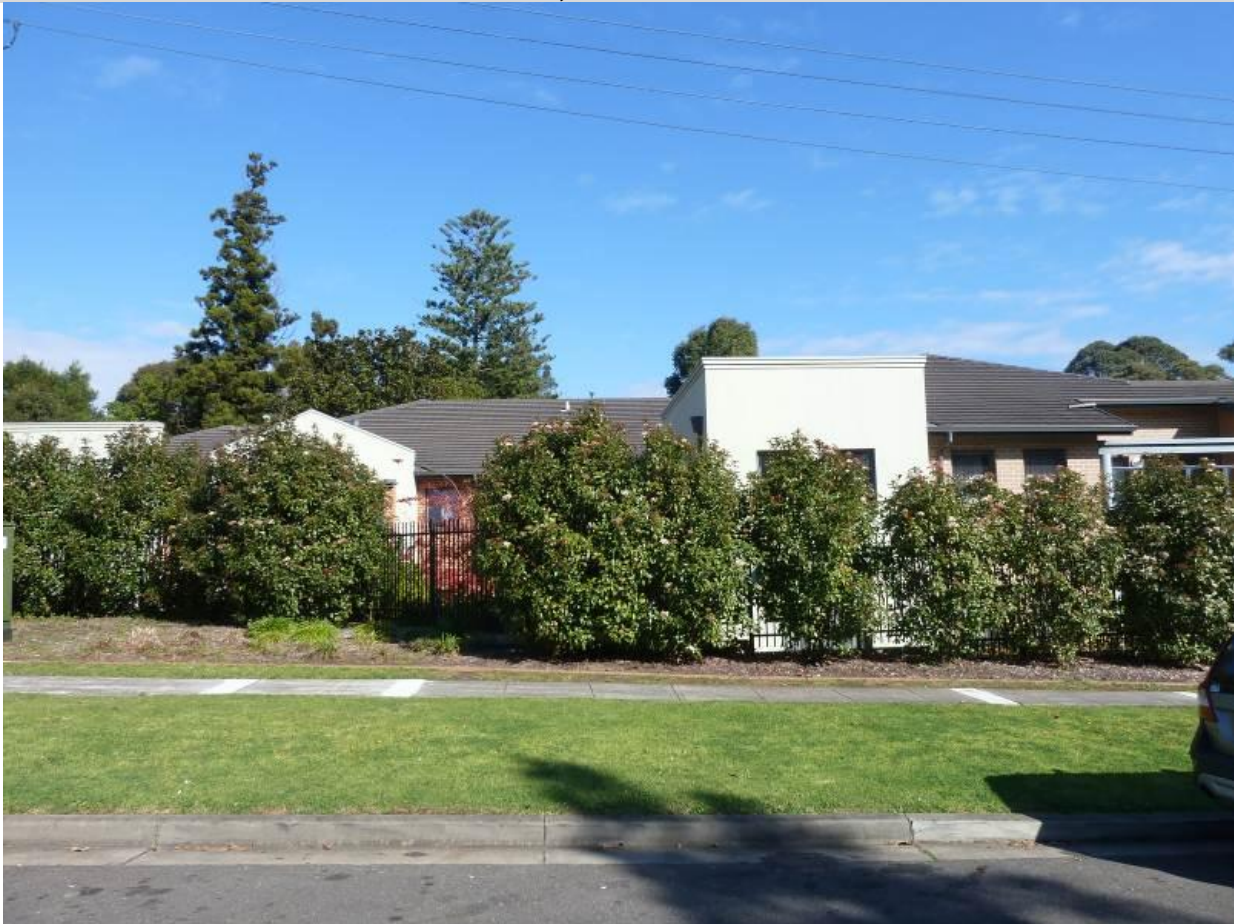
The remnant plantings from the earlier garden are in generally good condition although there is some evidence of minor dieback in some specimens, possibly due to a combination of site works, the prolonged drought of the early 2000s and competition effects.

Caption: View into site from Frith Avenue, showing in background, from left to right, specimens of *Cryptomeria japonica* (Japanese Cedar), *Magnolia grandiflora* (Bull Bay) and *Araucaria cunninghamii* (Norfolk Island Pine). The canopy of the Japanese Cedar appears to have deteriorated since 1993 when it was much more symmetrical. (Source: Chris Betteridge, Musecape).

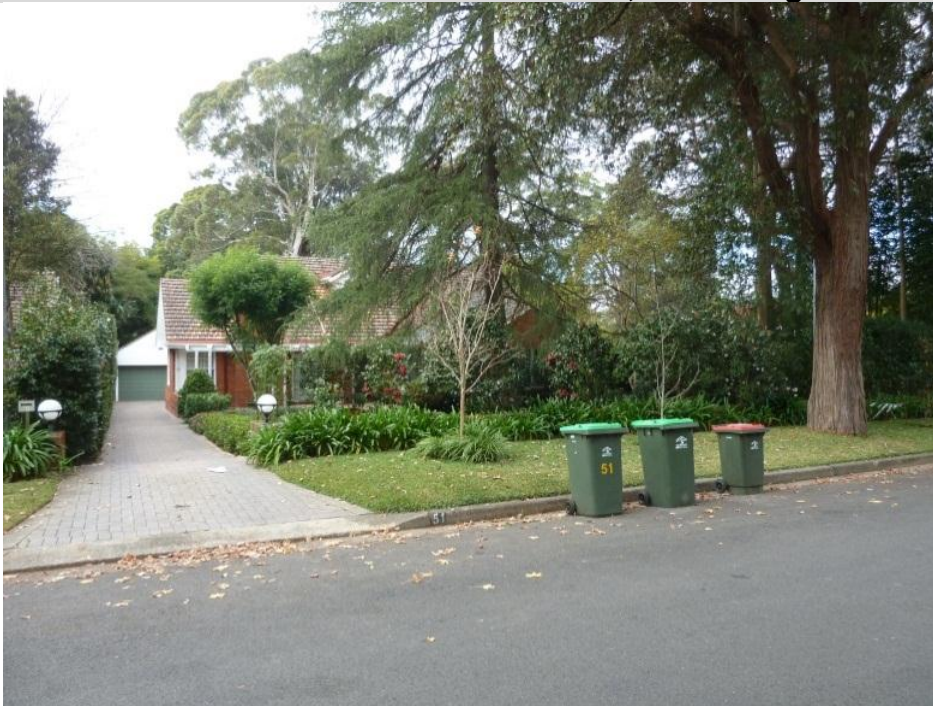
Caption: 51 Bundarra Avenue showing brick house with tiled roof and front garden with Deodar, ornamental flowering shrubs and remnant Turpentine on nature strip.

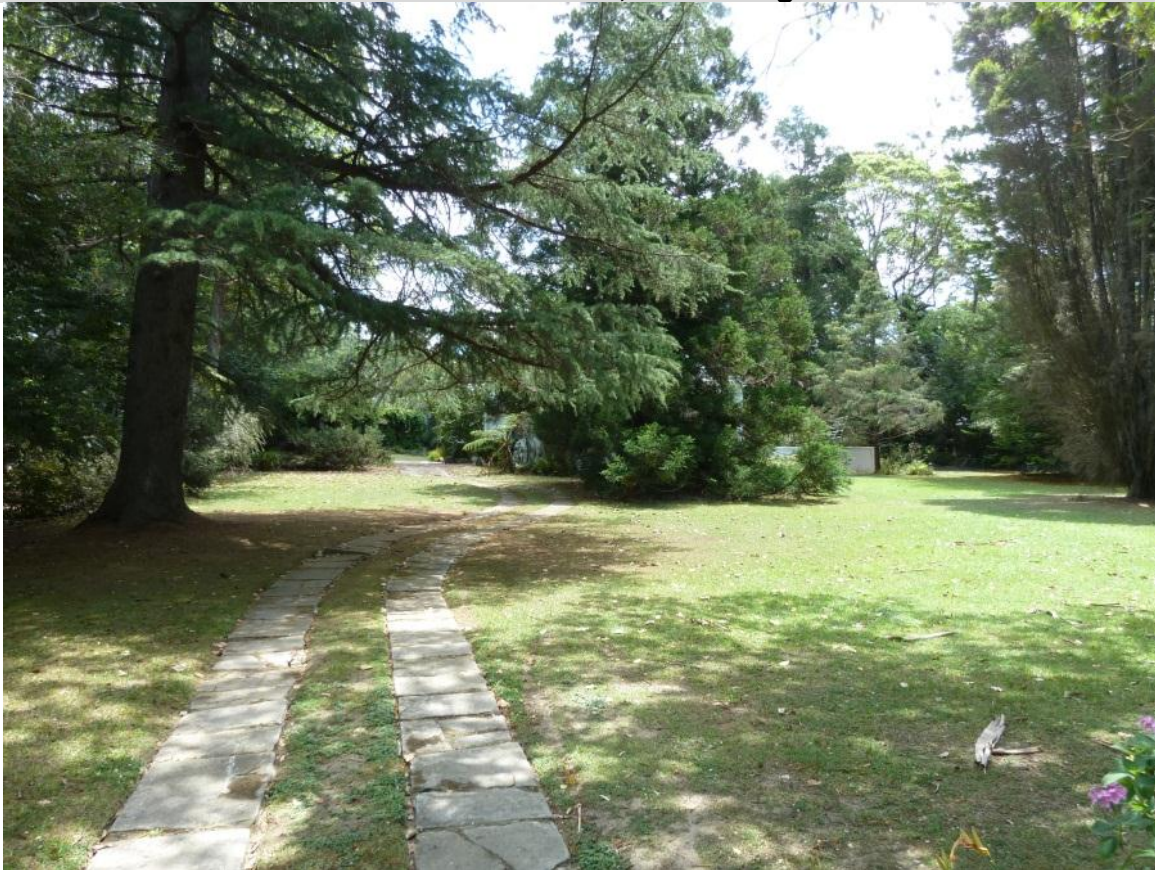
Caption: 54 Bundarra Avenue, stone vehicle tracks lead along south side of property from street to garage paved car parking area and garage at rear of house.

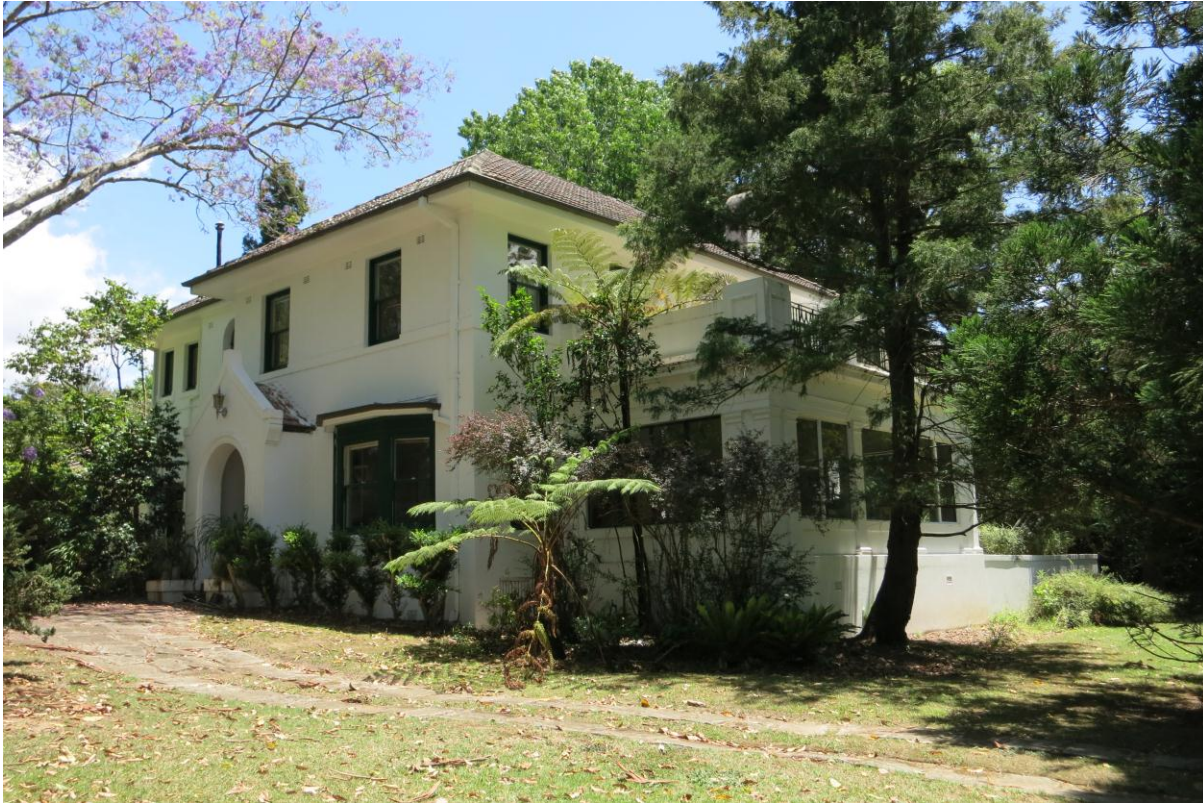
Caption: Front entrance, sunroom to right was part of the original construction and later enclosed.

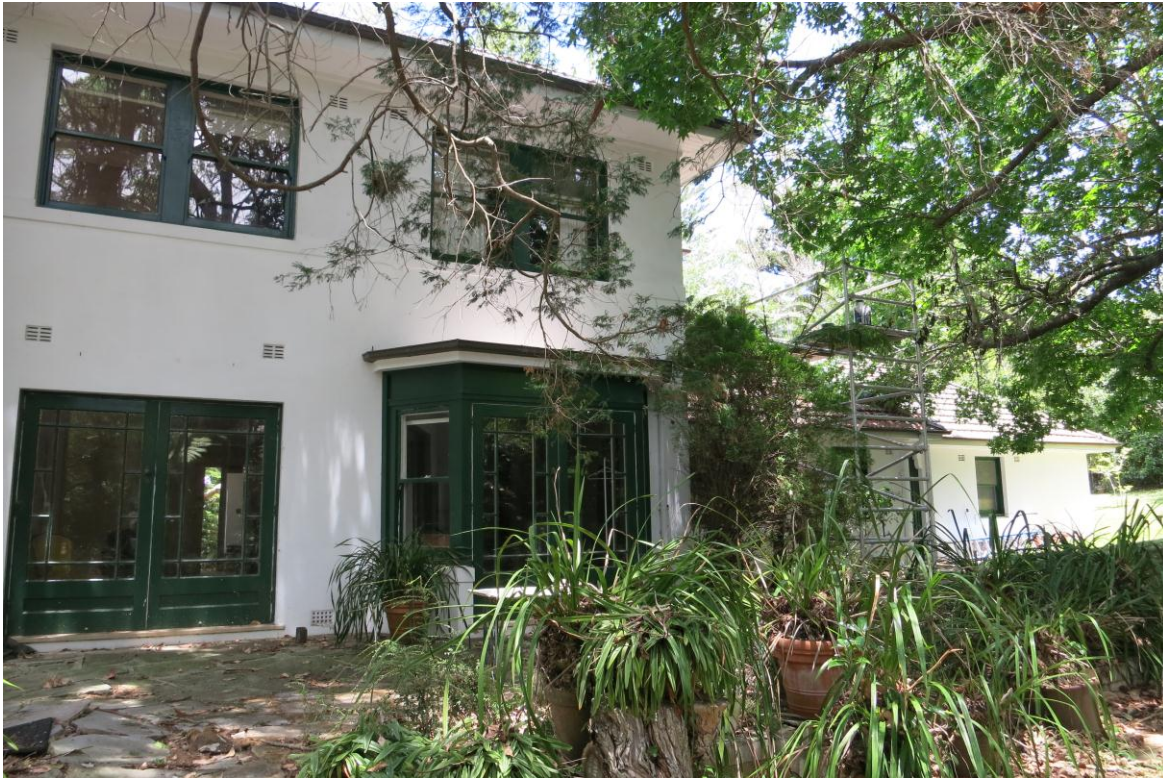
Caption: Main living areas open to c1937 paved terrace. To the right is the service wing and integrated garages.

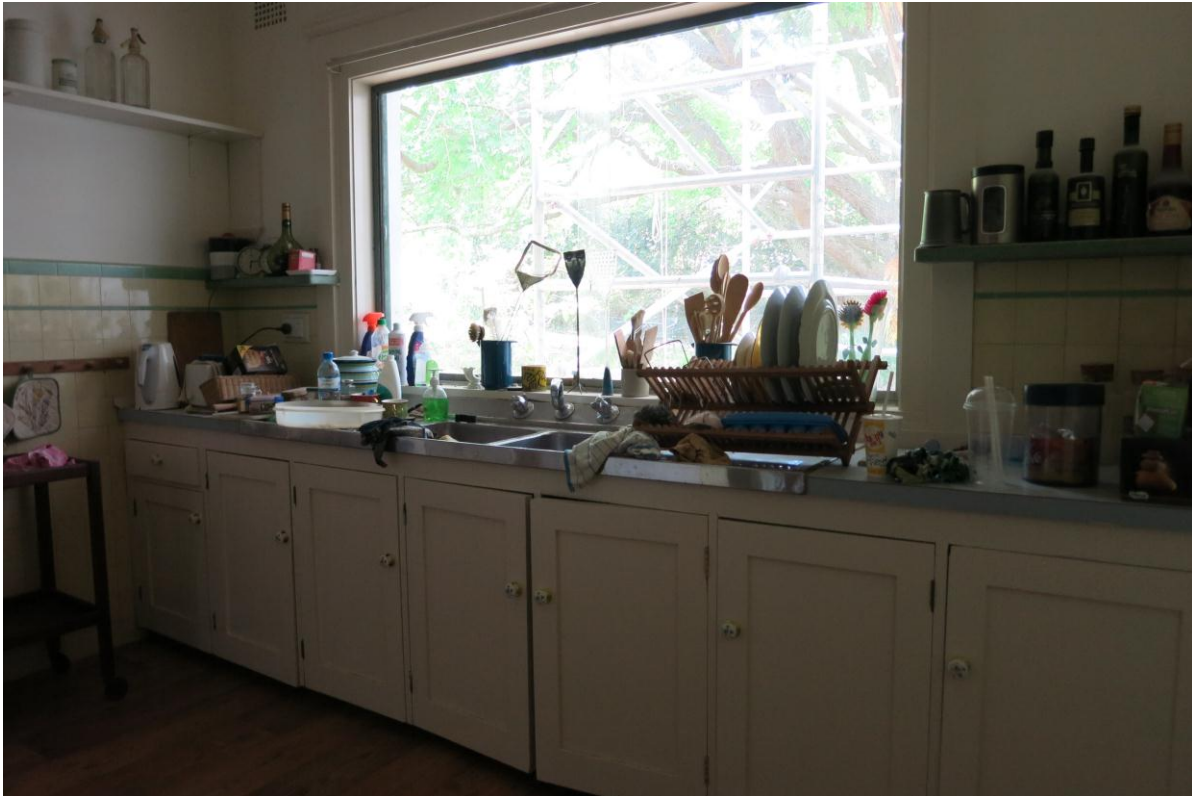
Caption: Original kitchen cupboards and tiling

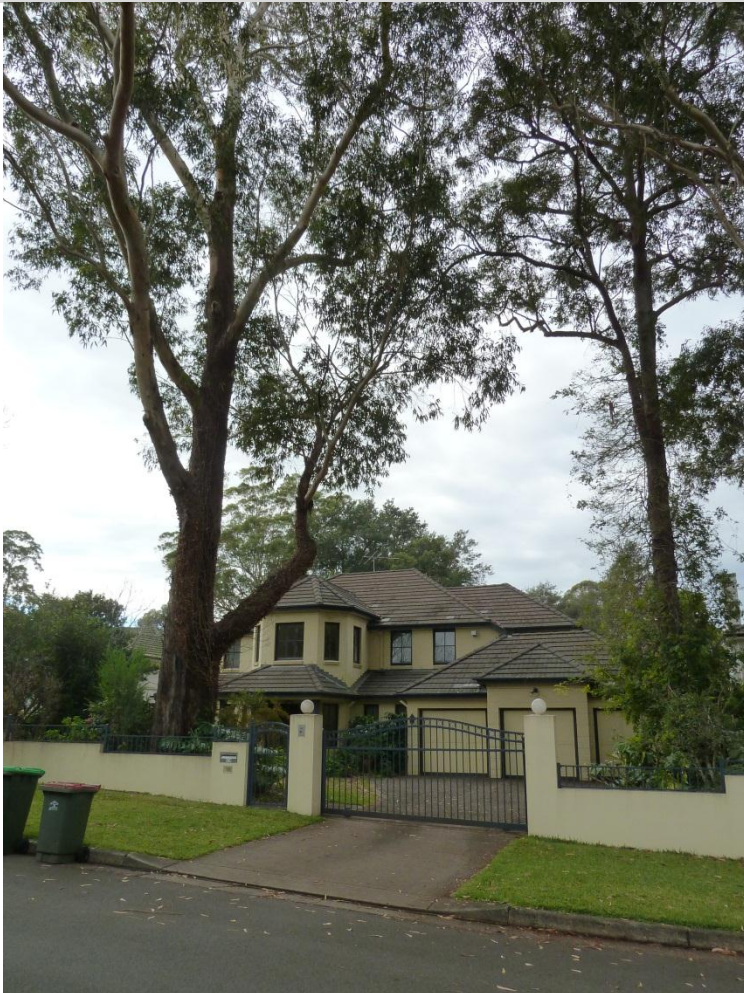
Caption: 57A Bundarra Avenue, showing recent two-storey house and new garden with remnant indigenous trees in garden.

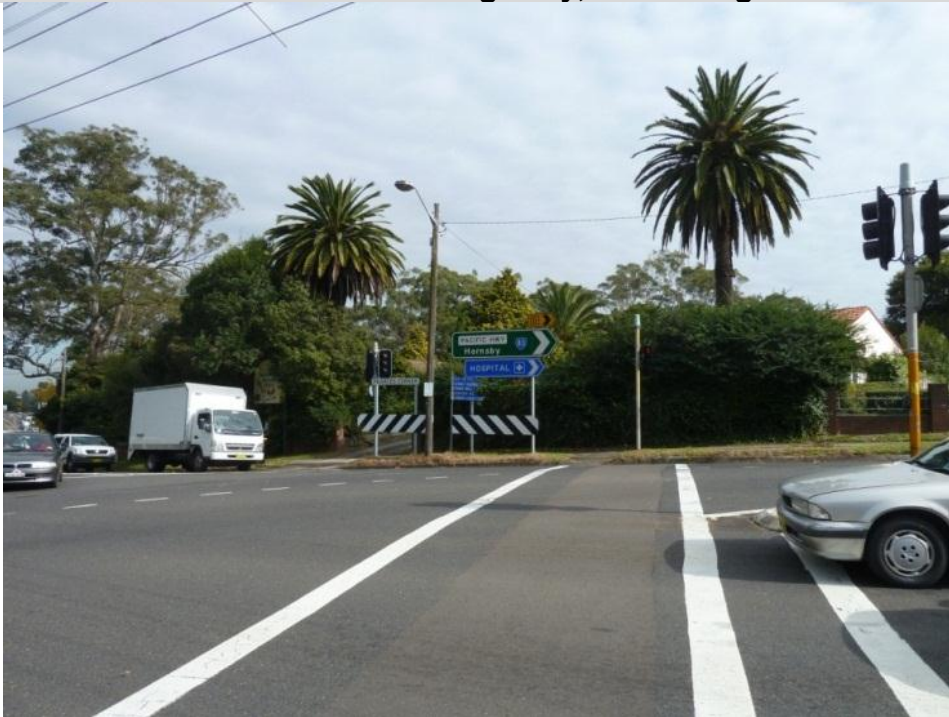
Caption: View across intersection to 1 Pacific Highway showing landmark quality of two *Phoenix canariensis* palms.

- Modification Dates:**
- Recommended Management:** Hedge must be kept pruned to prevent flowering and fruiting. Specimen of Sydney Blue Gum at front of 4 Pennant Hills Road will be protected under Tree Preservation Order (TPO). Manage site to retain and conserve palms, fence and hedge.

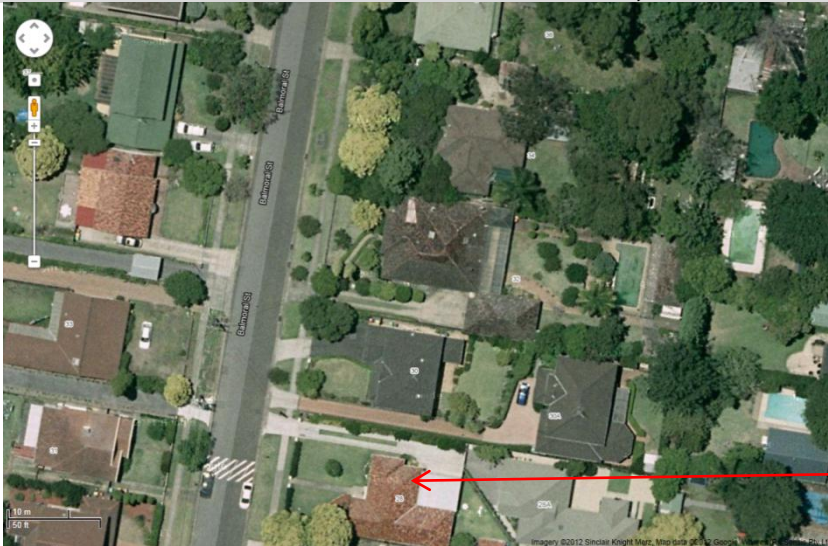
28 Balmoral Street,
Waitara

Caption: Air photo of 28 Balmoral Street showing rear garden subdivided off to create 28A.

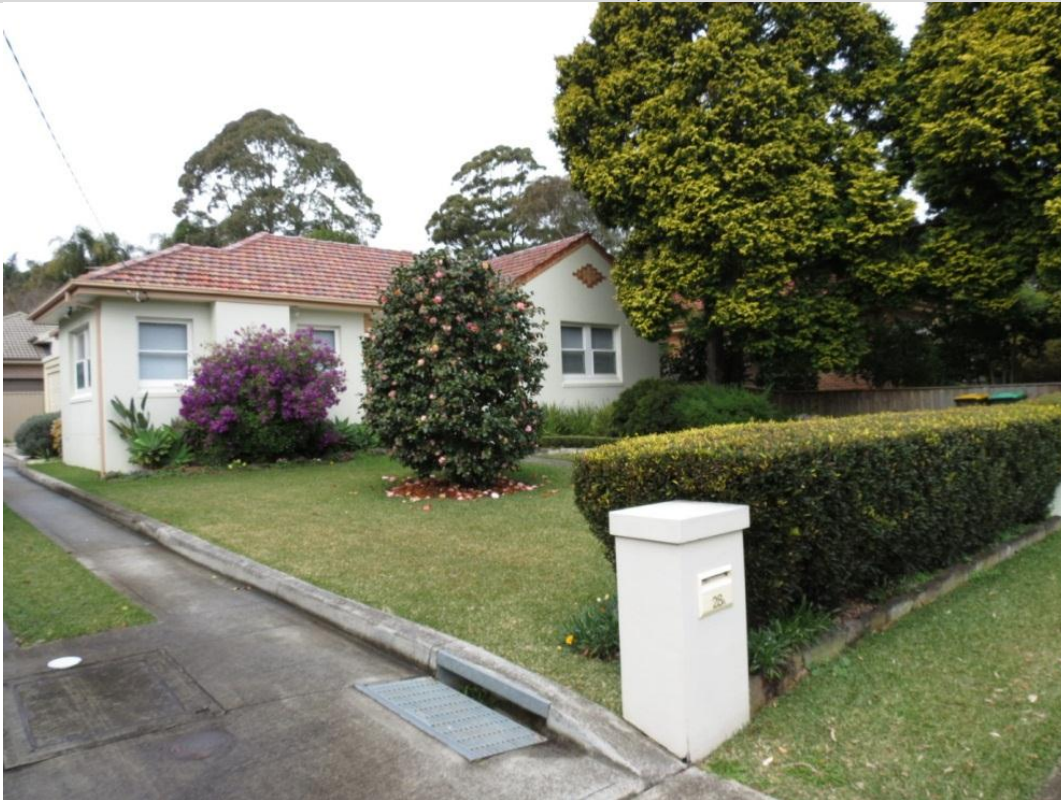
Caption: 28 Balmoral Street, Waitara, showing concrete strip and turf side drive to 28A, two remnant golden cypress trees. Since 1992 many front garden plants have been removed, hedge planted and house painted and chimney removed.

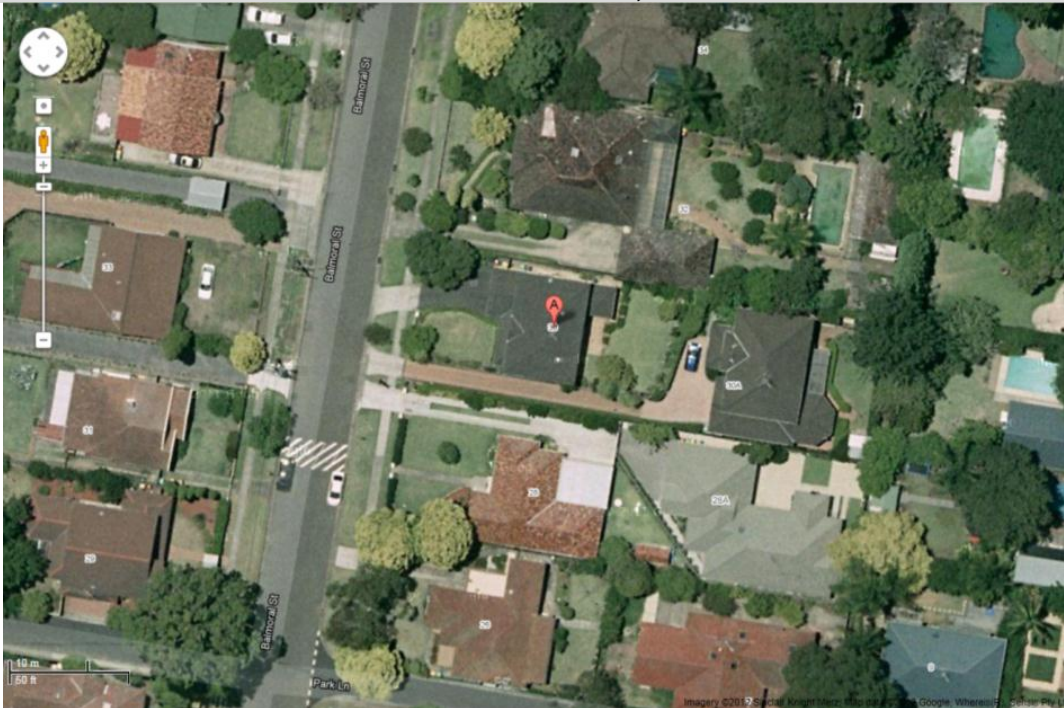
Caption: Air photo of 30 Balmoral Street, Waitara (marked with 'A' in red dot) showing rear garden subdivided off to create 30A with new house. Front garden has been altered with new driveway to No.30 and garden has lost significant.

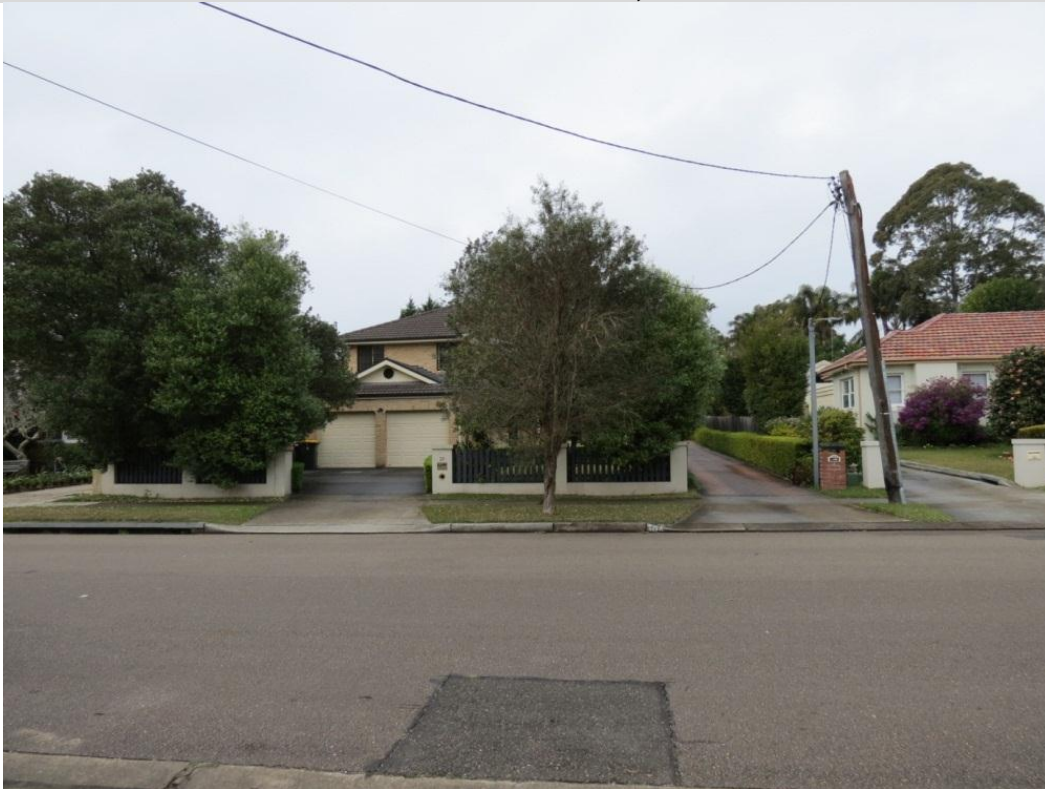
Caption: 30 Balmoral Street showing new two storey house with double garage and new drive, new plantings to front garden.

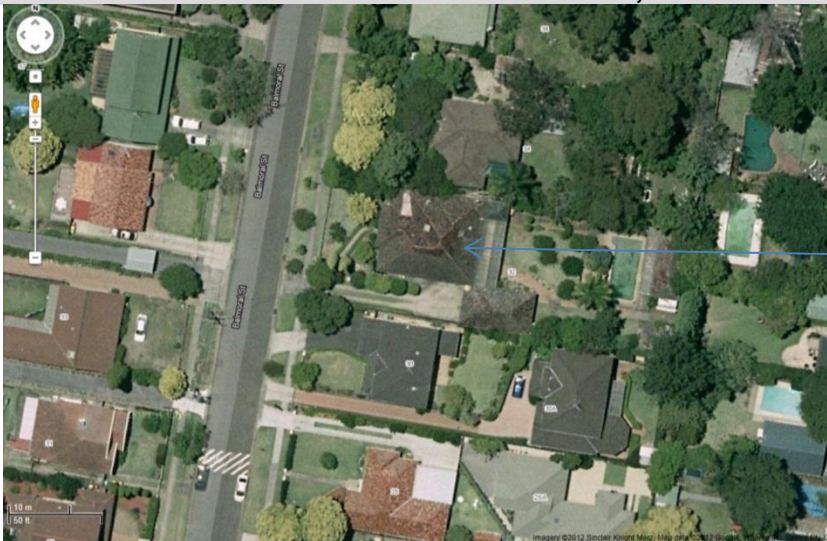
32 Balmoral Street,
Waitara

Caption: Air photo of 32 Balmoral Street (Source: Google Earth). Since this image was captured the rear garden has been subdivided from the house lot, a new concrete side drive has been installed and a substantial addition to the rear of the house has been built, including double garage with side entry.
