Hornsby Heritage Study Review Stage 5, 2012

Volume 3—Appendix G Part 2: Sites D31–E78 and Appendix H

Report prepared for Hornsby Shire Council
March 2013

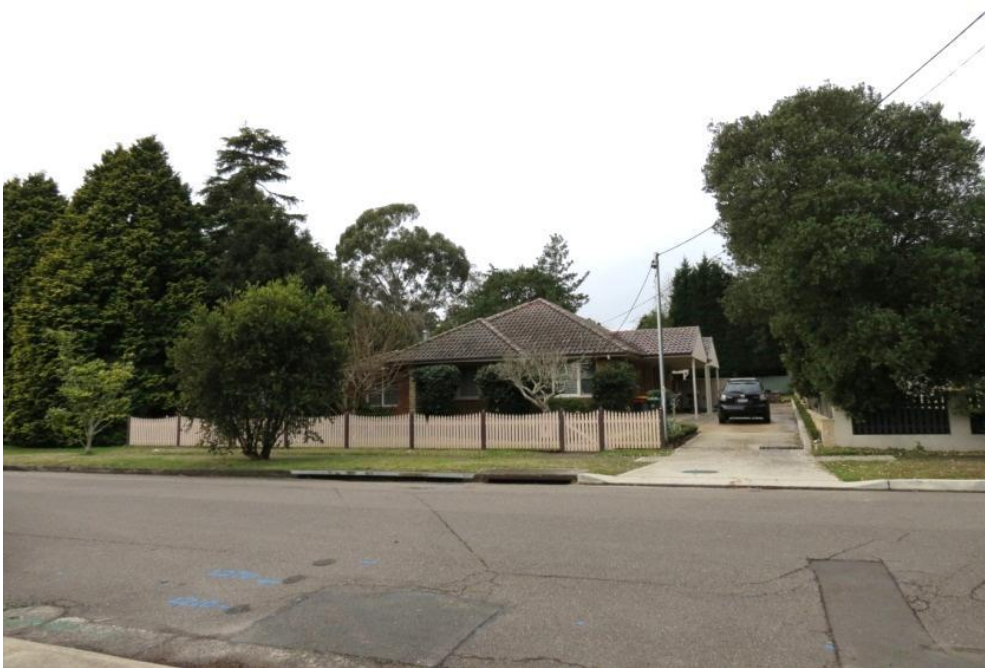
Caption: 32 Balmoral Street, Waitara, showing acorn top timber picket fence, an inappropriate style for the architecture and period of the house.

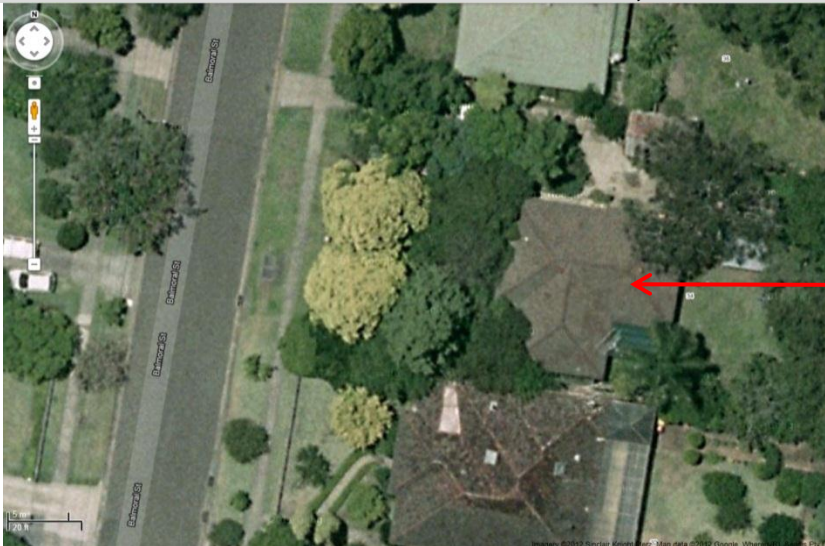
Caption: Air photo of 34 Balmoral Street, Waitara showing dense planting in front garden which now obscures the view of the house from the street.

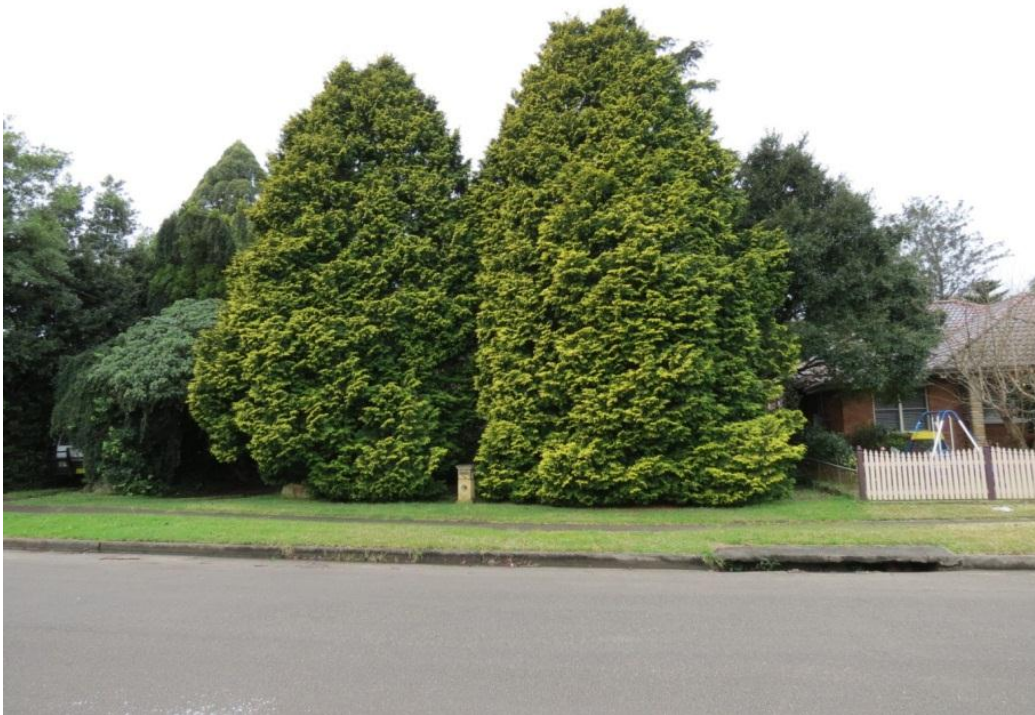
Caption: 34 Balmoral Street, Waitara showing mature golden cypresses and other plantings.

Physical Condition: Condition varies across properties but canopies of cypresses generally healthy at time of inspection. Detailed analysis of condition requires arborist assessment.

Recommended Management: Include mature cypress pines at 34 Balmoral Street on Significant Tree Register.
