# *Crosslands Reserve*

## *Park Masterplan*

*Adopted by Hornsby Shire Council  
9th August 2006 and updated  
on 12 November 2008*

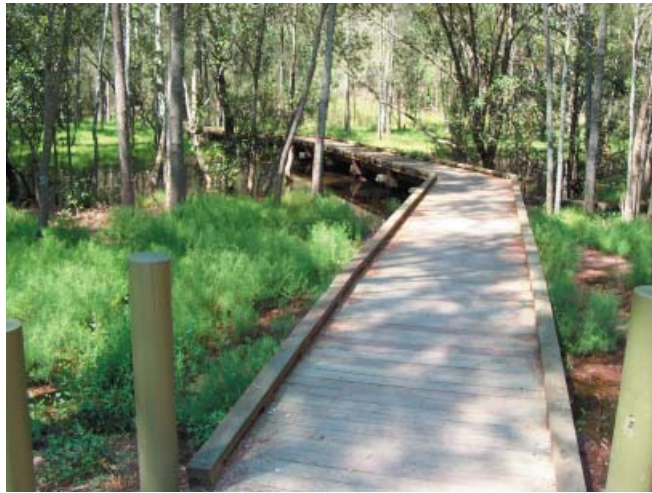
**Figure 1.7:** Wetland flanking the site's central and north-east margins.

the eastern margin of these flats. A wetland area comprises approximately half of the river flat at the northern end of the site, with a tidal channel extending south along the base of the hillslope at the rear of the carpark (see fig. 1.7).

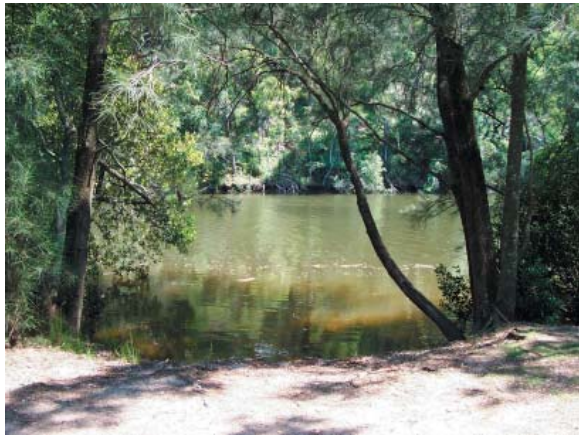
**Figure 1.12:** One of the larger of the few existing gaps in the mangroves flanking Berowra Creek

The bank of Berowra Creek is lined by Grey Mangroves *Avicennia marina* and River Mangroves *Aegiceras corniculatum* with Swamps Oaks *Casuarina glauca* also common. The mangroves form extended, almost continuous, stands along the creek's edge with only occasional gaps as a result of bank erosion, continued water access, and infrastructure (see fig. 1.12). The loss of individual mangrove trees, from dieback, in and around the Crosslands area was noted by the *Berowra Creek Estuary Management Study and Management Plan*. However this was not seen to be a serious concern, as mangrove communities have reportedly expanded in neighbouring areas along Berowra Creek over recent decades.<sup>16</sup> Mangrove species provide valuable habitat for fish, shellfish and birds. The importance of protecting foreshore mangrove communities, to protect fish habitat, is recognised in the Hawkesbury-Nepean River System Habitat Protection Plan prepared by NSW Fisheries (as described in section 2.12 Planting in Part Two Site Analysis, Issues and Opportunities).

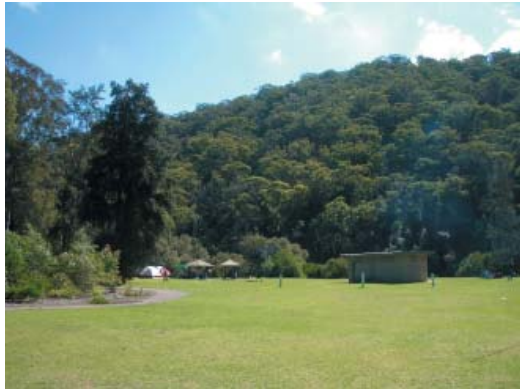
**Figure 2.3:** View across Northern area

The ground plane is predominantly mown turf which flows to the edge of creek banks to the north and west and towards the Casuarina wetland to the east. (see fig. 2.3) There are several large Eucalypts towards the central area of the northern part of the site providing shade and amenity.

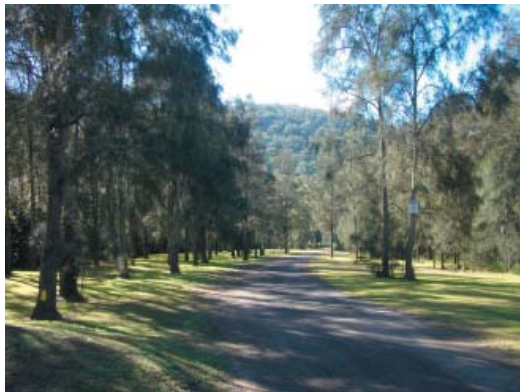
**Figure 2.4:** View looking north along access track

The site is bisected by a three metre partially sealed road which leads from the gate, gradually tapering to two 900mm pathways. (see fig. 2.4) There is a branch path to the west and a circular one to the east, both enclosing large mulched planted areas. (Refer to Section 2.2.2) The east path encloses a mound forming part of an Ecomax environmental treatment system for the adjacent brick toilet block. The mound is vegetated with trees, shrubs and ground covers within a mulched garden bed.

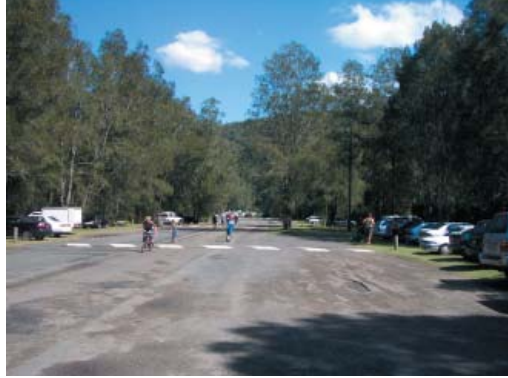
**Figure 2.7:** Central Parking Area

The central area of the reserve is used for car parking, generally allowing 90 degree parking on both sides of an access road. (see fig. 2.7) The boundary of this area is formed by the NPWS gate to the north and the turning eastwards of the entrance road to the south.

The parking pushes to the edges of this landscape corridor with mangrove planting on the western side and a flooded area of Casuarinas on the eastern edge. The resulting effect is of a poorly managed carparking area, dominated by paved surfaces. There are a series of rounded speed humps crossing the road, which appear quite large and over-designed for the site, but help prevent activities such as "burn-outs" by cars.

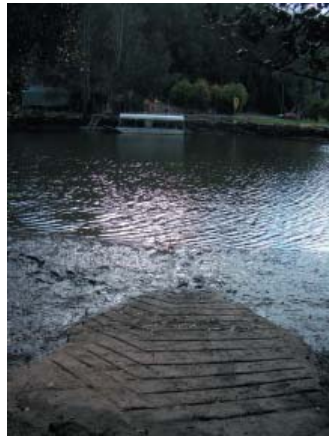
**Figure 2.8:** Conference Centre pick-up point

A small concrete ramp at the southern end of the carparking area is used to pick up visitors to the Convention Centre on the other

side of the river. The ramp is concrete to high-water mark, with mud exposed at low-water mark. (see fig. 2.8)

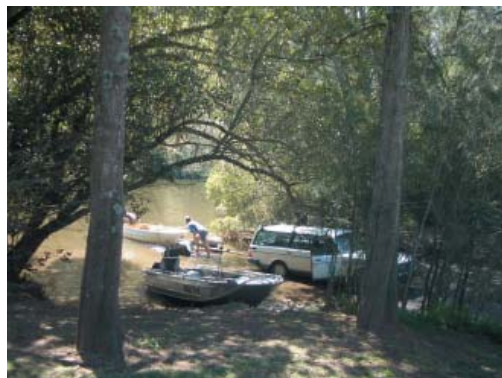
**Figure 2.9:** Boat Ramp Area

In the middle of the carparking area is a large mud ramp cut through the bank which is used for trailer-launching boats as well as hand-carried canoes. (see fig. 2.9)

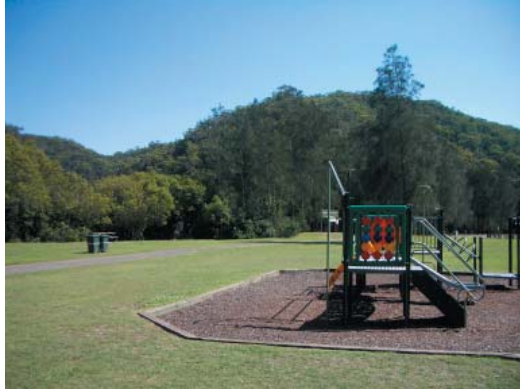
Figure 2.10: Existing playground on Southern Area

At the centre of the grassed area is a small childrens' playground. (see fig. 2.10) The grassed area surrounding the playground is mostly used for informal family recreation such as football or cricket.

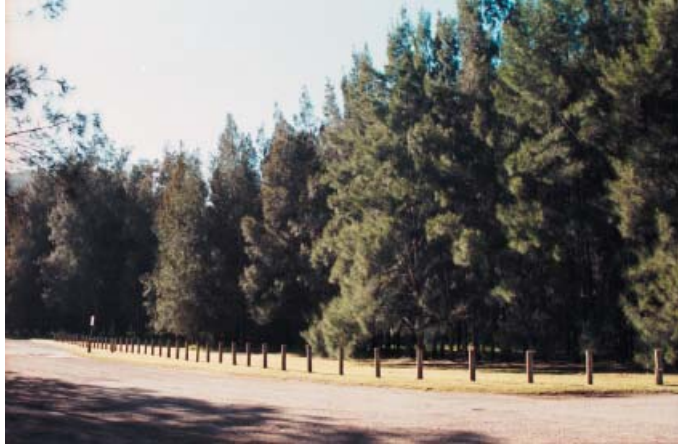
Figure 2.12: Central parking area

The central parking space is large and except on specific occasions, is mostly underutilised. Although the current sealed area is adequate for parking, users tend to park on the grass clearings beyond the sealed area, causing damage to the adjacent trees. The condition of the seal is poor and requires refurbishment. The carpark is poorly managed in terms of controlling the arrangement of cars and limiting their damage to adjoining trees and river edge areas.

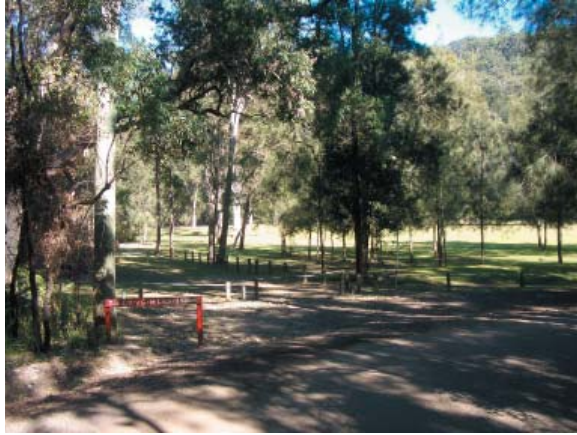
Figure 2.14: Site for new car park

If the existing track through the middle of the southern area is removed, provision could be made for a new service road/ carparking area for campers along the eastern edge. This area may be signposted to reflect its designation for use by campers only. (see fig. 2.14)

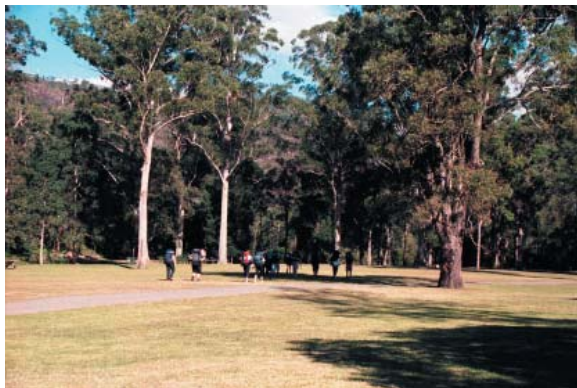
Figure 2.17: Great North Walk users

An unsealed roadway runs from the gate at the car park on the southern end, circumnavigates a mound and returns as a pathway link. This track was originally created for people to use as a bike track and is still used. The position of the track which forms two branches does not assist the movement around the site to picnic areas and does not lead to the Great North Walk track-head. (see fig. 2.17)

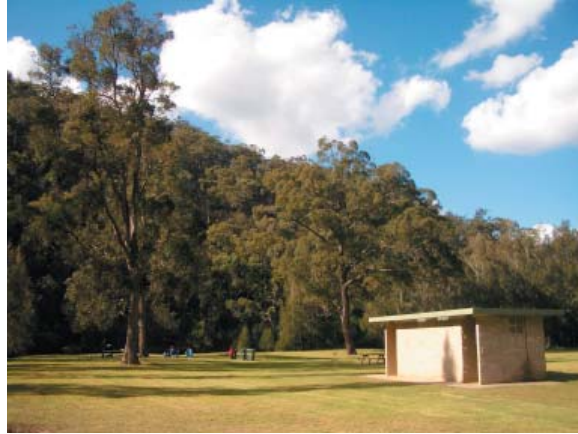
**Figure 2.18:** Visitor Amenities, Northern Area

Two toilet blocks are situated on site – one at the northern and one at the southern end. The toilets appear to be of 1970s masonry construction, rectangular in form. Male and female toilets are situated in the same block with three toilets in each of the male and female facilities. The number of cubicles in each toilet and the capacity of existing septic and storage tanks is not adequate for busy visitor days at the reserve.

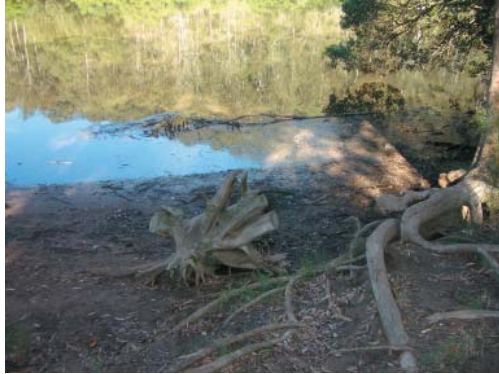
**Figure 2.22:** Erosion of banks, Southern Area

Access to the creek is made at two major points, one at the far northern end of the reserve and the other at the southern end. At the northern end, a shallow beach has been formed mostly through the continuous erosion of the surrounding turfed banks. This is a good vantage point for viewing the surrounding cliffs. At the southern end the beach has been made in a similar fashion and is surrounded by continuously eroding banks. (see fig. 2.22) The exposed areas of the bank are mostly very muddy.

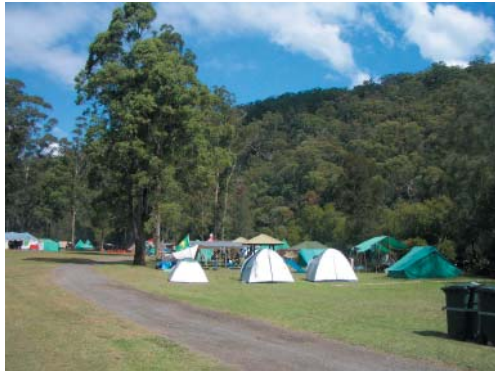
**Figure 2.23:** Typical camping arrangements Southern Area

end. (see fig. 2.23) Crosslands Reserve is used by a variety of community groups including scouts for large camping events. Camping is mostly concentrated on the edge of the creek and under the trees to the south. Camp sites are not currently regulated by numbering or location.

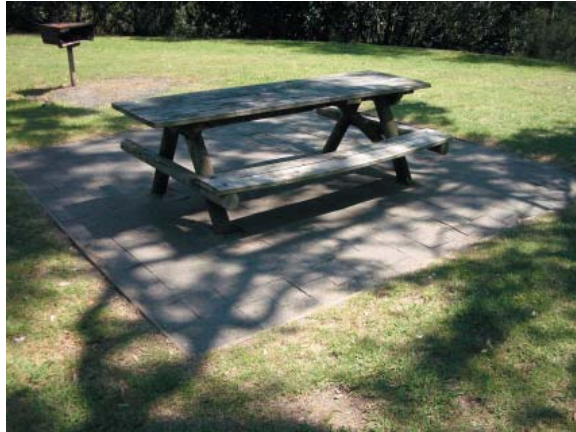
**Figure 2.24:** Existing picnic bench and barbeque

There are five roofed picnic settings on the site, two in the southern area close to the entry gate on the western side and three in the northern area close to the toilet facility. These facilities comprise tables with fixed bench seats and a corrugated iron roof, set on a paved slab. (see fig. 2.24) The condition of all elements is fair. The picnic settings seat a maximum of 6 people.

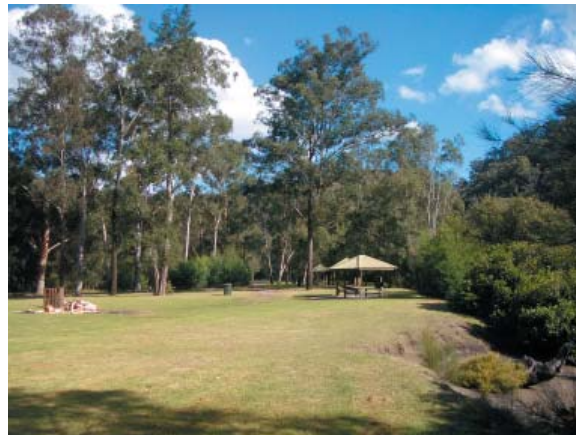
**Figure 2.25:** Roofed picnic setting

The picnic settings in the site consist of freestanding timber seat and bench construction and are sited both in the northern and southern areas of the site. (see fig. 2.25) Most are in poor condition and require replacement. A customised design for a picnic setting could be developed as part of a suite of details, including roofed picnic settings.

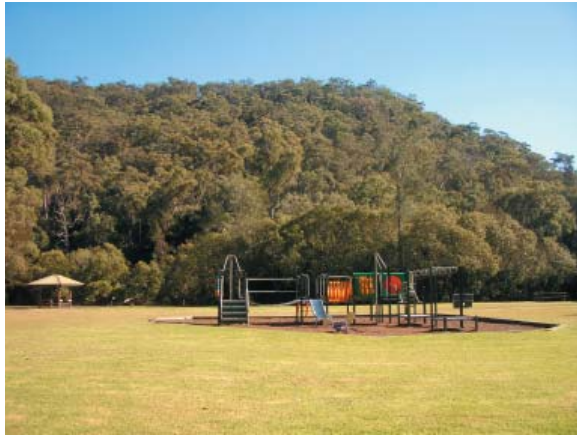
Figure 2.26: Playground

The playground is situated in the middle of the southern area of the reserve. The location is prominent within the reserve and the playground lacks any shade or surrounding seating equipment. It consists of a multi-play equipment unit to accommodate younger children. The playground surface is bark mulch with timber edges. (see fig. 2.26)

The playground area provides an additional recreation experience that is not considered an essential element in a park setting of this nature, especially given the wide variety of alternative recreation opportunities already available within the park. If a playground facility is required long-term in the park, it should be moved to a more discreet area where there is more shade and where it does not conflict with other users. Consideration will also need to be given to the site's environmental conditions, including the flooding potential of some of the lands. The playground could also offer a more diverse range of play experience.

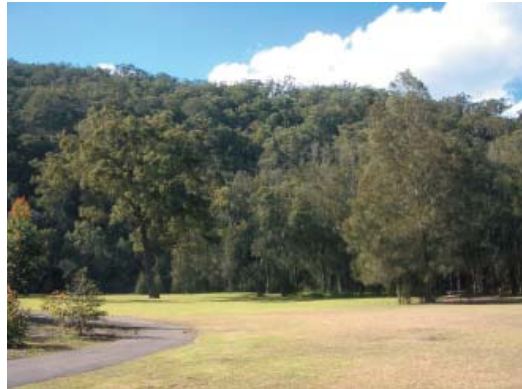
Figure 2.28: Turf, Northern Area

Mown turf is the main ground surface in the northern and southern (see fig. 2.28)

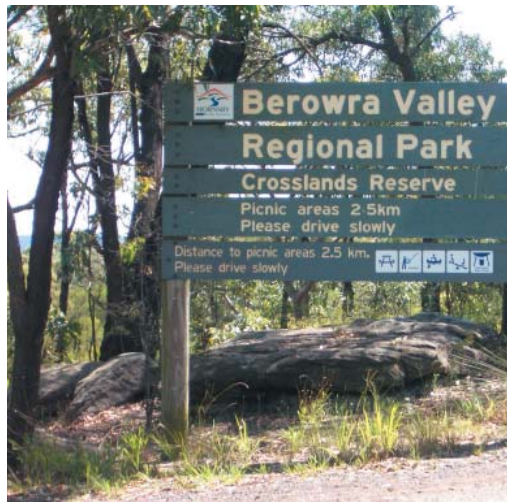
Figure 2.29: Main entry sign

Signage on the site is limited to regulatory and informational, including 'No Consumption of Alcohol' signs and other regulatory matters. (see fig. 2.29)

The main park entry sign at the top of Somerville Road is a timber construction, a typical National Parks sign with routed lettering. The

sign shows the joint logos of Hornsby Shire Council and National Parks and has a series of regulatory symbols showing permissible recreational activities. A second sign displaying similar information is located in Crosslands Reserve where the access road meets Berowra Creek.

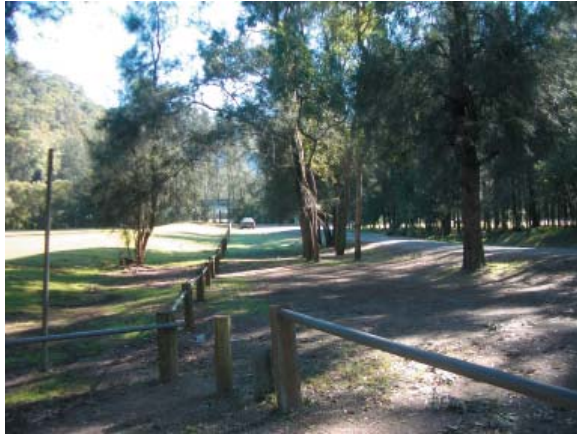
Figure 2.33: View west from the entry

The view west from the entry point in the site is dominated by the presence of parked cars. Views south show the expanse of the southern area of the reserve, although this view is obscured by some plantings. (see fig. 2.33)

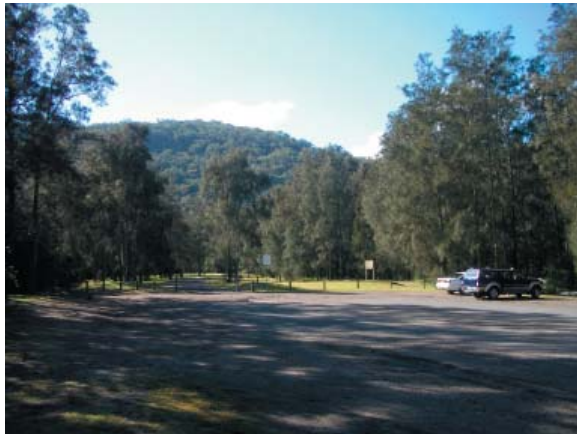
Figure 2.34: View north cross the carpark

Framed by Casuarina woodland, this vista does not give a strong sense of being in a reserve as the open space area to the north and south of the site is not visible from the car park. (see fig. 2.34)

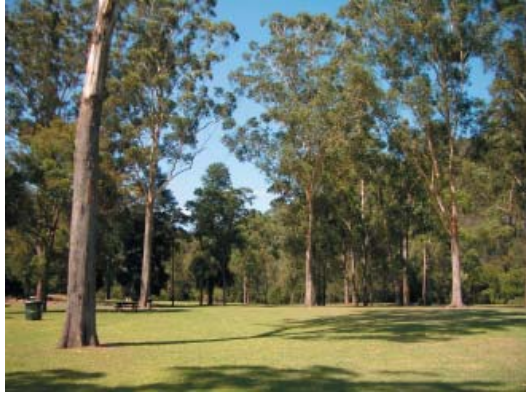
**Figure 2.37:** Scattered tree groups: Southern Area

The large open space` within the southern area of the site requires more enclosure on the western edge closer to the mangroves whilst leaving a clear open space for recreation. There are also opportunities to supplement existing tree groupings and provide more spaces for shade and recreation. (see fig. 2.37)

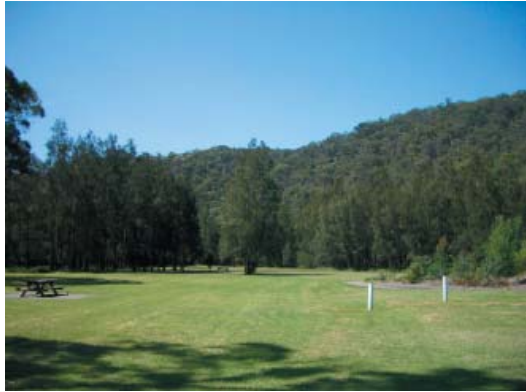
**Figure 2.38:** Typical tree groups: Northern Area

Within the northern area, opportunities for tree planting would exist on the open eastern side and to supplement existing tree groupings in other areas. (see fig. 2.38)

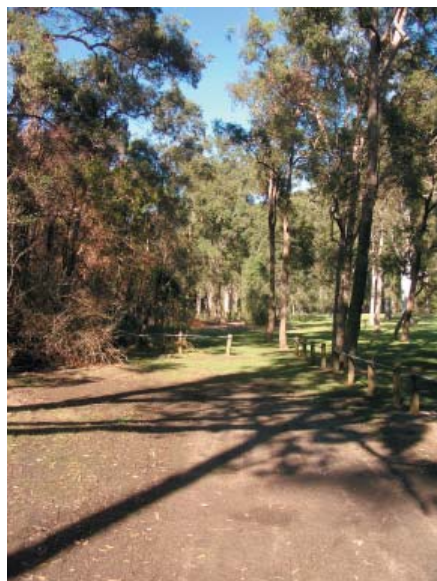
Figure 3.2: Proposed location for new car park Southern Area

At the eastern end of the new accessway and turning road, the Masterplan proposes a small carparking area to accommodate approximately 8 cars, that can be used by campers. (see fig. 3.2) The same access way may also be used for general maintenance access, and an extension further into the site is possible.

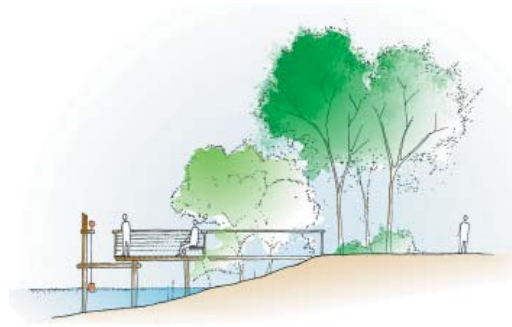
Figure 3.5: Possible concepts for riverside platforms

It is recommended the riverside walk is developed as a 2-3 metre wide pathway

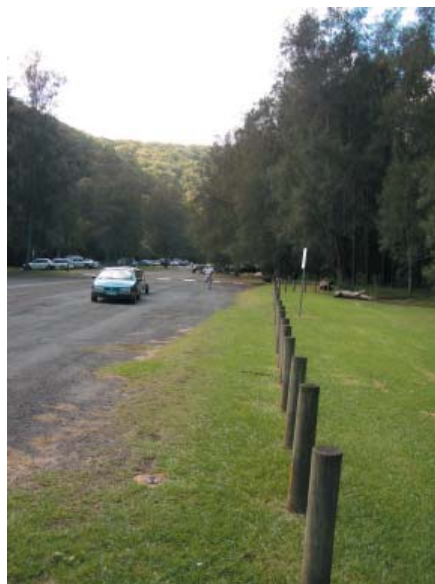
**Figure 3.7: Central parking area**

1. High end treatment; 10 - 20 yr life: 75mm thick AC14 asphalt overlay over prepared existing surface i.e. fill potholes mechanical wire brush and tack coat.
2. Mid treatment, 5-15 Yr life: 2 Coat 7/10 spray seal on a prepared existing surface i.e. fill potholes, mechanical wire brush and tack coat.

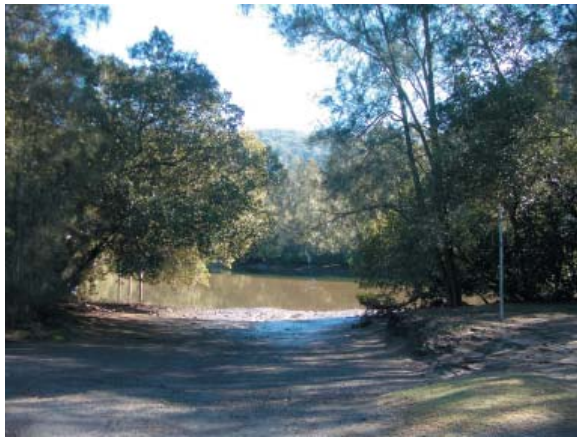
Figure 3.8: Boat Ramp

Signage for regulations related specifically to ramp use and water-based activities
