Hornsby Heritage Review Stage 3

Review of Heritage Items

prepared for
Hornsby Shire Council

July 2004
Ref: 0313

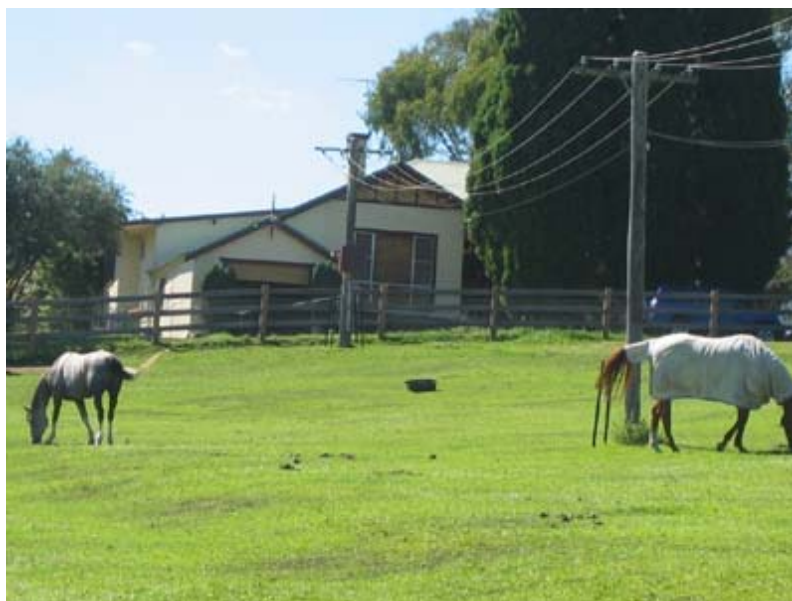
Caption: Front elevation of cottage from Geelans Road across paddock

Physical Condition: Good
Modification Dates:
Recommended Management:
Management:

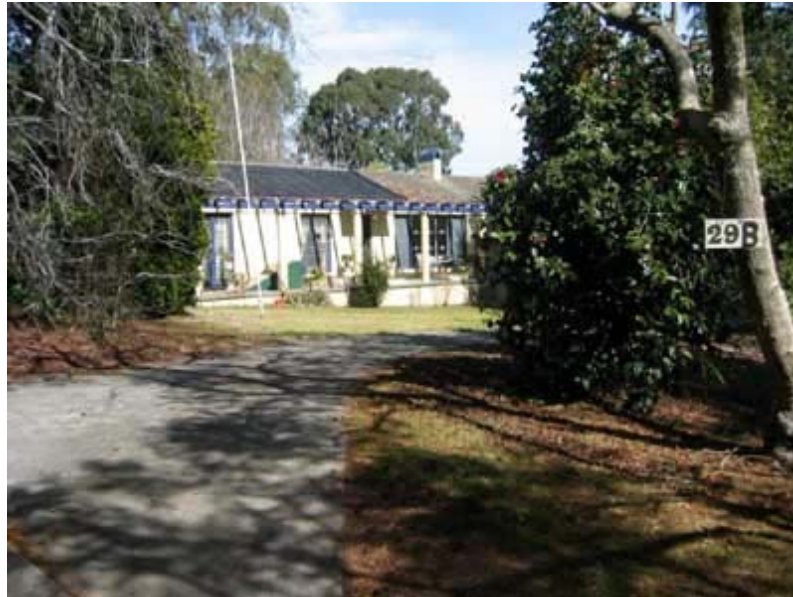
Caption: Front of house from driveway

Physical Condition: The house has been well maintained and is in good condition.

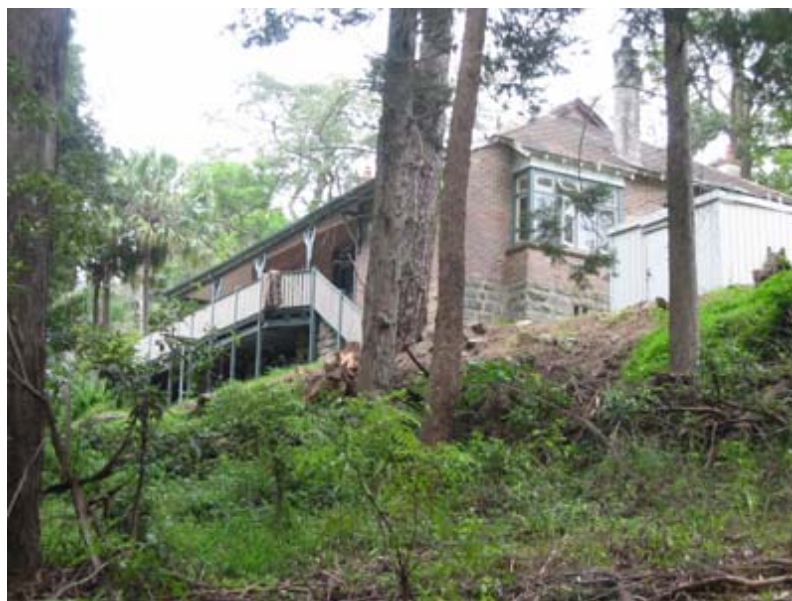
Caption: "Chilworth" 24 Welham Street, taken from Chilworth Reserve.

Physical Condition: Good

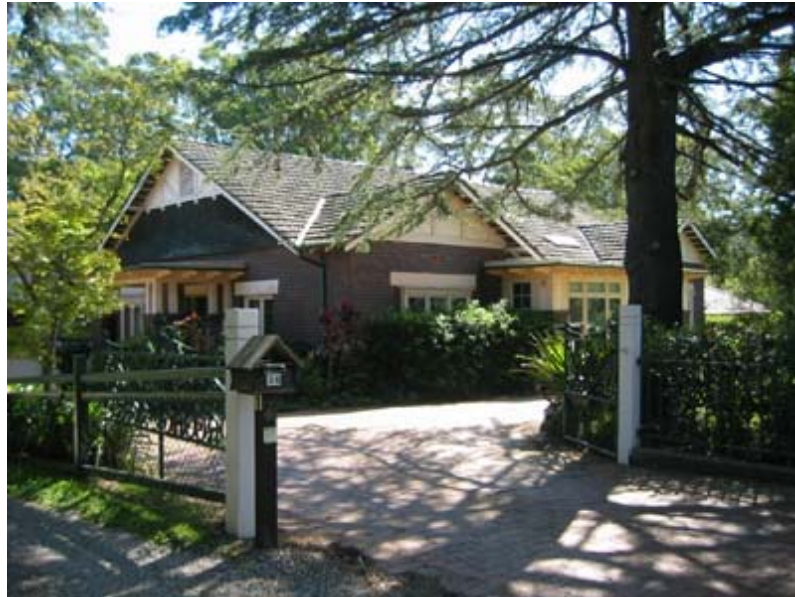
Caption: Driveway entry to property with Deodar in foreground

Physical Condition: Fine and intact.

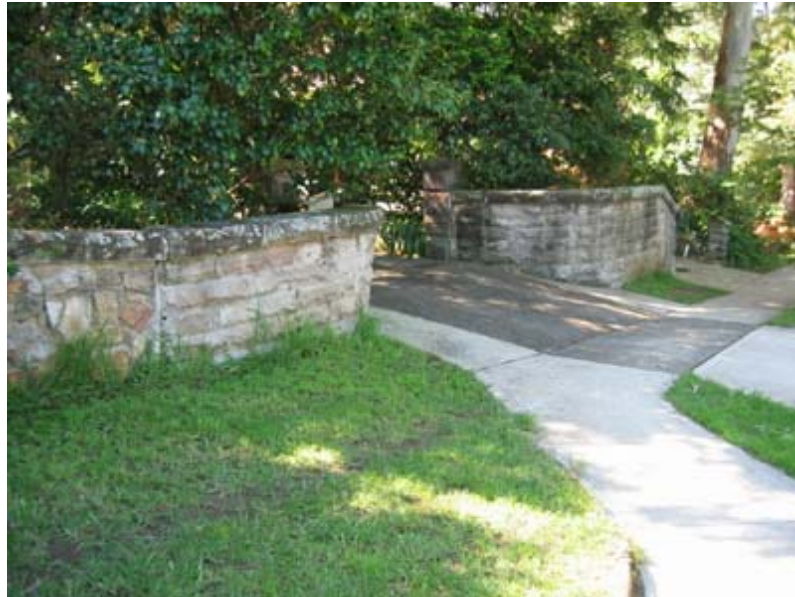
Caption: Driveway portion of Stone fence

Physical Condition: Moderate - Some disturbance in stonework is evident, however fence is structurally sound and retains aesthetic appeal.

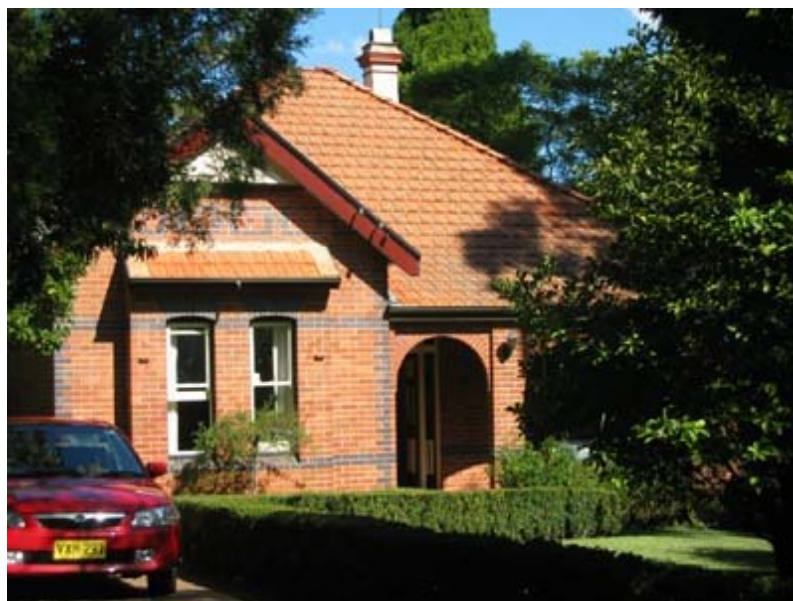
Caption: Front Elevation of Property from Street

Physical Condition: Very Good

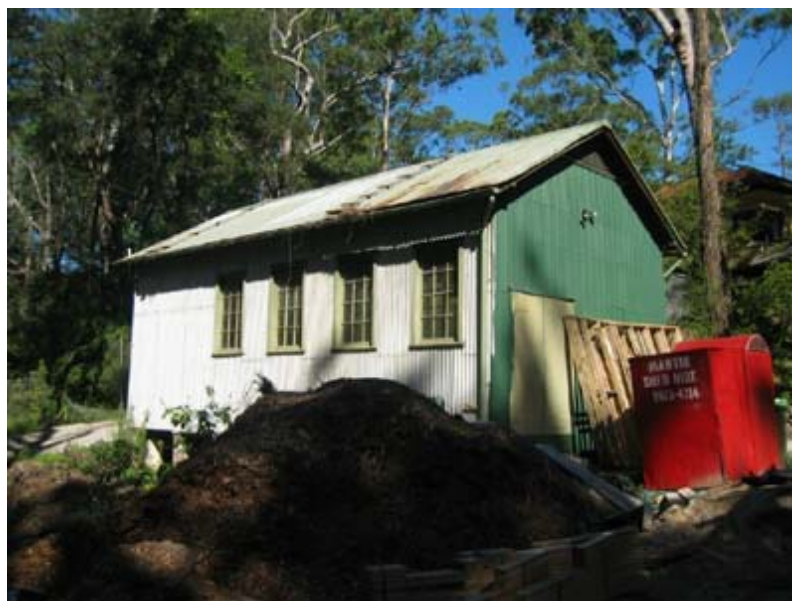
Caption: Munitons shed from rear of site

Physical Condition: Good condition. Shed appears to be unaltered.

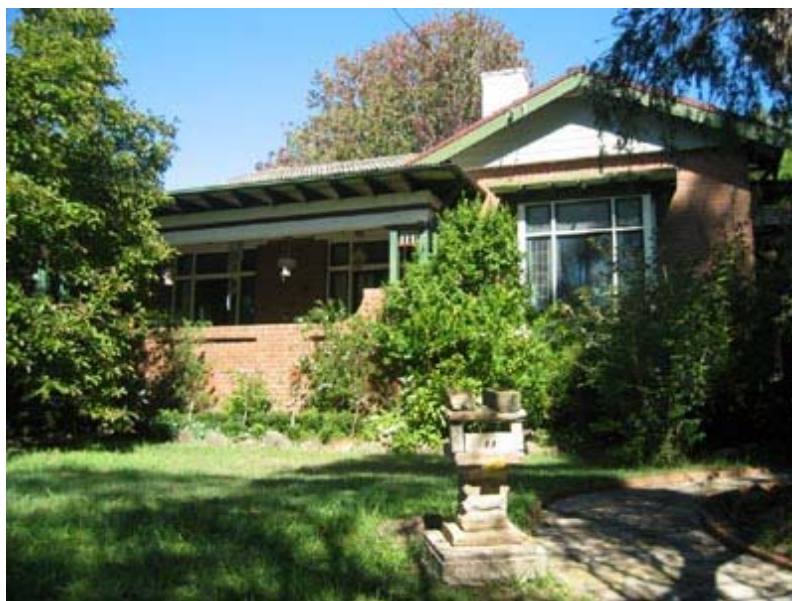
Caption: View from street

Physical Condition: Good - Building appears to remain largely intact. Modifications are sympathetic to original fabric.

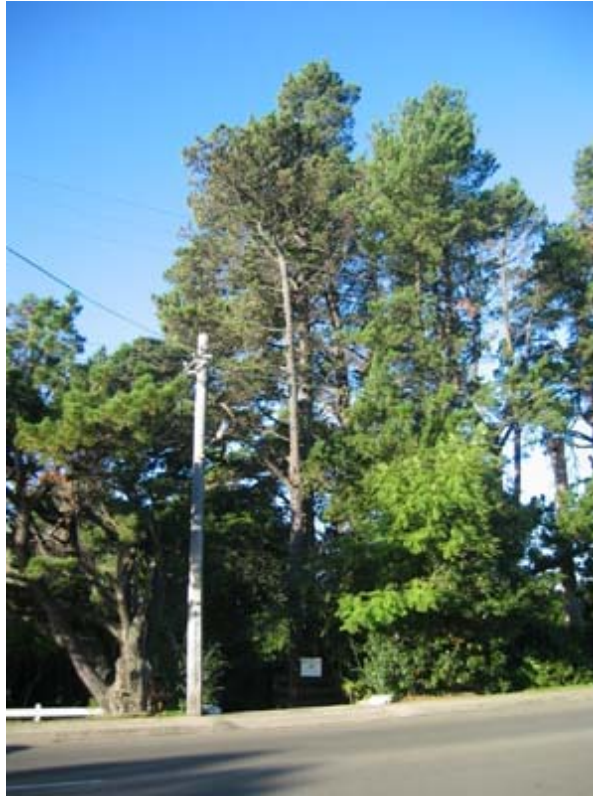
Caption: Trees from Turner Road

Physical Condition: Good - Trees are healthy and appear not to be endangering or hindering adjacent properties.

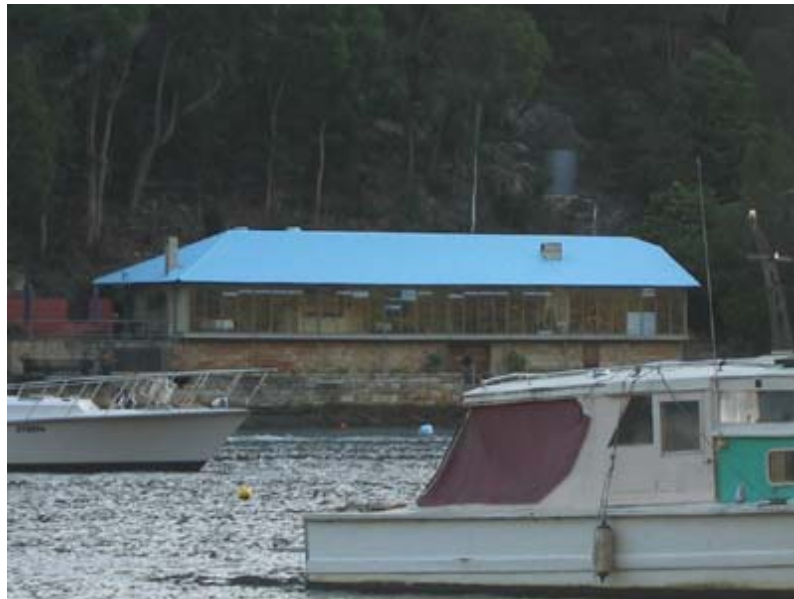
Caption: Berowra Waters Inn as viewed from opposite side of Berowra Creek

Physical Condition: Building appears to be in good condition.

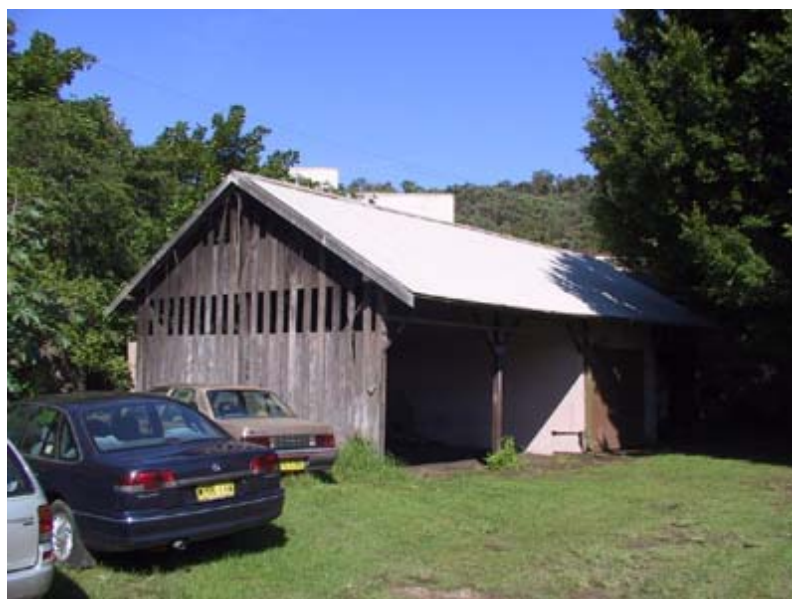
Caption: Front and side of shed

Physical Condition: Moderate - Whilst some areas require repair or replacement and rot is evident in some sections, overall the building is of sound quality and retains much of its original style.

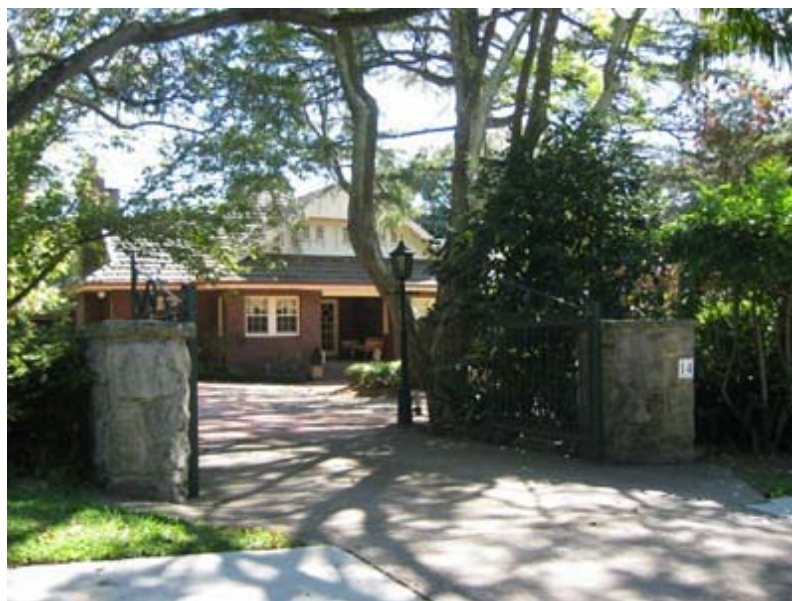
Caption: Entrance driveway

Physical Condition: Very Good. Little evidence of alteration.

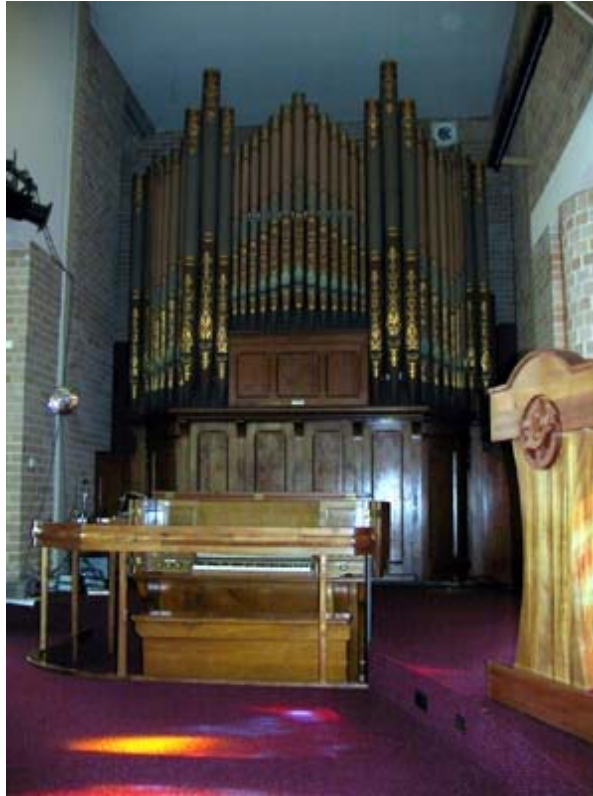
Caption: Pipe Organ within Church Interior - adjacent to altar

Physical Condition: Due to regular maintenance and cleaning the item is in fine condition and is used regularly during services.

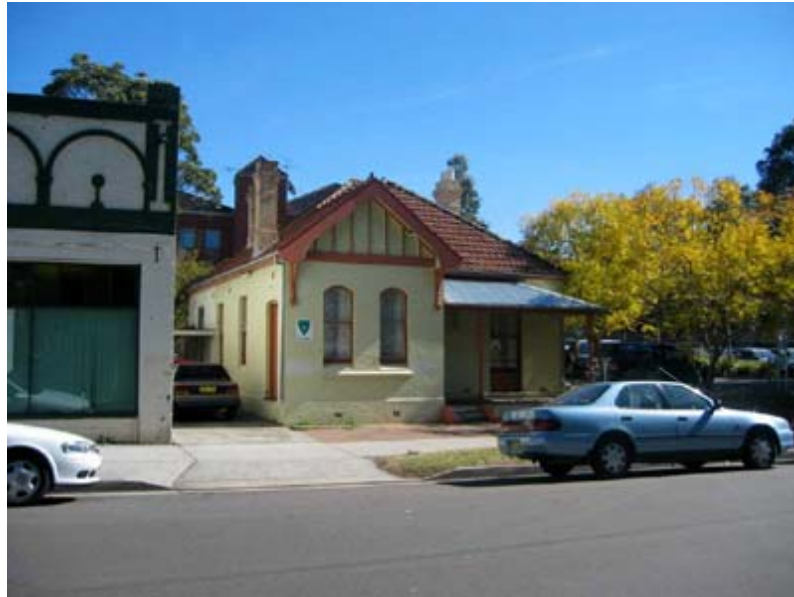
Caption: Cottage from Jersey Street

Physical Condition: Very little modification is evident, on the interior and exterior.

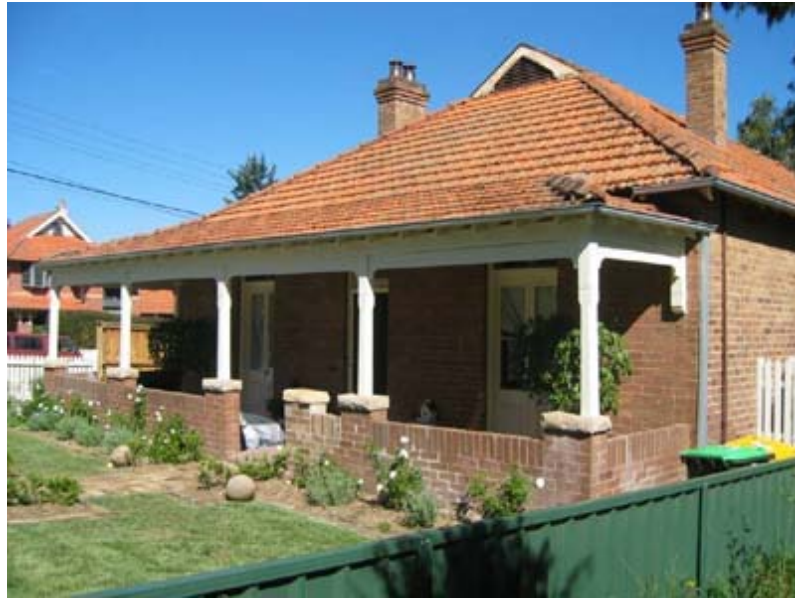
Caption: Front Verandah from adjacent property

Physical Description: Simple late federation brick bungalow. Imposing terracotta roof with lean-to for deep verandah on modestly decorated timber posts facing Norfolk Street. The symmetry of matching chimneys and windows either side of the gambrel and door is broken by the gable end and continuation of the verandah on the Sommerset Street side. The ornate timber fence complements an austere yet well maintained garden.

Physical Condition: The building is well maintained and largely intact. Modifications coinciding with extensions to the rear of the property are sympathetic.

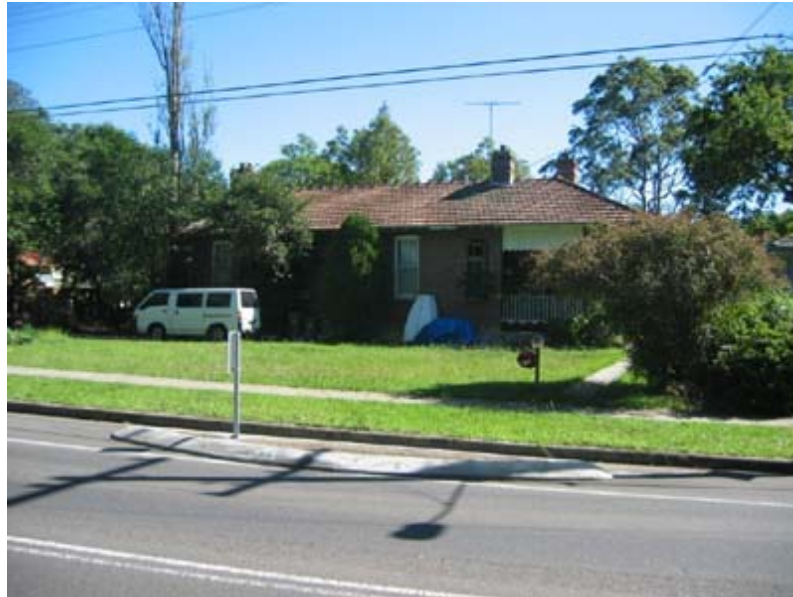
Caption: Front of house from Malsbury Road

Physical Condition: With little evidence of any modification, this building is original, intact and in good condition.

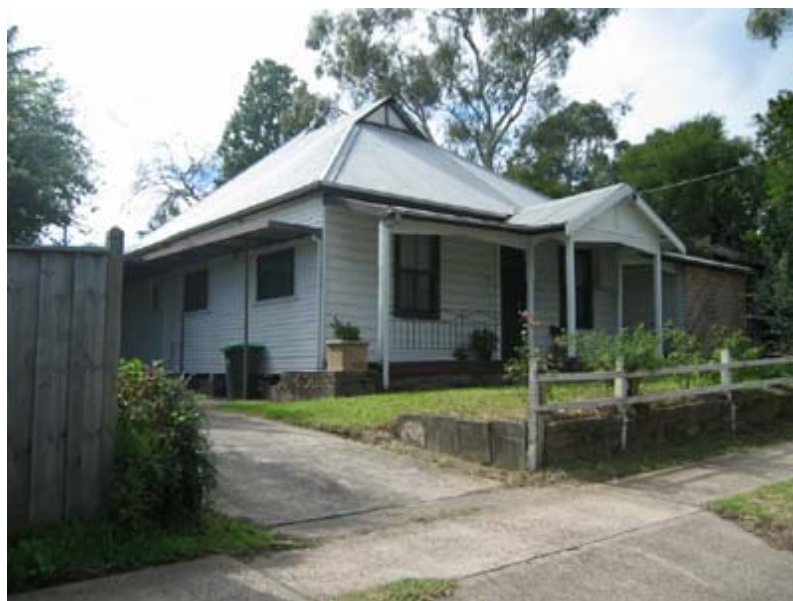
Caption: Driveway entry from Boundary Road

Physical Condition: Moderate. Whilst building appears from exterior to be sound the owner has expressed concerns regarding termite infestation.

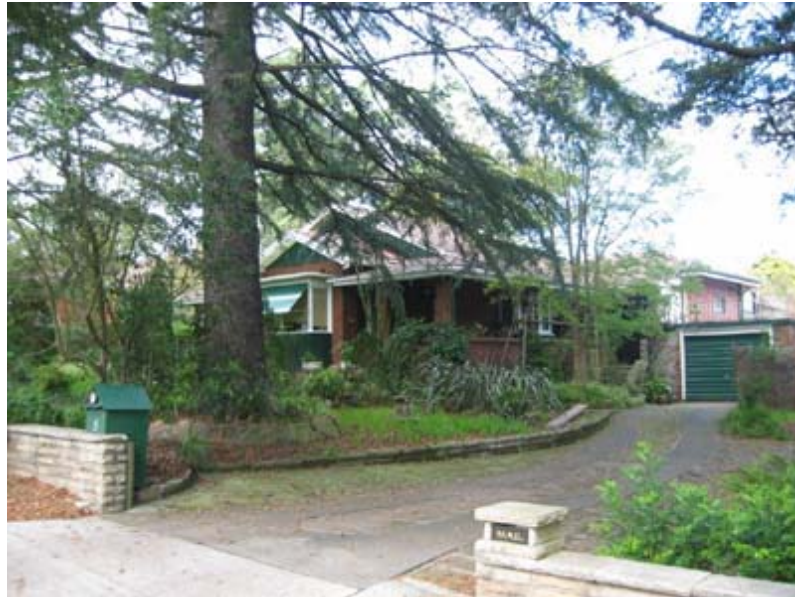
Caption: House and Garden from footpath of Stevens Street

Physical Description: Attractive red brick Inter war bungalow on sandstone foundations with timber shingled gable infill, bay windows and deep verandahs. Garden appears to be of similar period to house.

Physical Condition: The building is largely intact and retains much of the original cornice work, fittings and internal layout. Alterations (such as the Carport) do not diminish the integrity of the house.

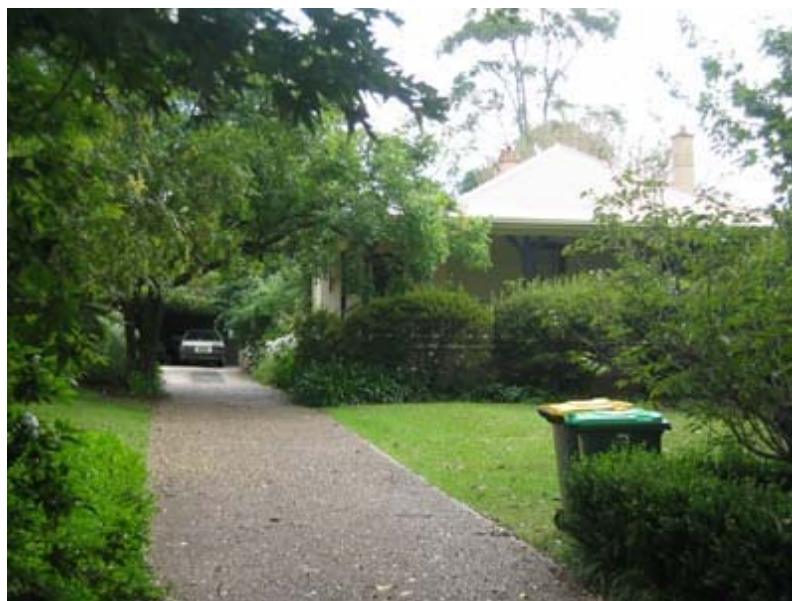
Caption: Driveway, garden and front of house

Physical Description: Early 20th Century Federation brick bungalow with a pitched roof, broken over the encircling verandah, sections of which have been enclosed at various times to create an ensuite,

dressing room and study. Brickwork has been painted and original tiles replaced with profile roof cladding. Chimney stacks appear to be original.

Physical Condition: Condition of the building is good, however various alterations to the original building are evident, and a detached rear addition resides at the rear of the property.

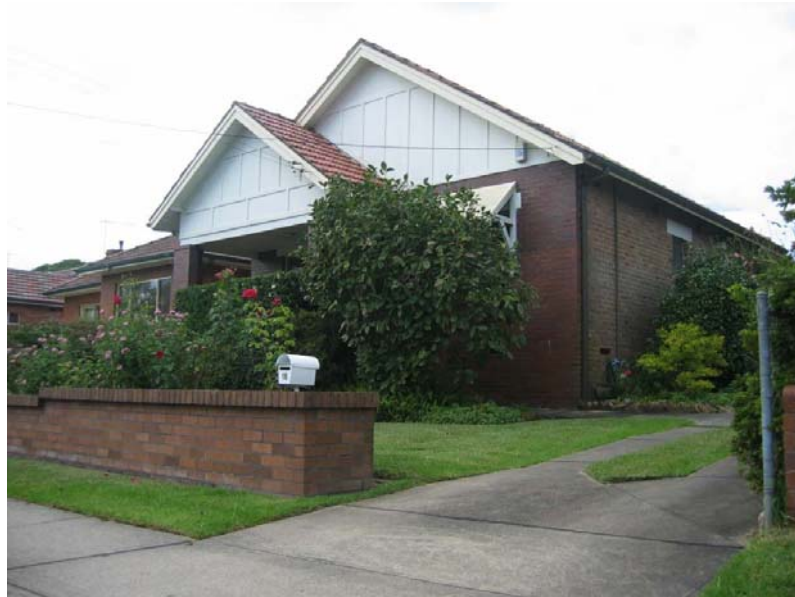
Caption: Front of House from footpath of Maple Avenue

Physical Condition: Intact with little alteration.

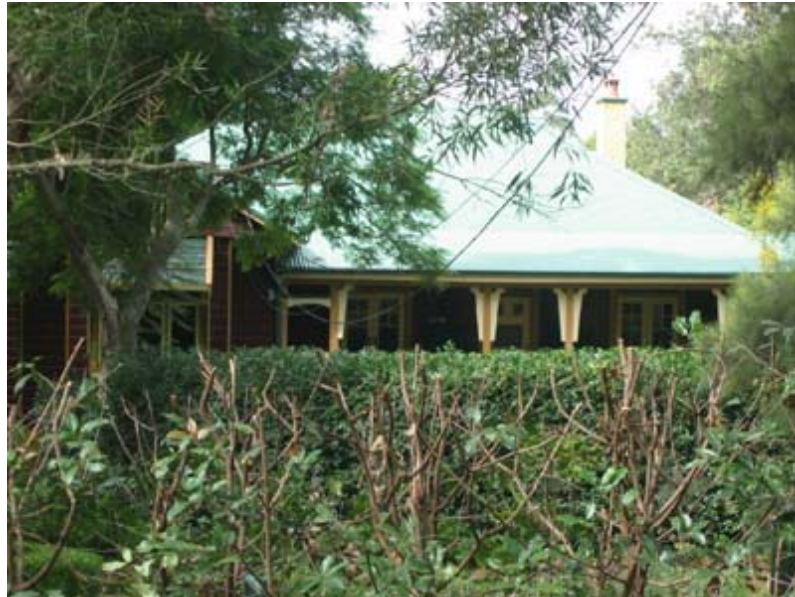
Caption: Verandah and garden to front of property

Physical Condition: Largely intact, however evidence of alteration (particularly to verandah timbers) exists.

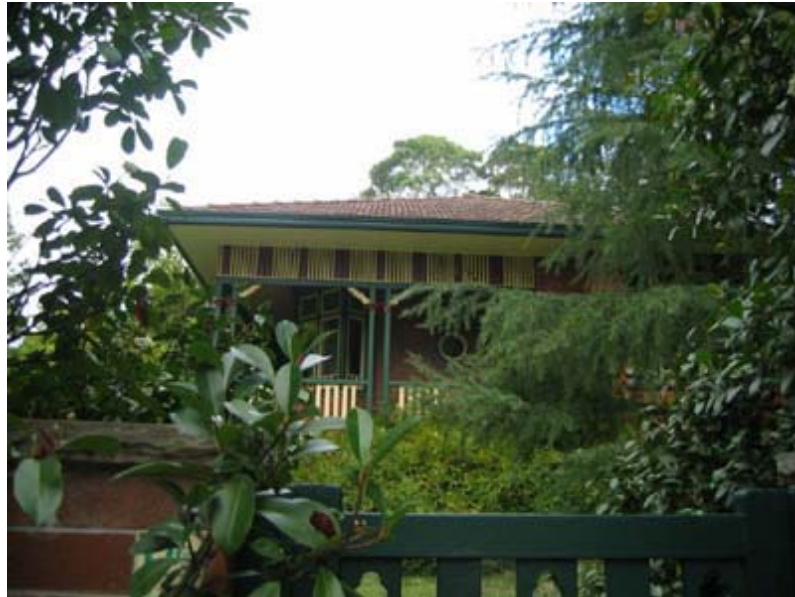
Caption: Verandah of Property from Stevens Street

Physical Condition: Despite some modification the house retains the essence of its Federation styling.

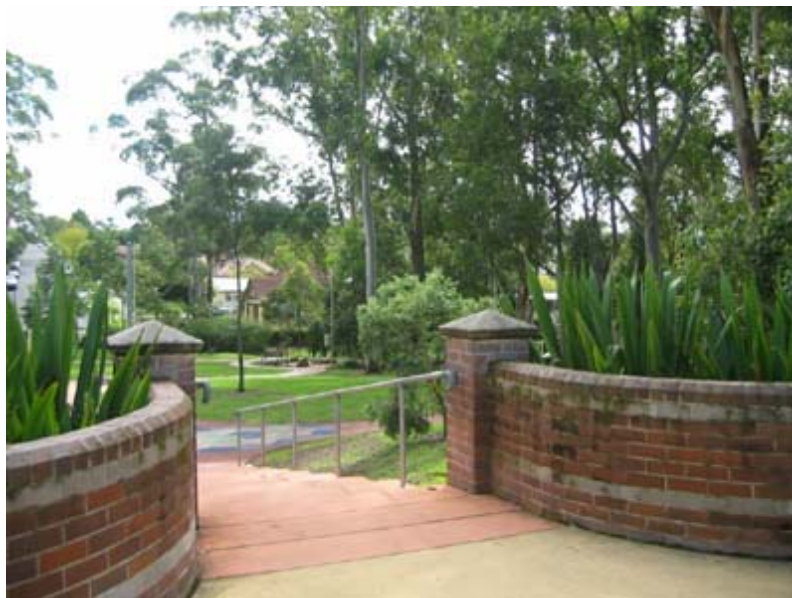
Caption: Park Entrance from Yarrara Road

Physical Condition: The park is well maintained and in good condition.

Modification Dates: The last major development occurred in 1992 with replacement of equipment and landscaping modifications.

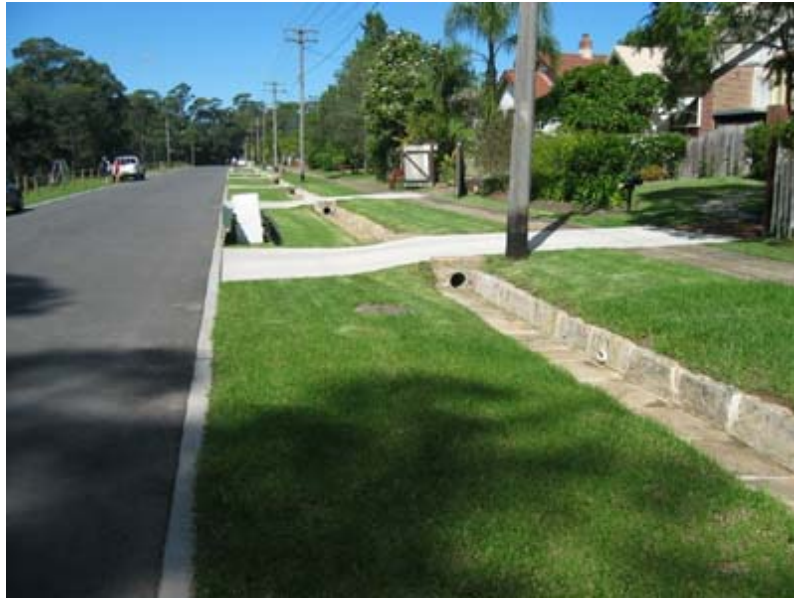
Caption: Sandstone drain from Dawson Avenue

Statement of Significance: Rare and intact early 20th Century sandstone flagged kerb and gutter, upgraded as part of depression era work in 1960s and recently repaired.

Physical Condition: Due to recent remedial work the kerb and gutter system is considered to be fully functioning and in good condition.

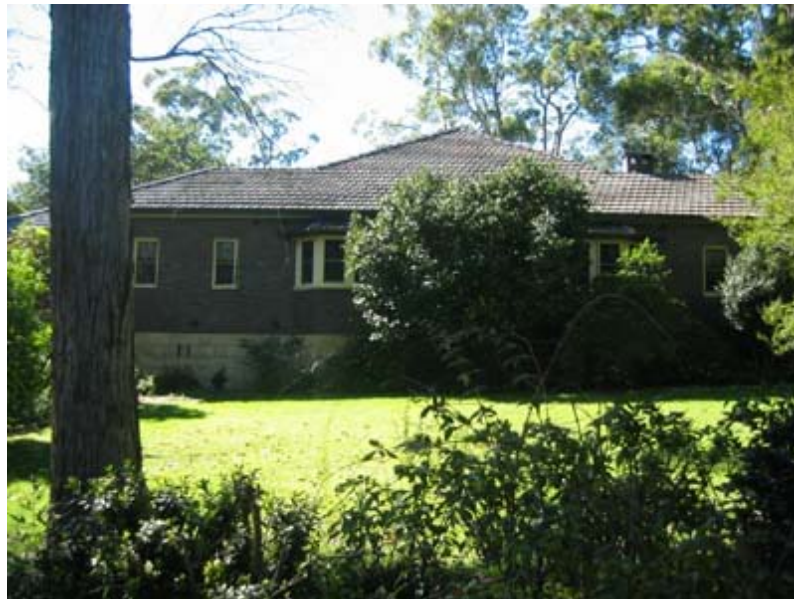
Caption: Street Elevation and yard

with prominent (original tiled) hipped roof plane and large painted timber bay windows is broken only by the small projecting chimney and adjacent detached garage. Sandstone is carried through to driveway and front fence. Beautiful garden is well presented featuring shrubs, lawns, garden beds and large mature trees.

Physical Condition: Building appears largely untouched and in good condition from the street.
