HORNSBY SHIRE COUNCIL  
REPORT ON PROPOSED FILLING

OLD MAN'S VALLEY  
HORNSBY

REPORT S8463/2-AC      JULY, 1989

RE: Report on Proposed Filling, Old Man's Valley, Hornsby

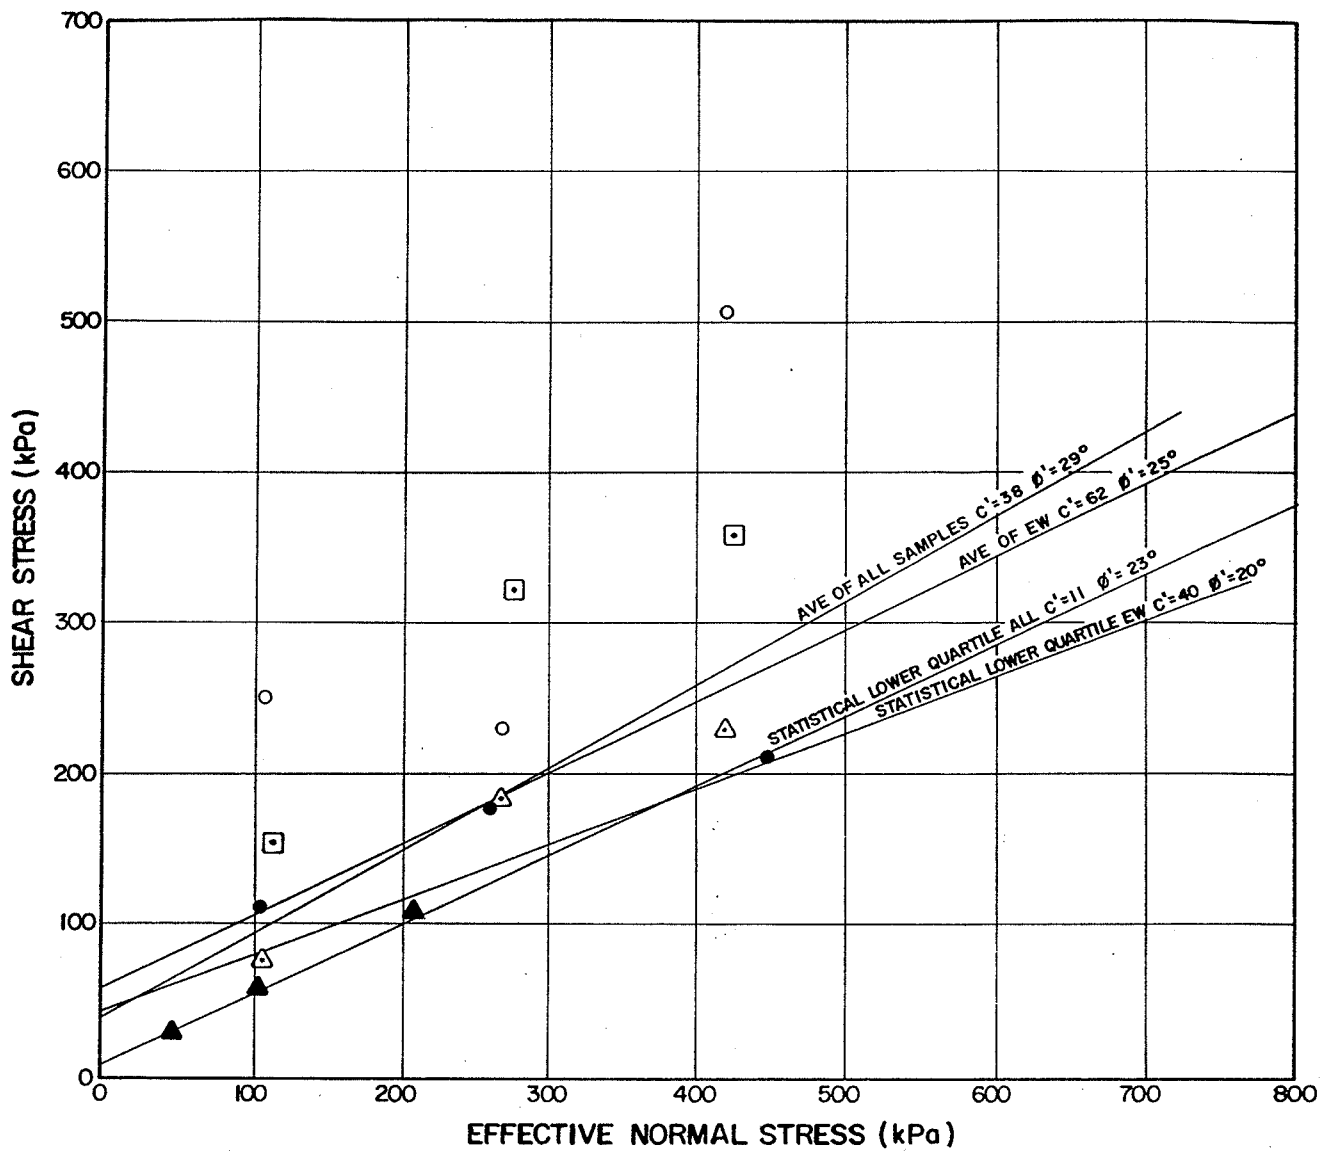
**FIGURE 8**

One triaxial and four direct shear strength tests have been undertaken on samples from the site. These results are summarised in Figure 8 as shear strength versus normal effective stress, and to allow plotting of the triaxial results the shear and normal stress on the failure surface have been used to give the plotted points.

It is normal practice to adopt, for design, values approximating the lower quartile, and to require a factor of safety of at least 1.5 using these. Figure 8 shows the average values and computed lower quartile results for all tests and for tests on extremely weathered breccia only. For the extremely weathered breccia, values of  $C' = 40$  kPa and  $\phi' = 20^\circ$  are obtained, while for all results the values are  $C' = 11$  kPa and  $\phi' = 23^\circ$ . The lower bound is  $C' = 5$  kPa and  $\phi' = 25^\circ$ .

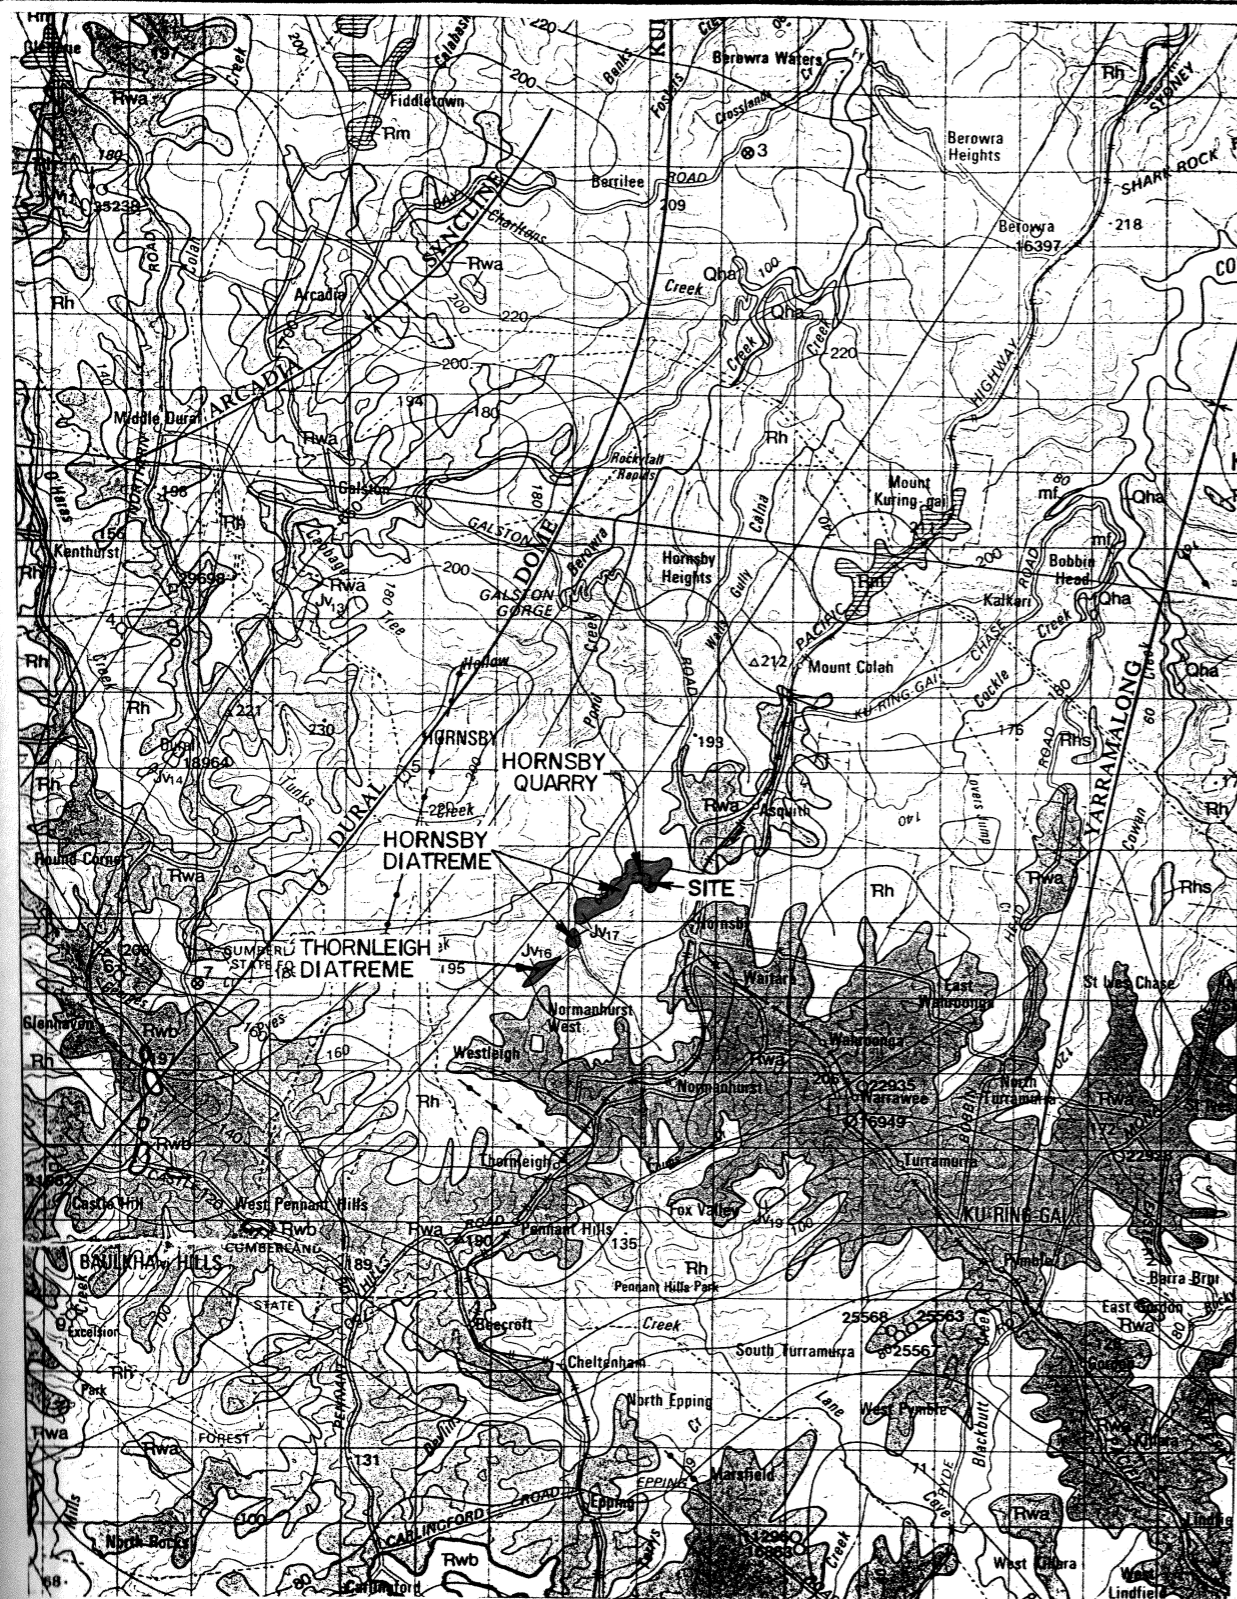
FIGURE 9a

The Sydney 1:100,000 Geological Series Sheet 9130 indicates that Old Man's Valley is underlain by volcanic breccia, with the surrounding plateau comprising Hawkesbury Sandstone (see Figure 9a). Hornsby Quarry, situated immediately west of the proposed filling at Old Man's Valley, is sited within the volcanic breccia which is generally called the Hornsby Diatreme. The geology sheet indicates the Hornsby Diatreme to be dumbbell shaped and elongate for about 1.5 km in the NE/SW direction and is generally less than 400m wide. The southern extremity of the diatreme is separated from the main body by a sandstone bar across Old Man's Valley. The Thornleigh Diatreme is situated some 200m to the south west (along projection of the long axis) of the Hornsby Diatreme and is separated from it by Hawkesbury Sandstone. The relationship between the Hornsby and Thornleigh Diatremes is not known. They may represent unrelated individual intrusions or they may be related. Further, it is unknown whether the Hornsby Diatreme represents a single intrusion or a number of intrusions. Certainly, the dumbbell shape alludes to the possibility of more than one intrusion. If the Hornsby Diatreme represents a number of intrusions, their relationships and effects on one another are unknown.

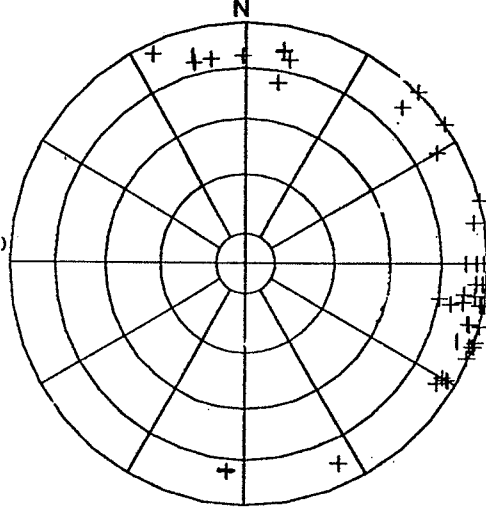
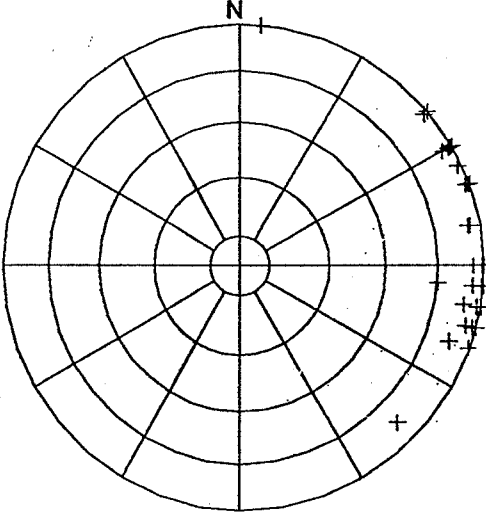
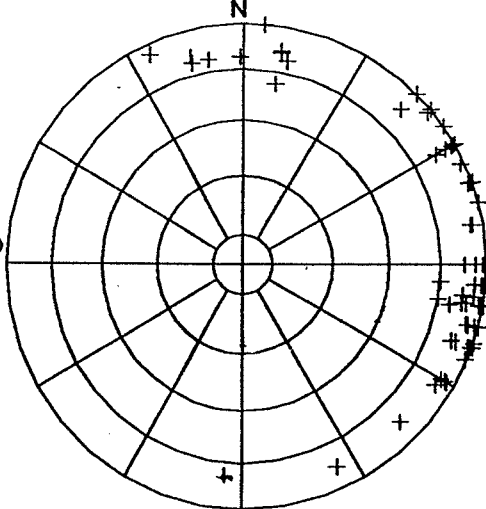
**FIGURE 10**

Results of the joint survey on benches 1 and 2, individually and combined, are presented on stereonetts in Figure 10. The plot for bench 1 indicates that the dominant joint set strikes north-south and is sub-vertical or dips steeply to the west; the minor joint set strikes east-west and dips steeply to north and south, typically to the north. There is also a possible subordinate set striking north-west/south-east and dipping steeply to the south-west, although this may be part of the dominant joint set. Similarly, the plot for bench 2 has the north-south and east-west joints encountered in bench 1.

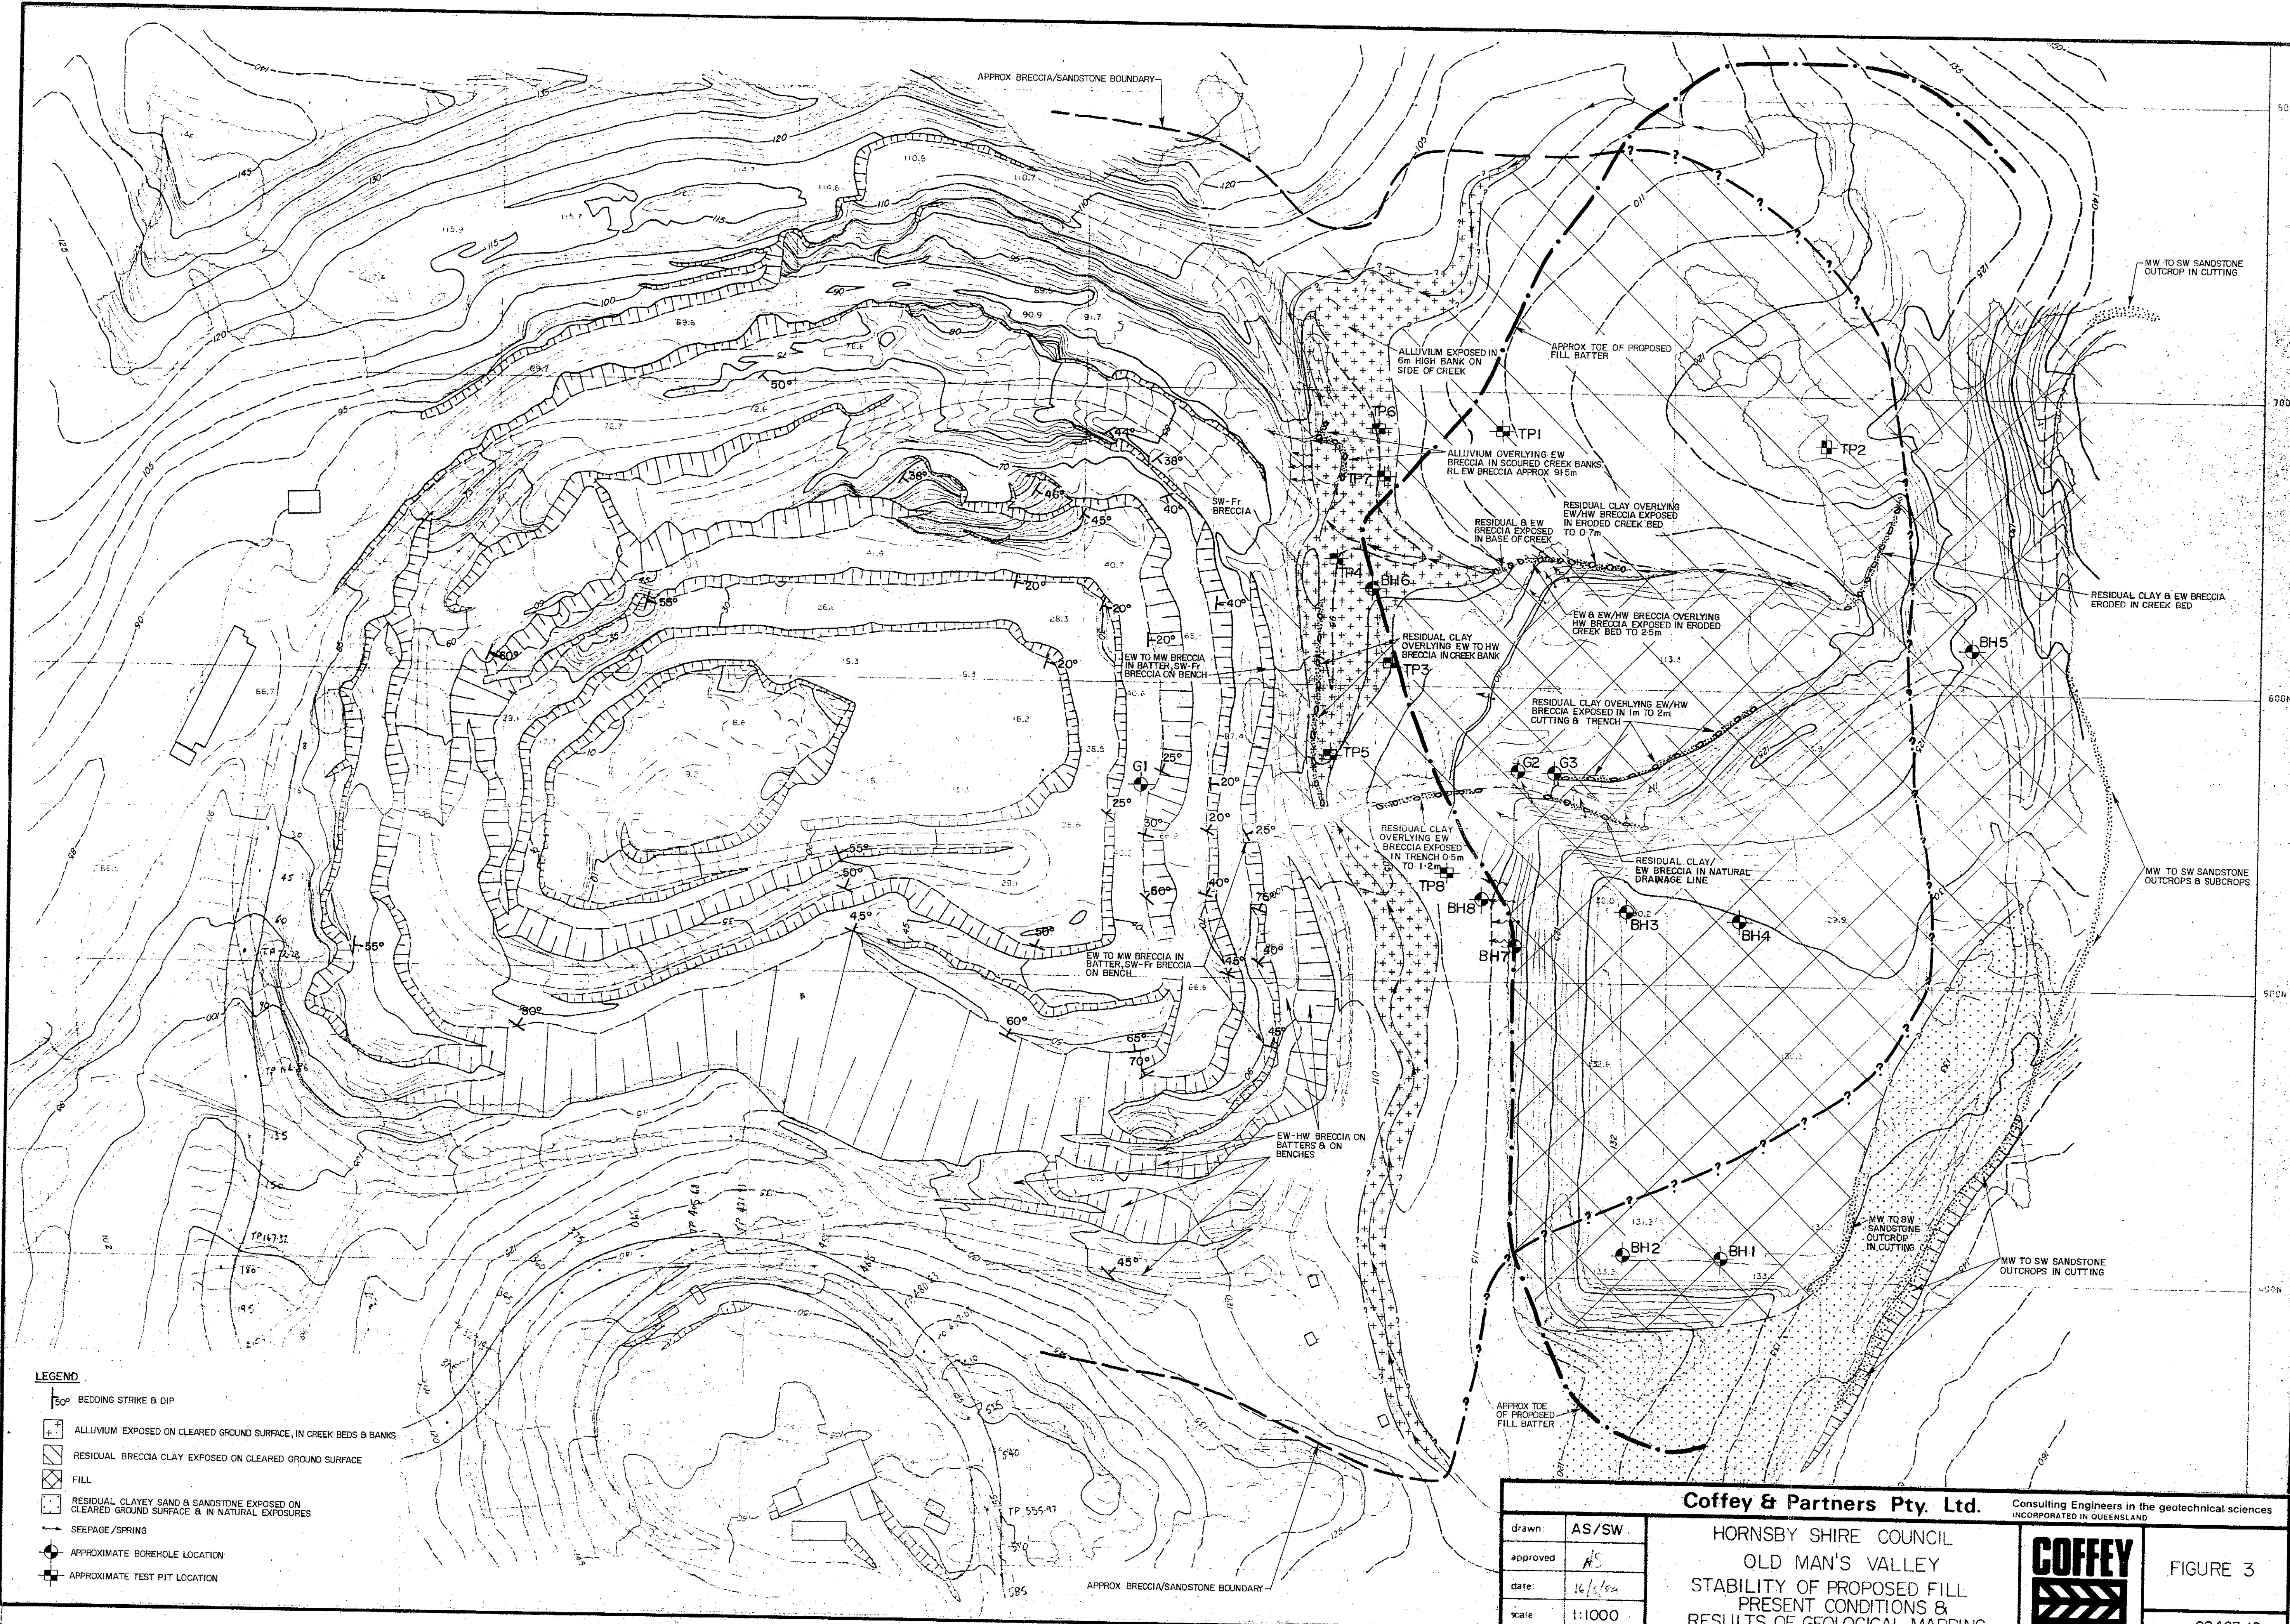
To the west of the fill the natural surface consists of deeply weathered breccia at the southern end and alluvium to the north west (see Figure 3 and sections at 270, 310 and 350m on Figures 6 and 7). The depth of weathering, as evidenced by excavator refusal on slightly weathered grey breccia, decreases to the north. Intermediate between the alluvium, residual soil/ extremely weathered breccia is a clay layer of high plasticity and a cemented sand layer - both are thin. The alluvium consists of silty and clayey loose sand.

Figure 1 (site plan) shows the interpolated boundary between the volcanic breccia and the Hawkesbury Sandstone. The location of this boundary has been assessed based on field mapping along creek lines and of surface exposures as shown on Figure 3 undertaken by Coffey & Partners and on the

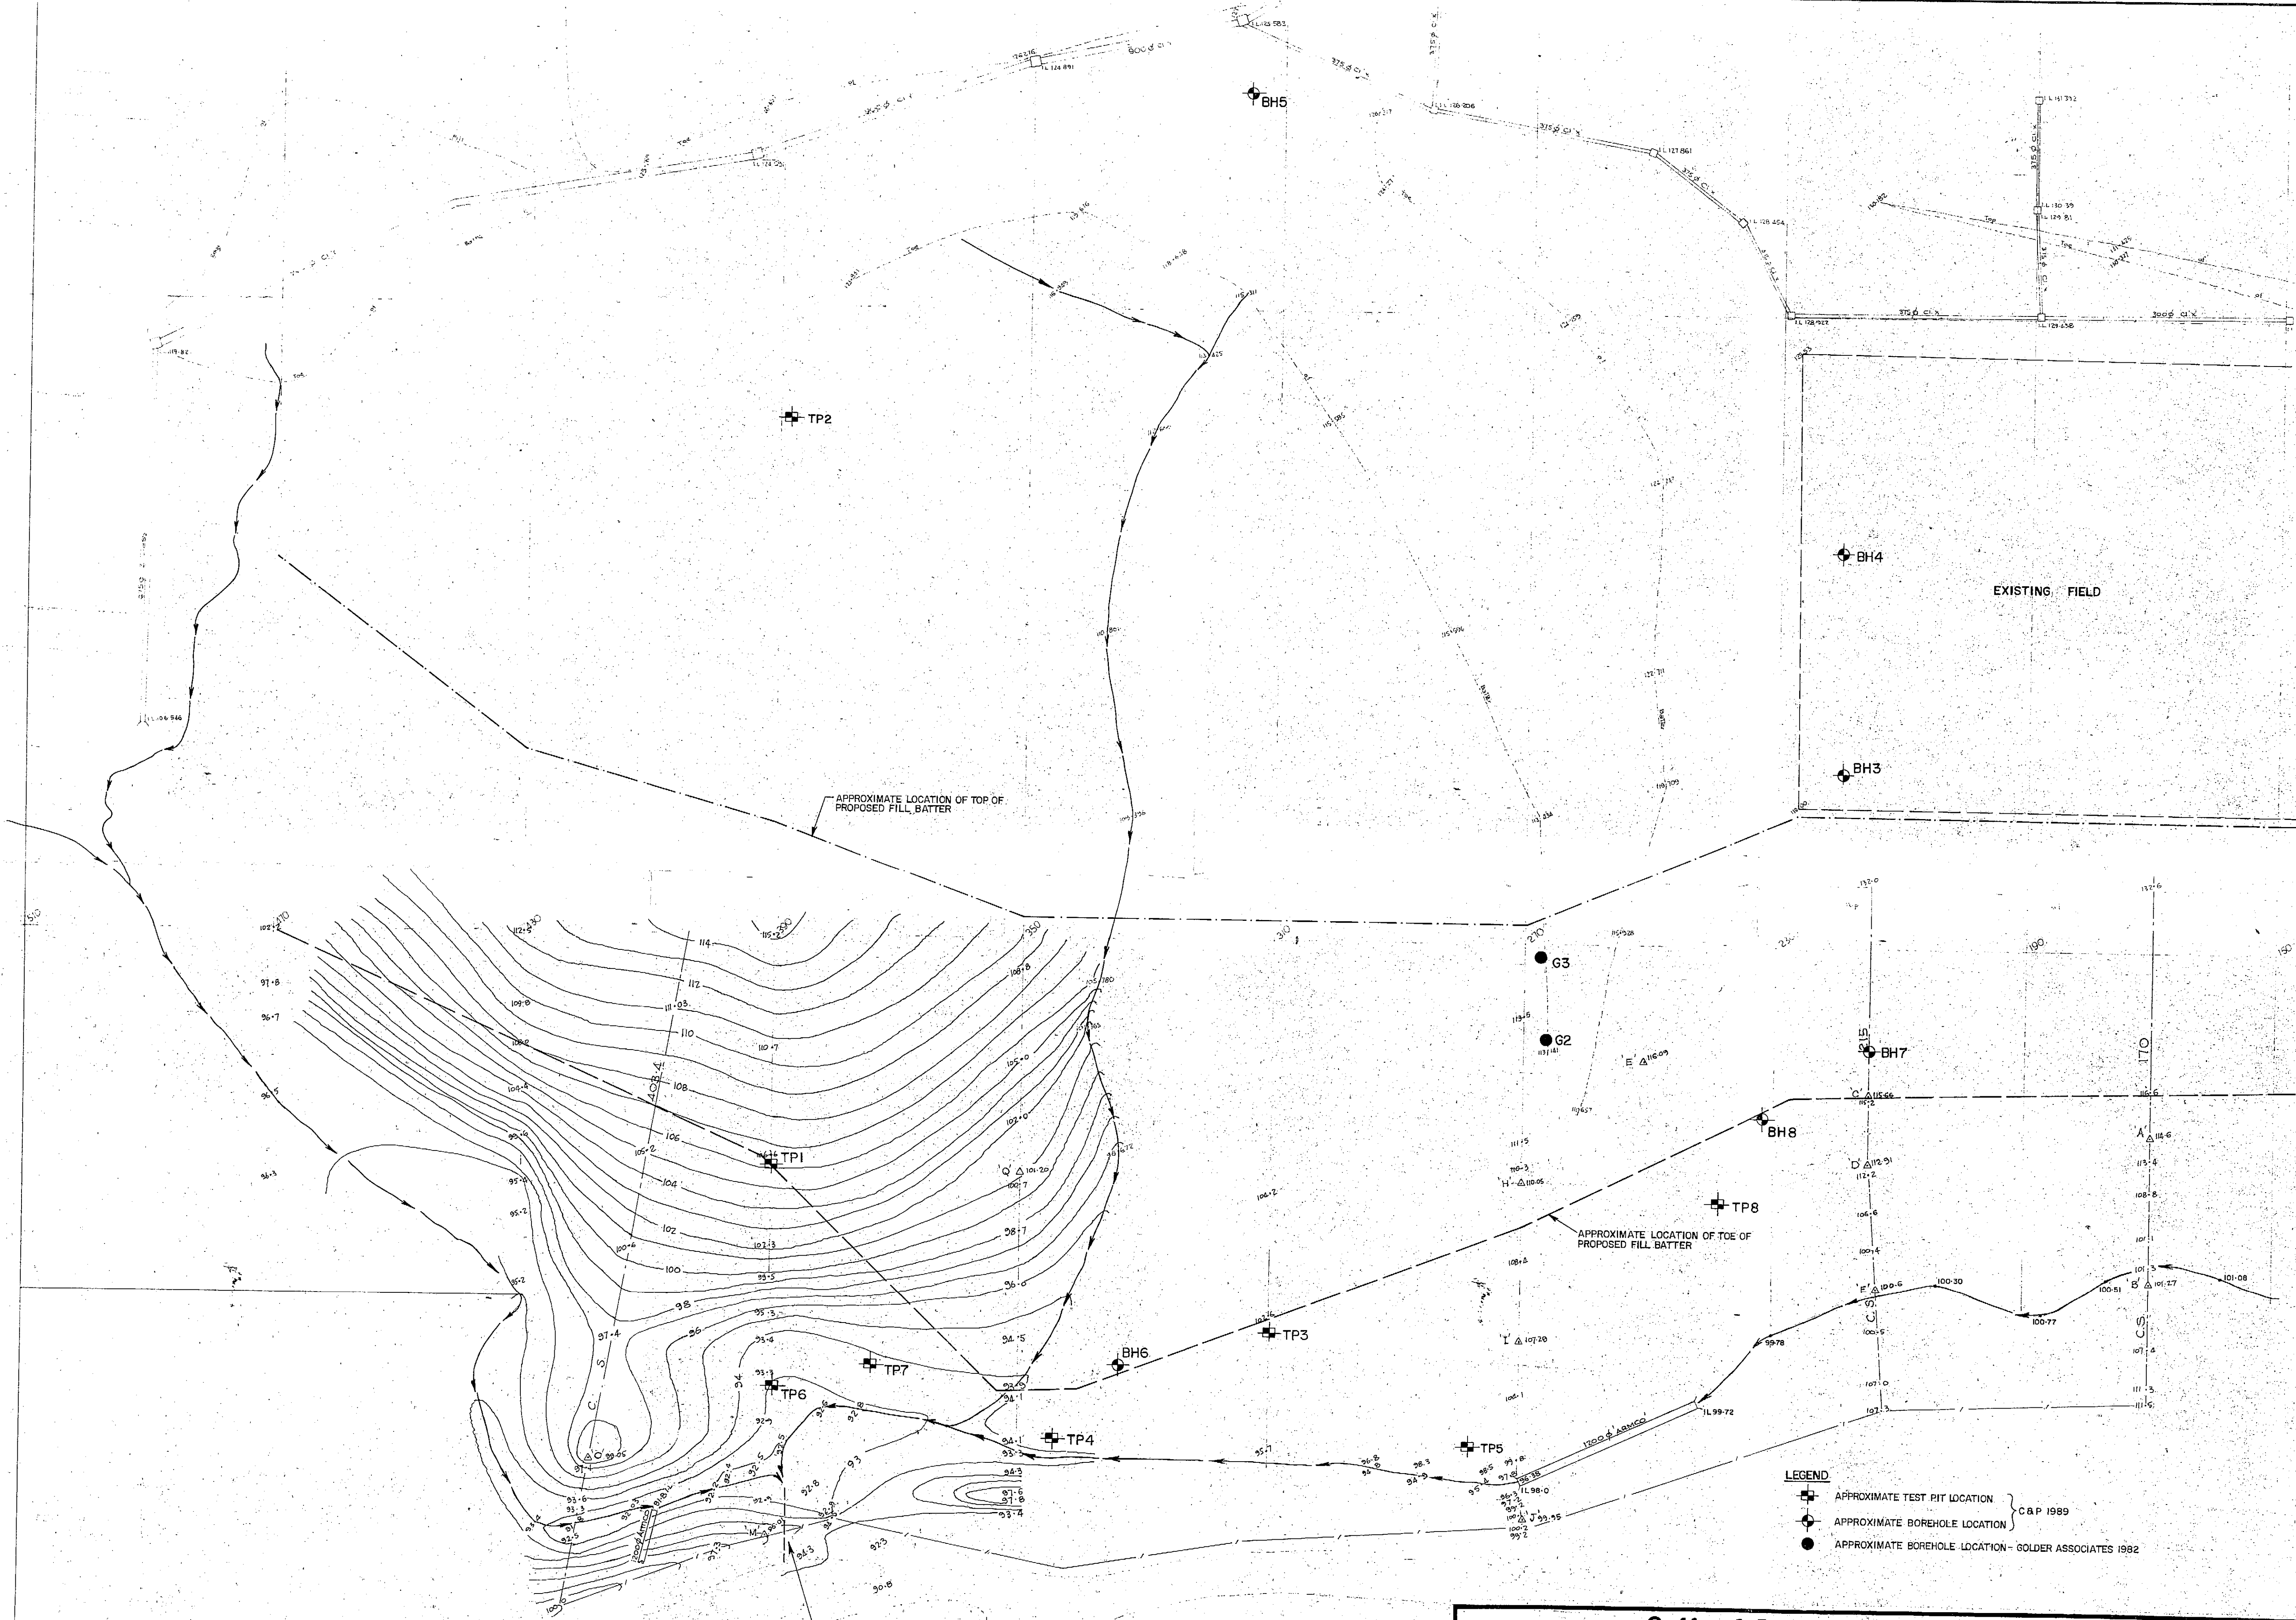
Results of the mapping of bedding planes of the diatreme exposed in the quarry are summarised in Figure 4. The mapping indicates that the dip of the bedding planes in the quarry ranges from less than  $10^{\circ}$  and up to  $75^{\circ}$ . Over the northern half of the quarry face, beds generally dip towards the south east quadrant while over the southern half, beds generally dip towards the north east quadrant. Most bedding was observed to be dipping into the eastern face of the quarry, indicating that the centre of the basinal structure or the pipe structure probably lies east of the current quarry. Extrapolation of the measured bedding dip directions suggests that the centre of the basinal structure is situated east of the existing quarry behind the present eastern face of the quarry. The general lack of clear bedding structures in Golder's hole G2 and in Coffey & Partners' hole BH6 is consistent with this assessment of the structure.

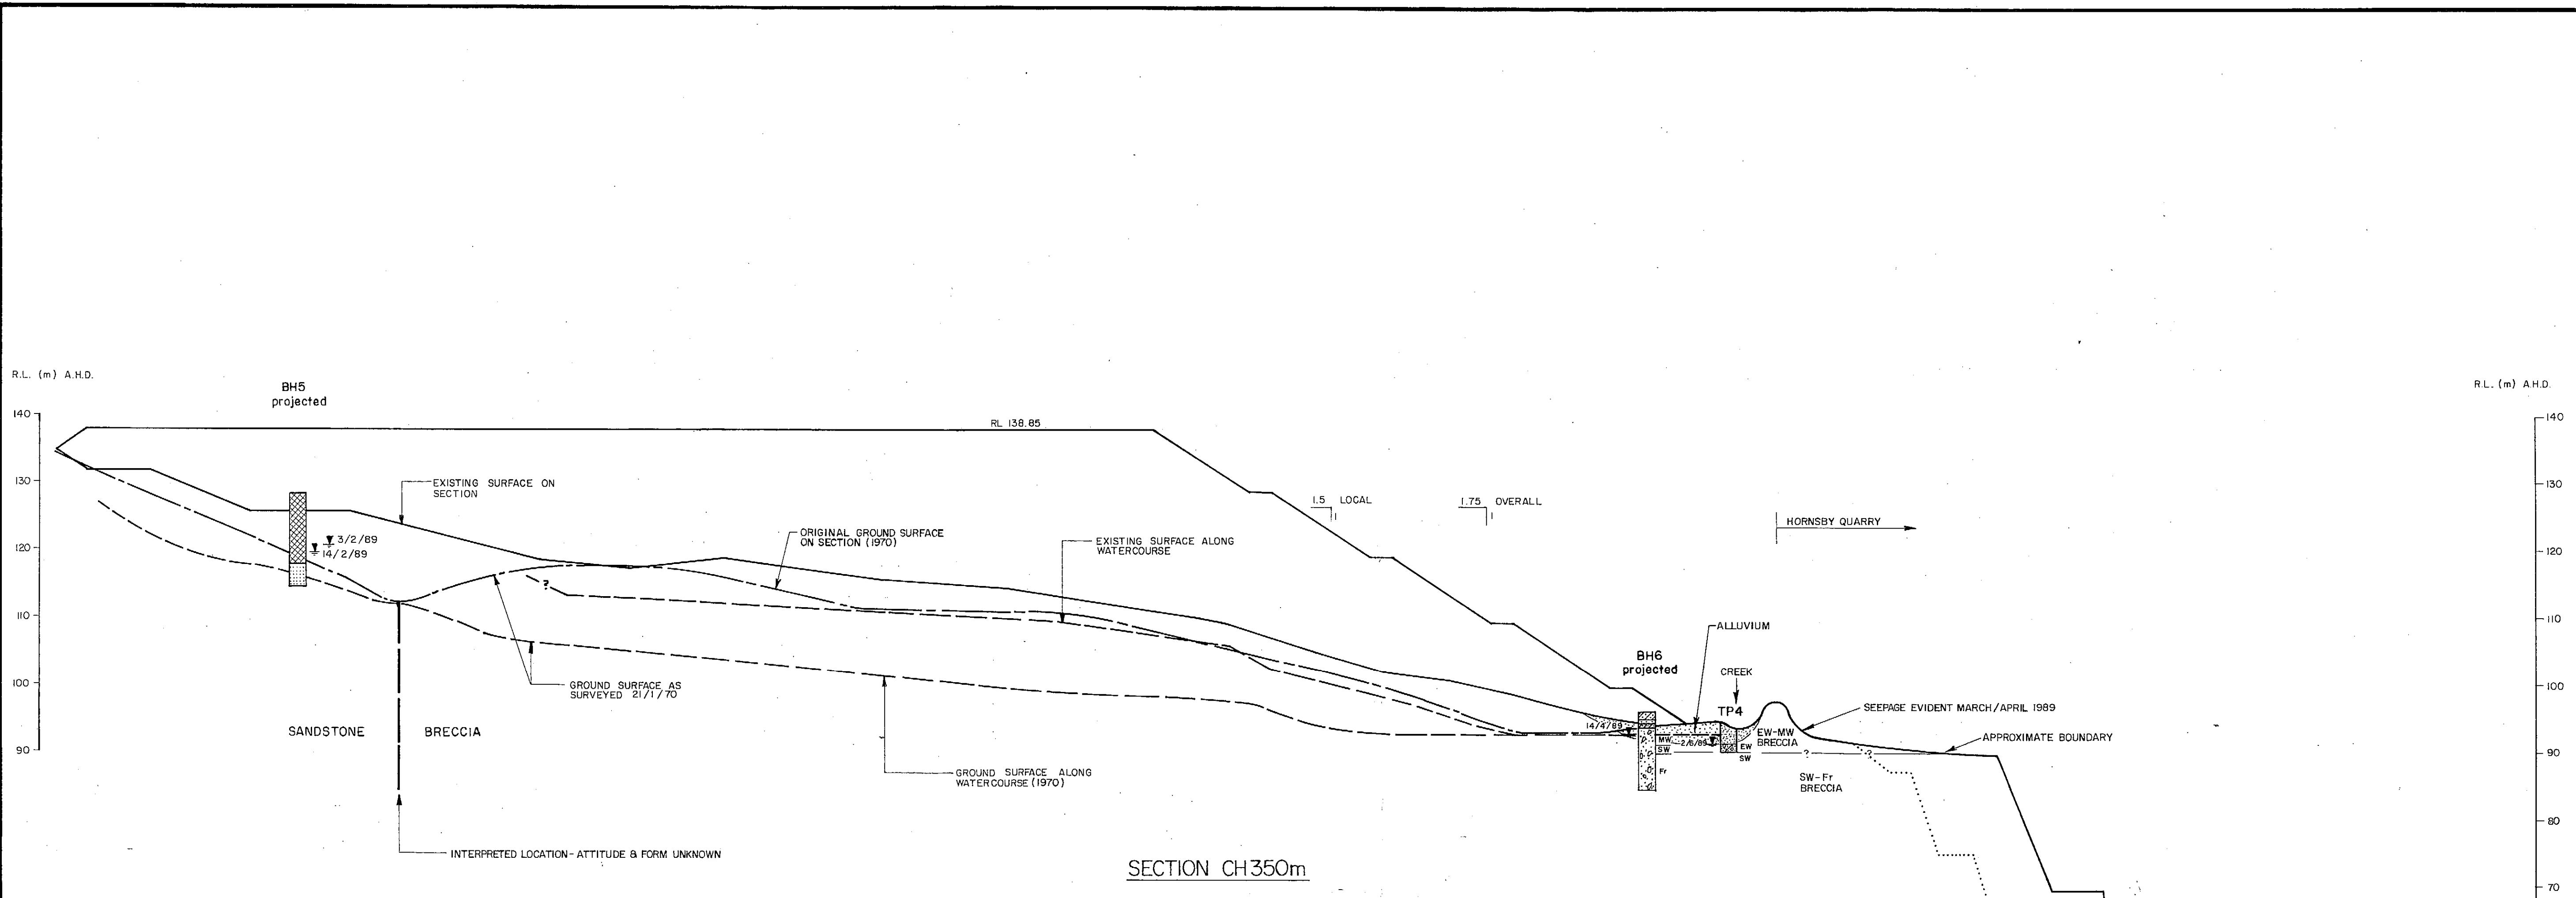
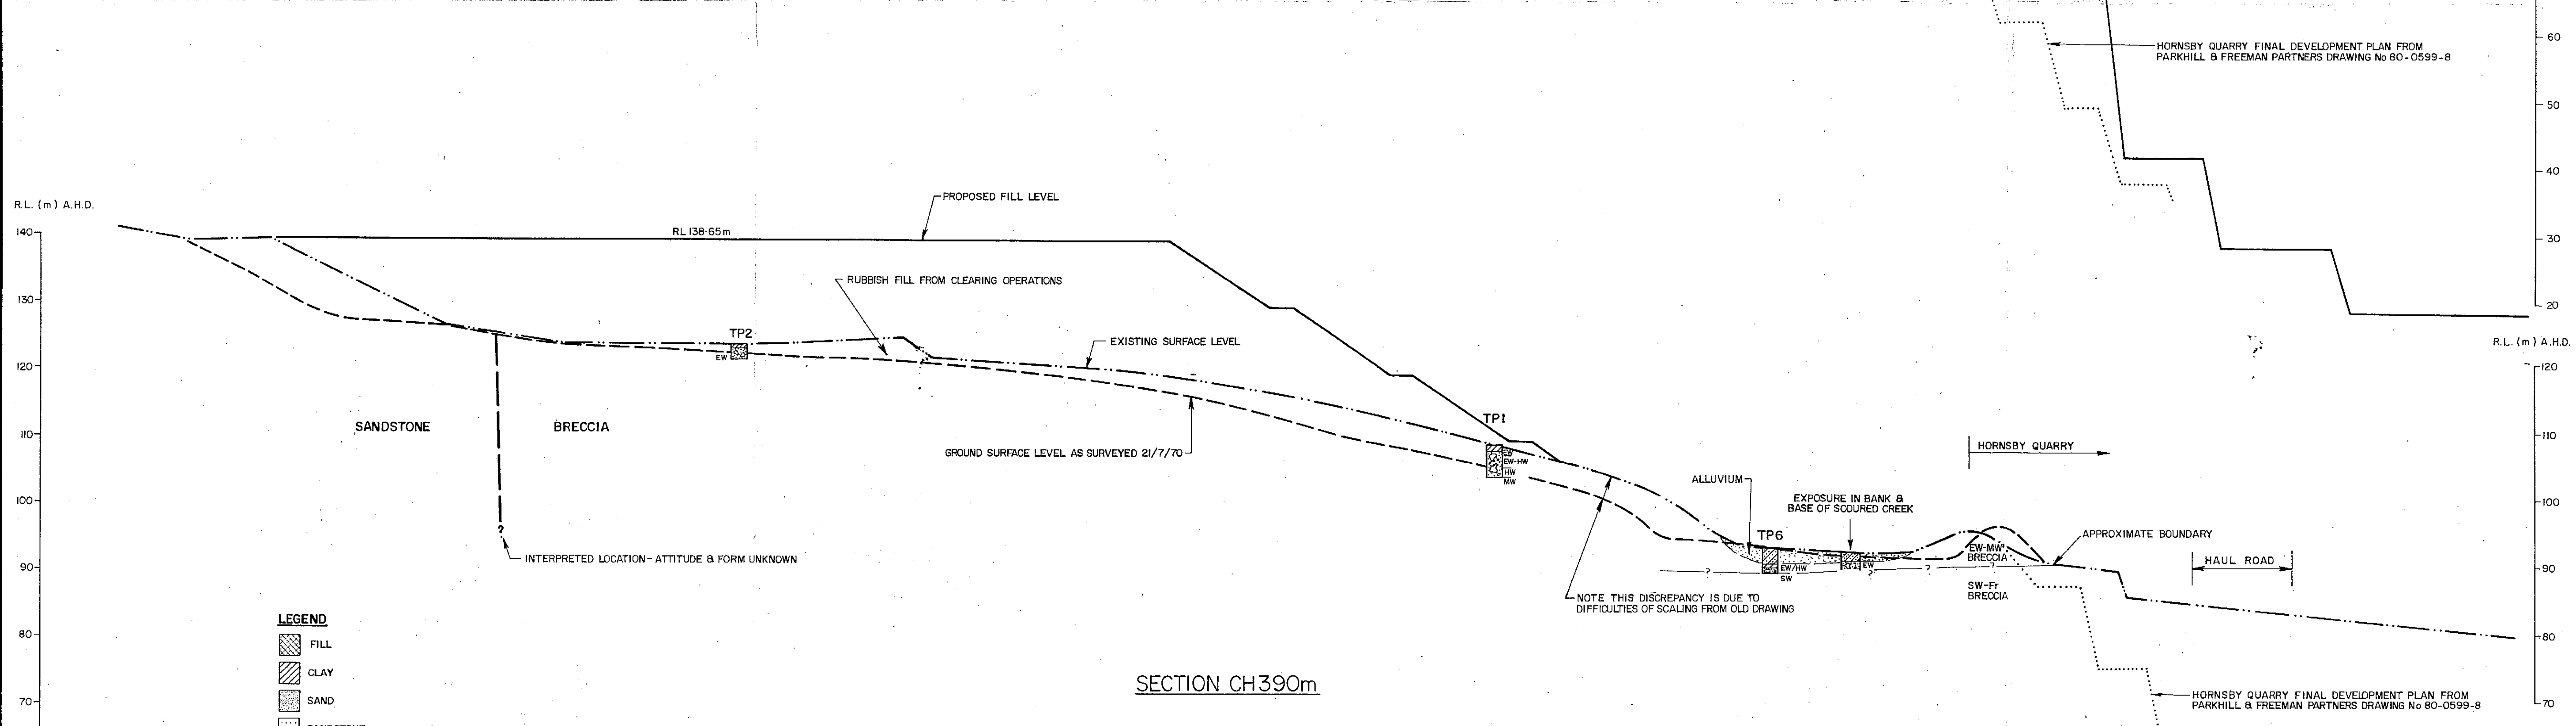
At this section the existing fill is about 20m back from the creek, with a residual breccia slope between. The data suggests a greater depth of weathering than at Ch 350 (Figure 6). Because of the unknown quality of the fill, a groundwater level at the fill and residual soil surface has been assumed.
