HORNSBY SHIRE COUNCIL  
REPORT ON PROPOSED FILLING

OLD MAN'S VALLEY  
HORNSBY

REPORT S8463/2-AC      JULY, 1989

RE: Report on Proposed Filling, Old Man's Valley, Hornsby

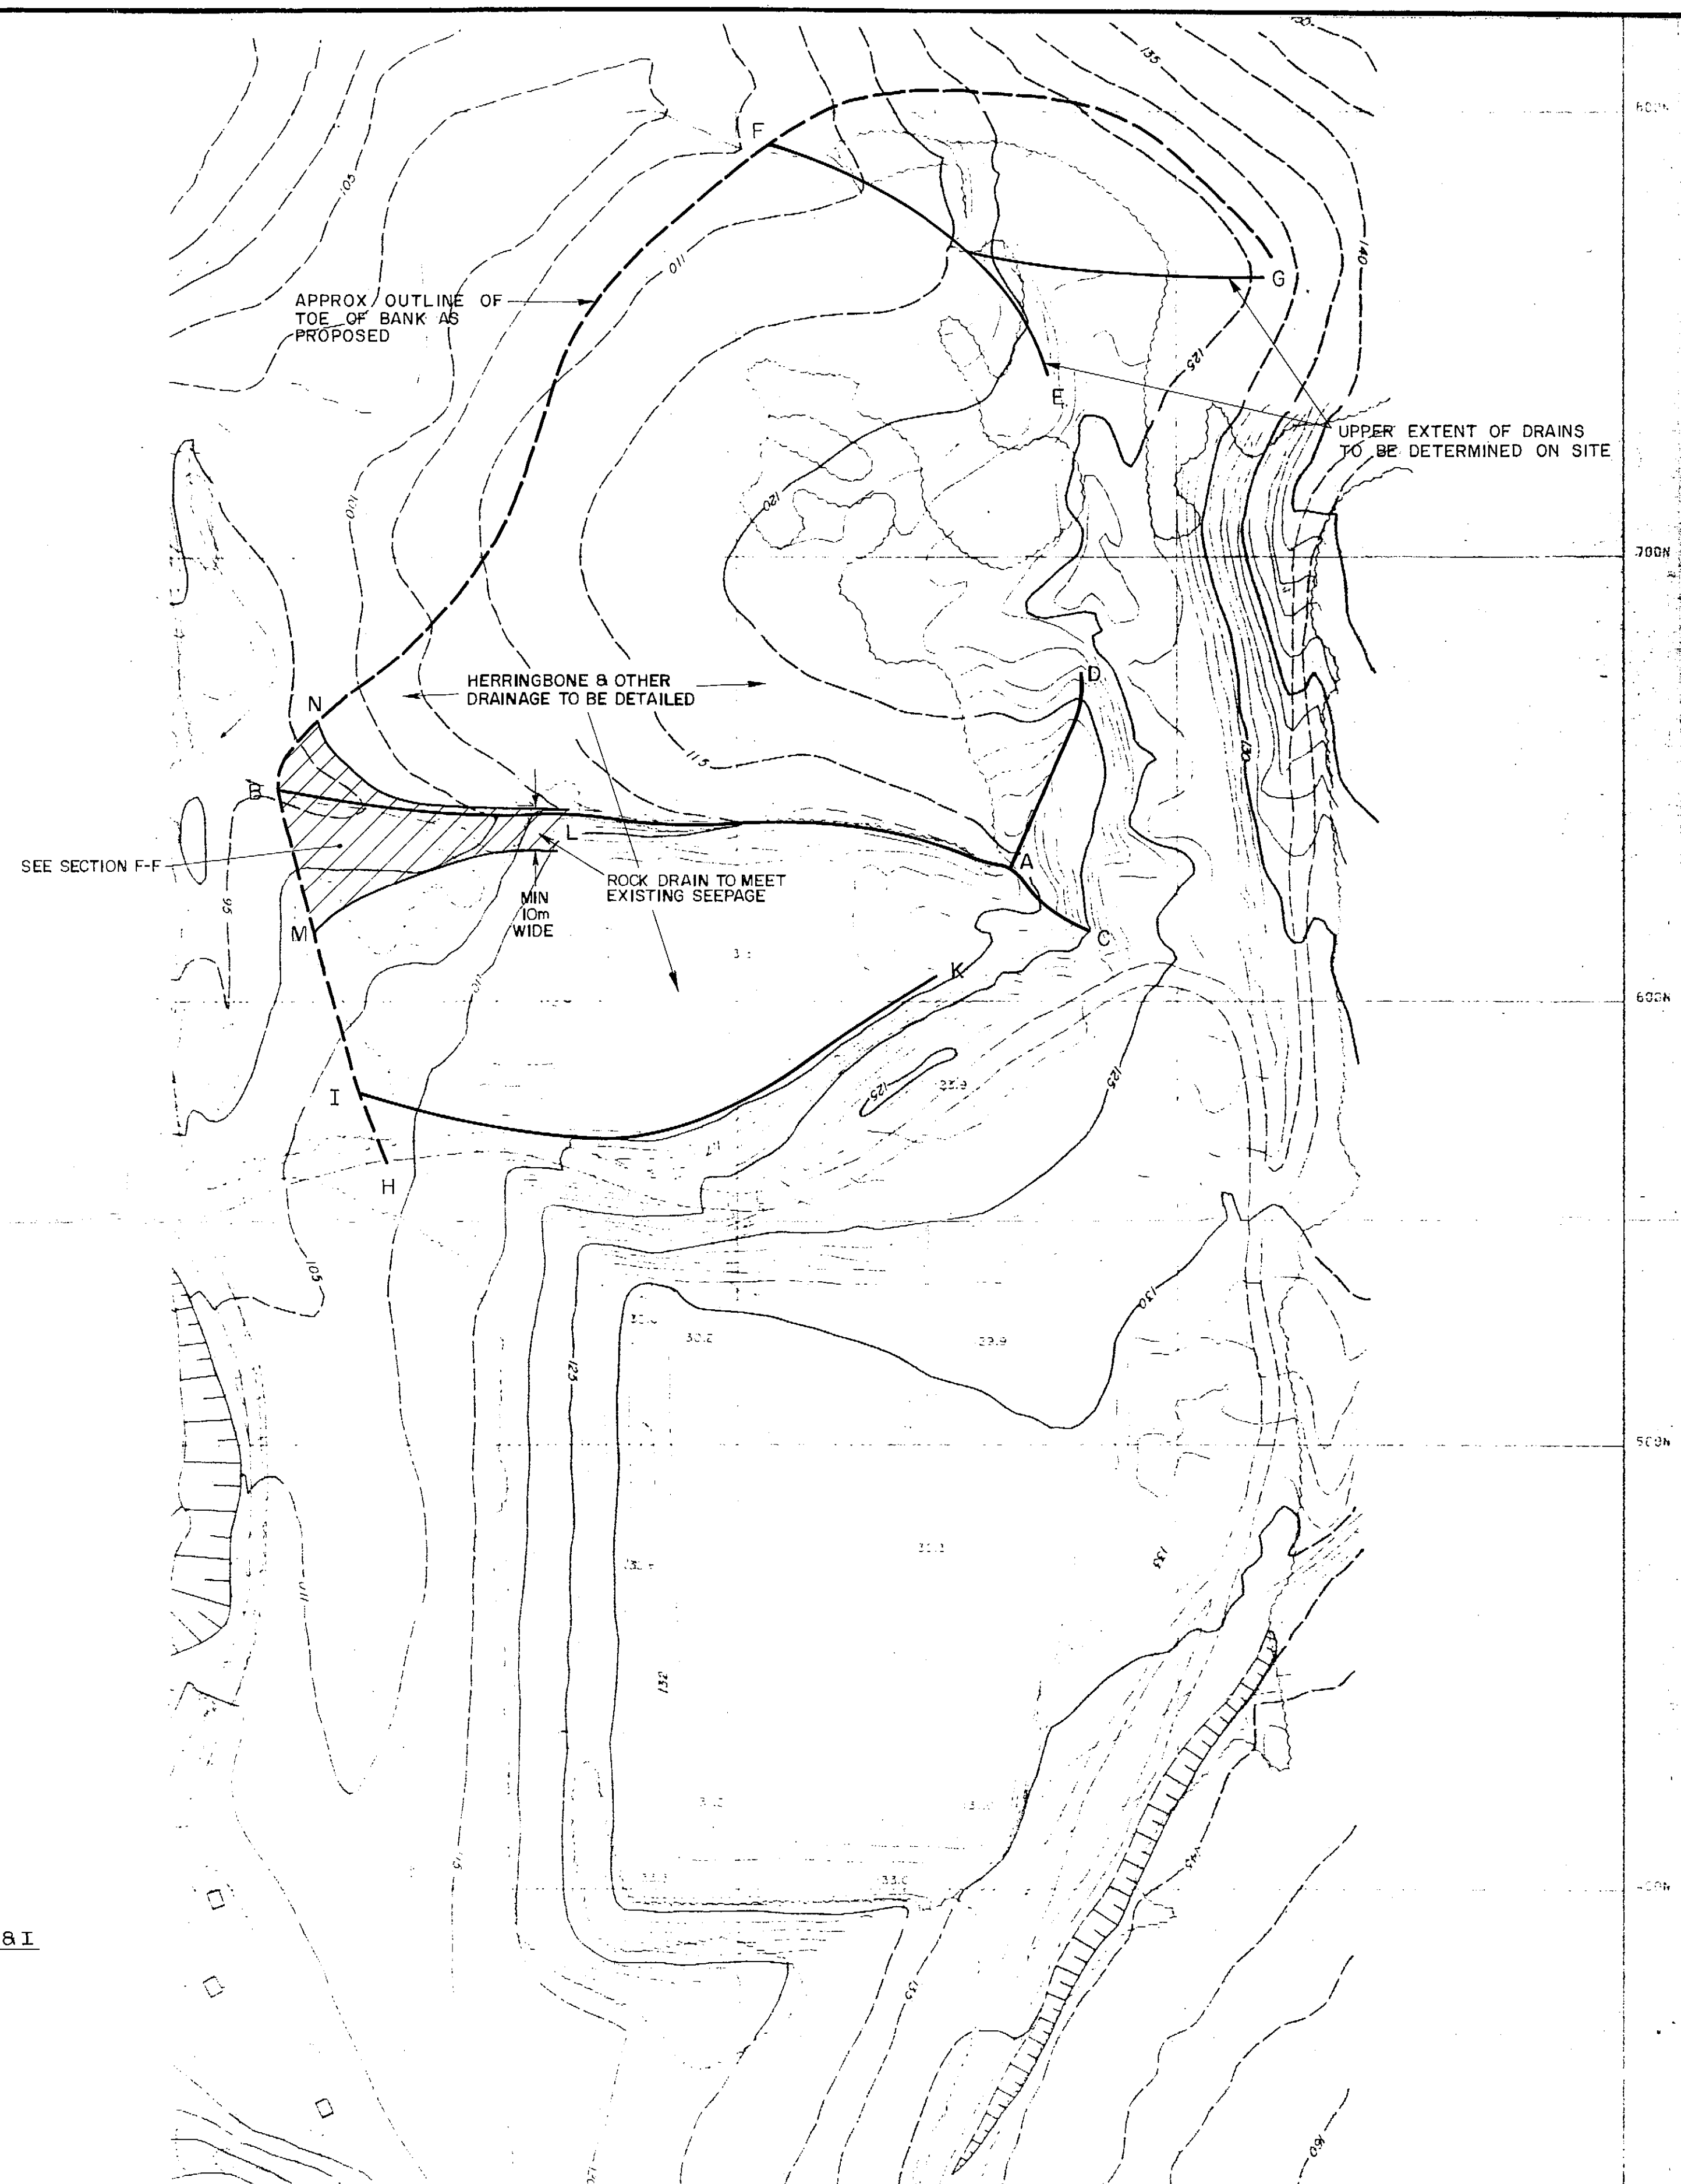
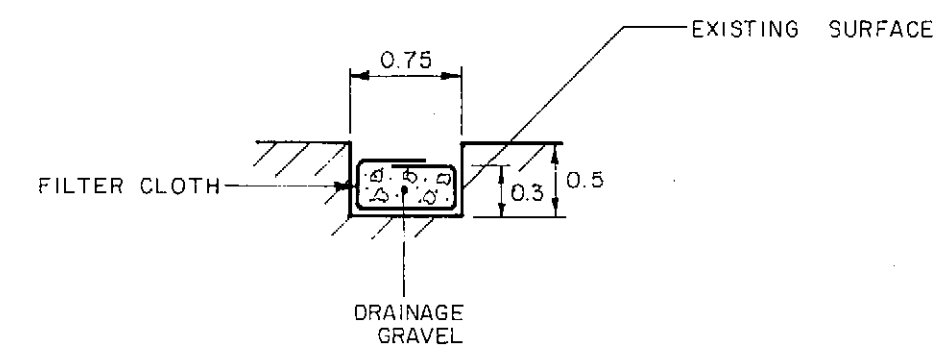
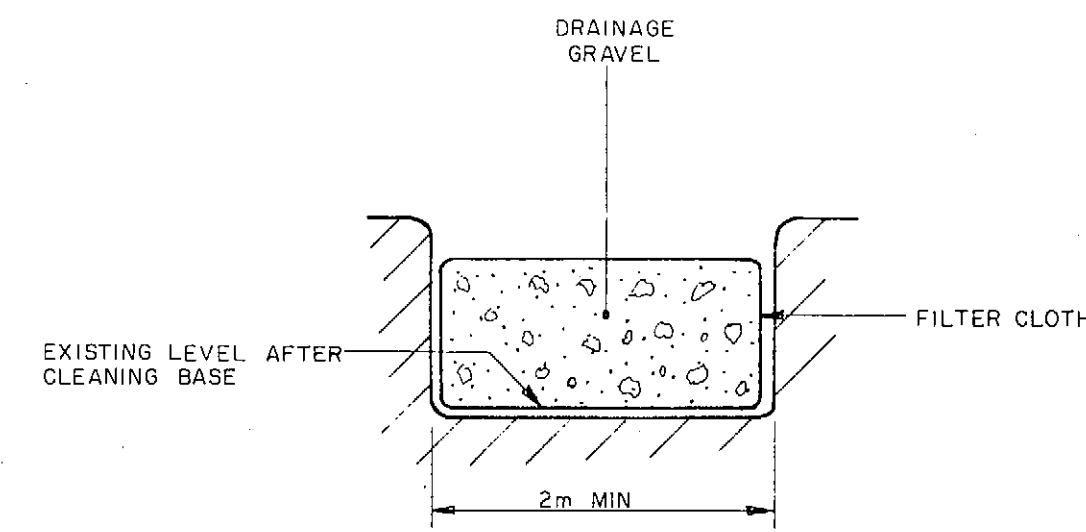
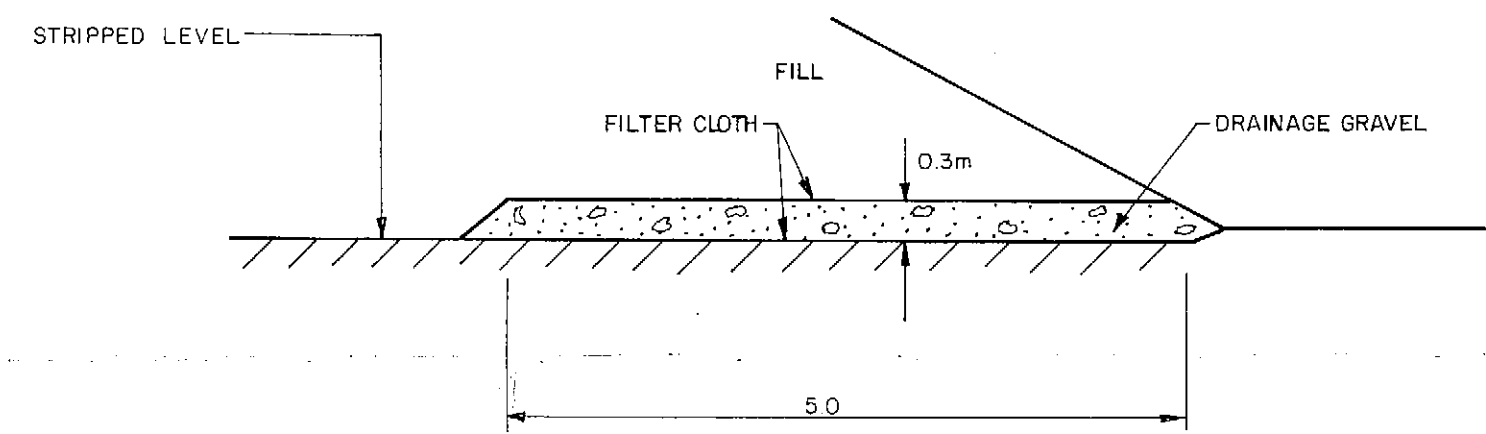
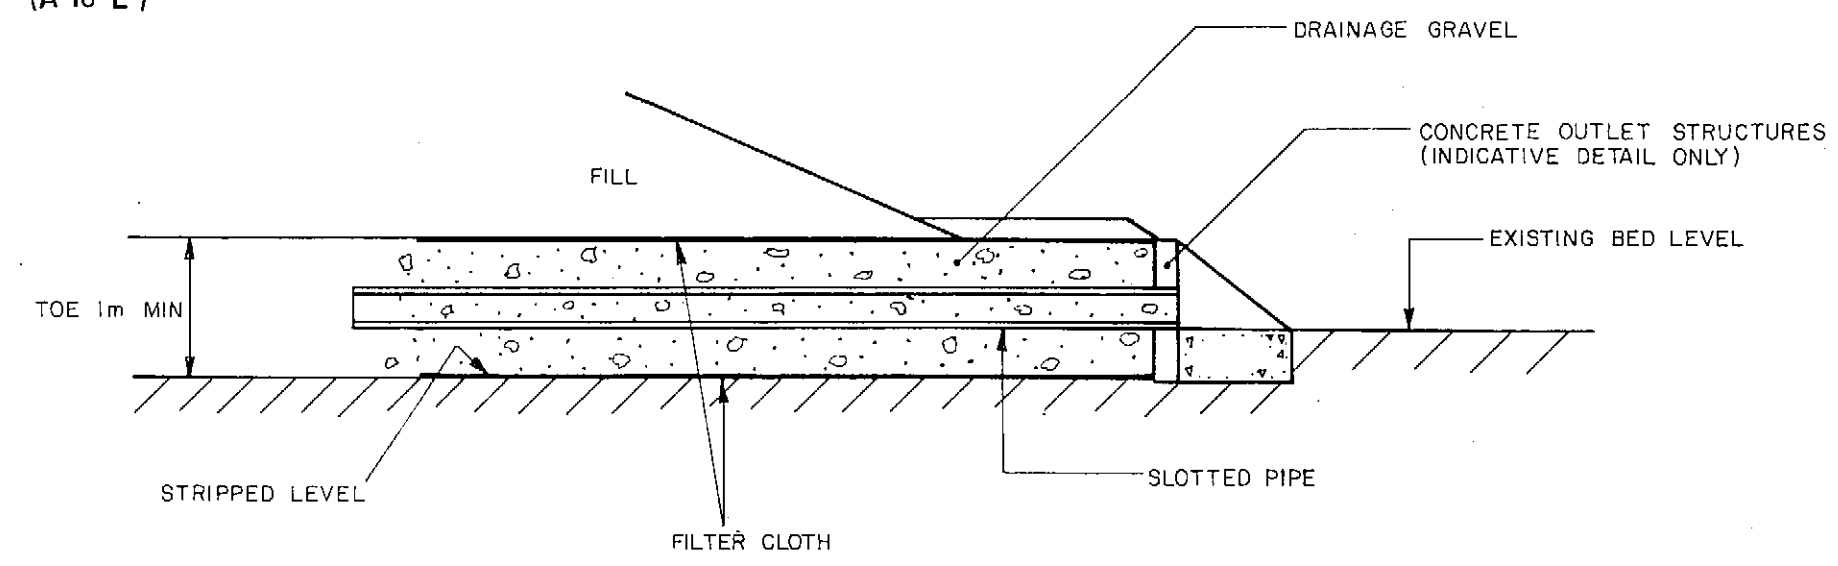
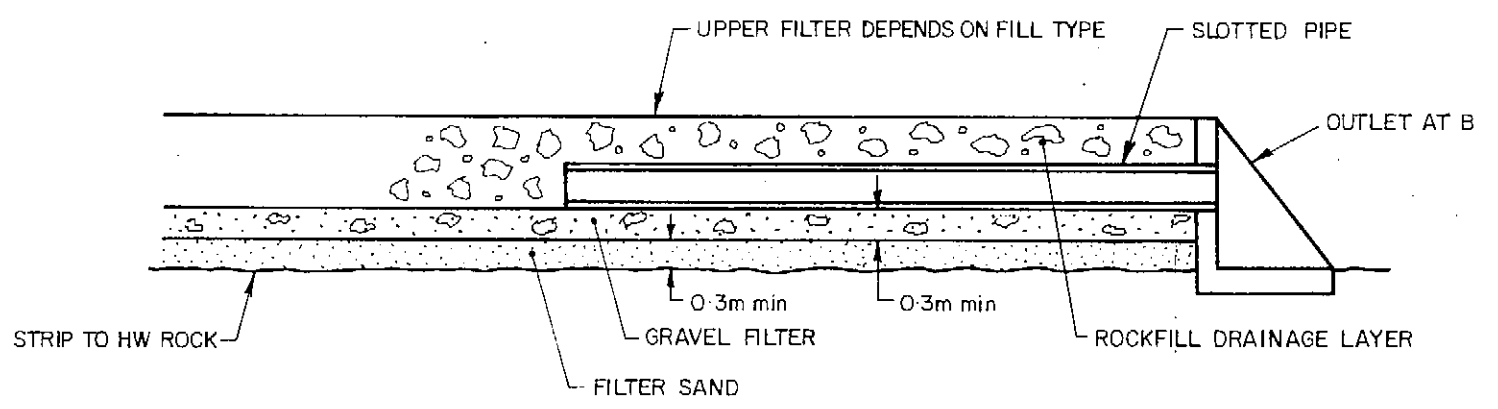
<b>Coffey &amp; Partners Pty. Ltd.</b>		Consulting Engineers in the geotechnical sciences INCORPORATED IN QUEENSLAND	
drawn:	CPT/AB	<b>HORNSBY SHIRE COUNCIL</b> OLD MAN'S VALLEY INDICATIVE DRAINAGE DESIGN	
approved:			
date:			
scale:	1:1000		
		<b>COFFEY</b>	FIGURE 13
			job no: S8463 / 2

Figure 13 shows a tentative layout for subsurface drainage at the northern end. A large filter cloth protected gravel drain is proposed down the present central depression, extending down to the present edge of filling. Because of the high measured flows at this location, a higher capacity drain is required downstream of this point and a rockfill drainage layer protected by conventional two stage filters is proposed. Prior to placement of this drain the area should be stripped of all alluvium, residual soil and extremely weathered breccia. Dewatering of this excavation will be necessary and, depending on the nature of exposed rock, it may be necessary to slush grout the surface, both to inhibit softening and to minimise seepage into the underlying rock.

Depending on details of the amended fill design it may prove necessary to modify the drainage details given in Figure 13 and this drawing must be considered as indicative only.
